Project Category: Residential Exterior|

Residential Exterior \$50,000 - \$100,000

Completion Date: May 21, 2020

Location: Middleton, WI

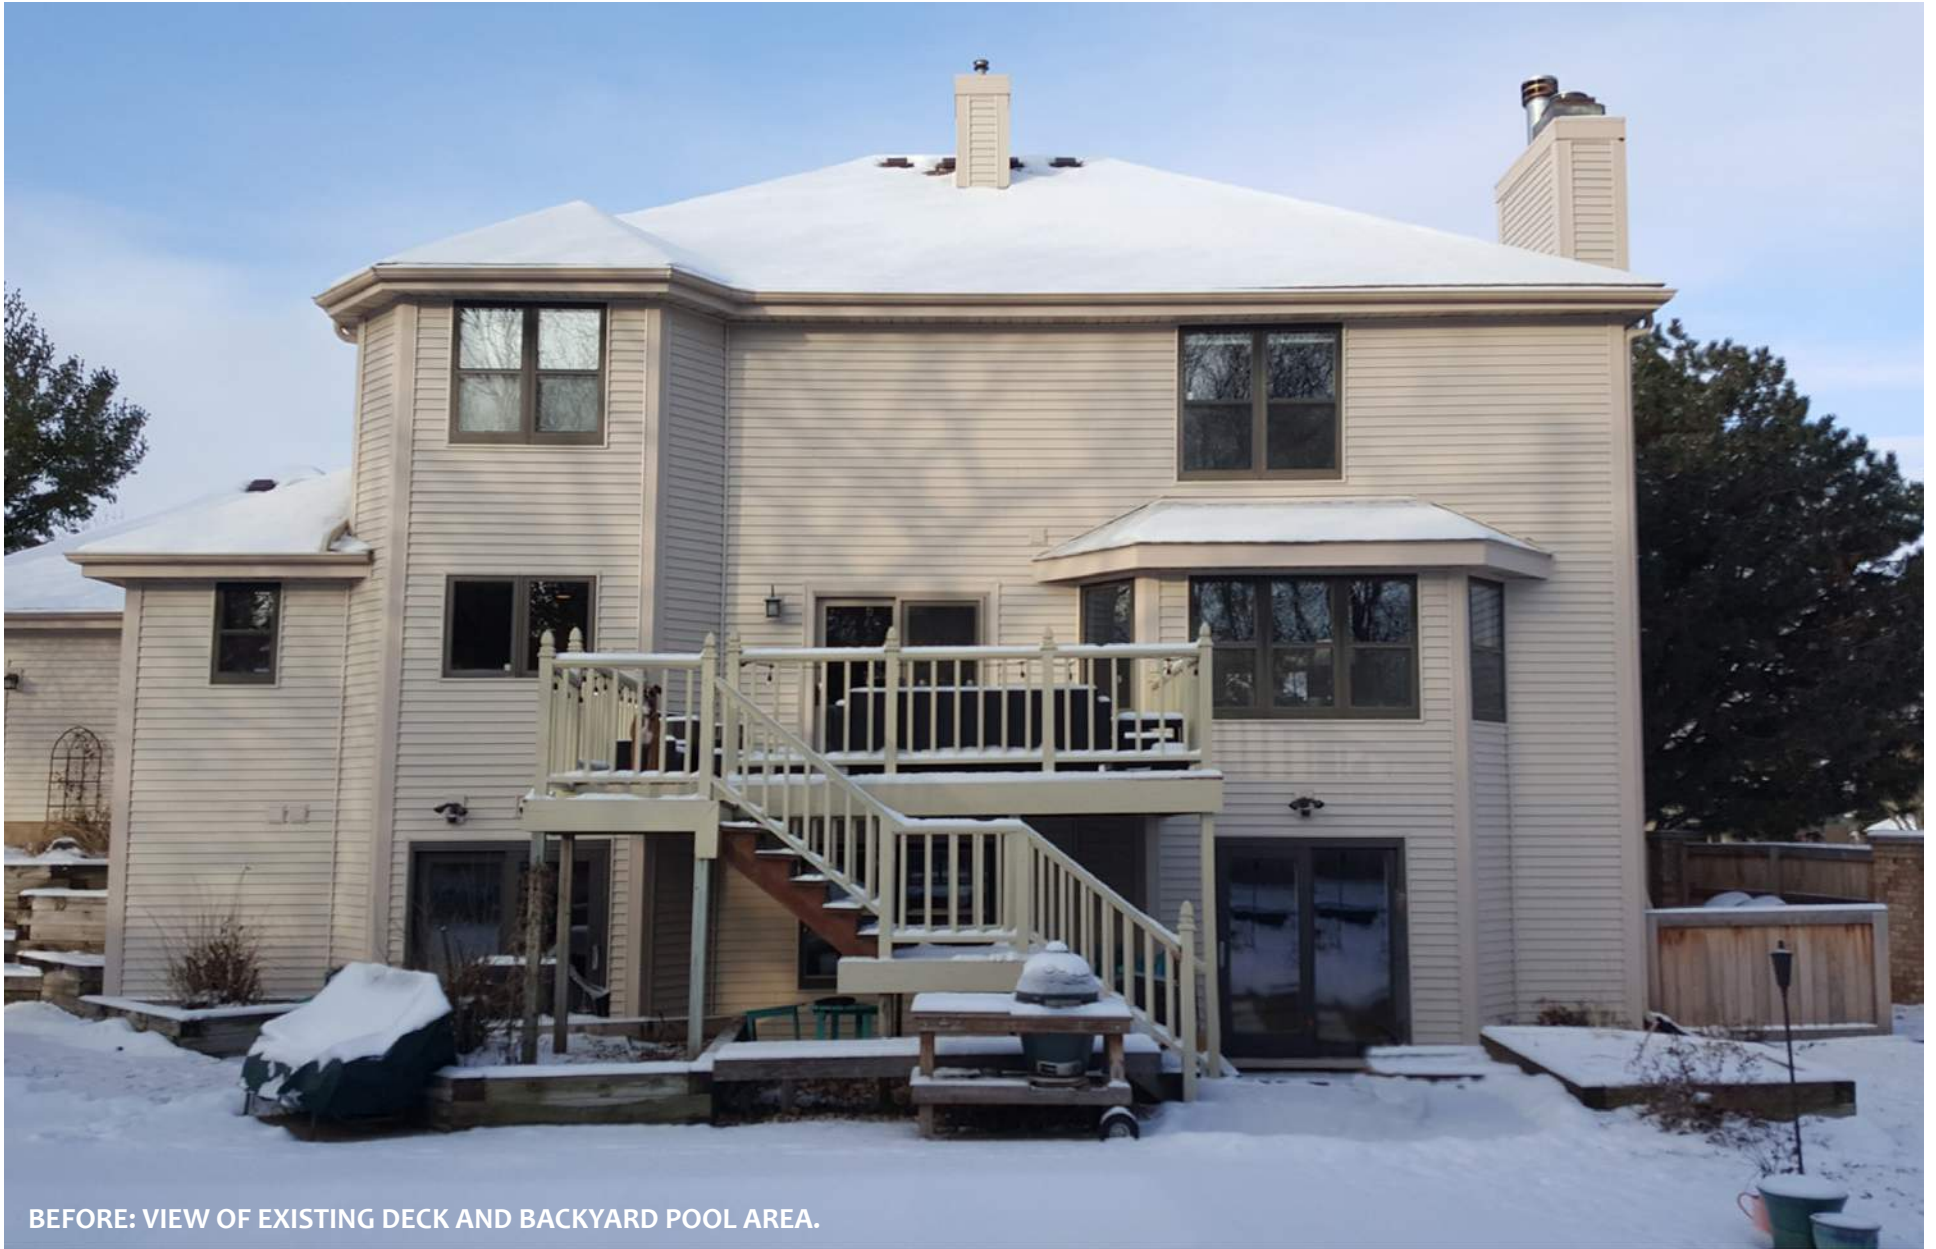
BEFORE: VIEW OF EXISTING DECK AND BACKYARD POOL AREA.

While the front of the existing home and its interior are generally formal in their design and feel, the backyard was different. With the pool, the trees, and the wood fence, it had a much more relaxed feeling. However, the deck that connected them was on the verge of falling down. It was visibly tilted, and besides that, it was too small for what they wanted to use it for.

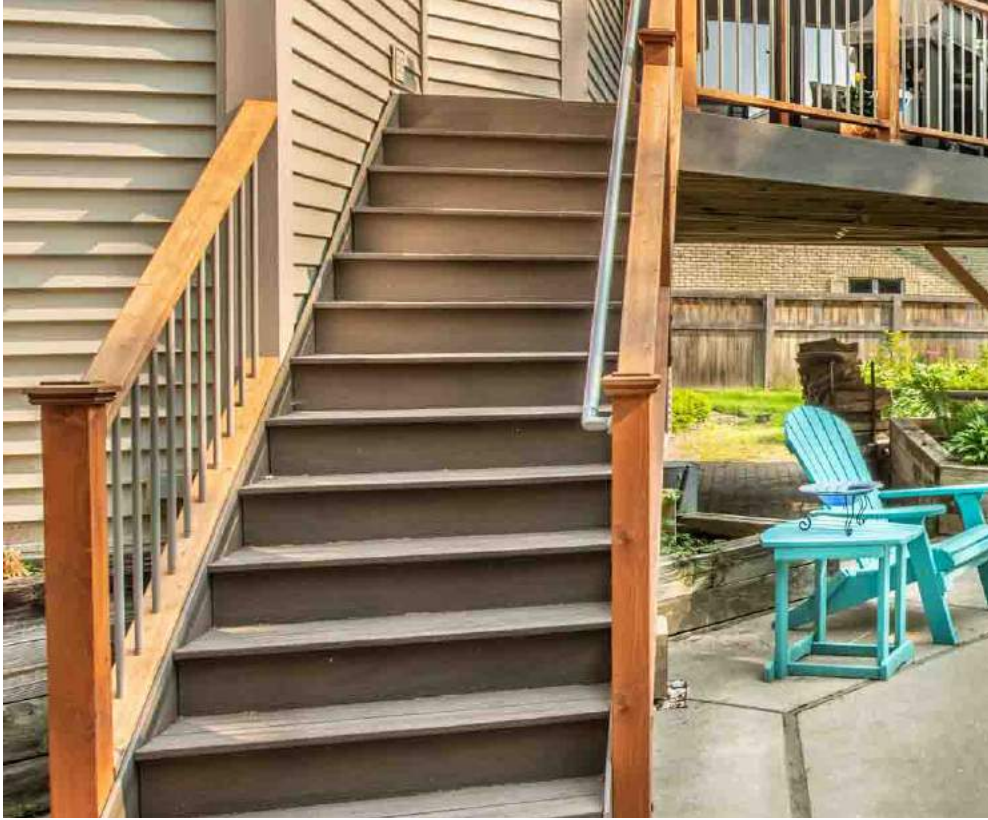
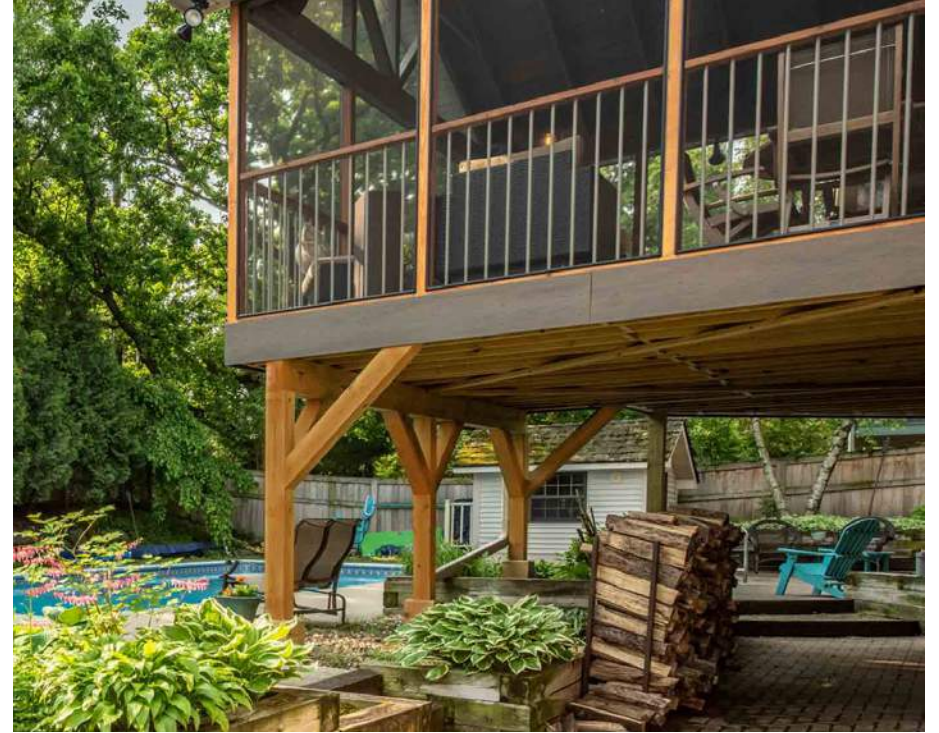
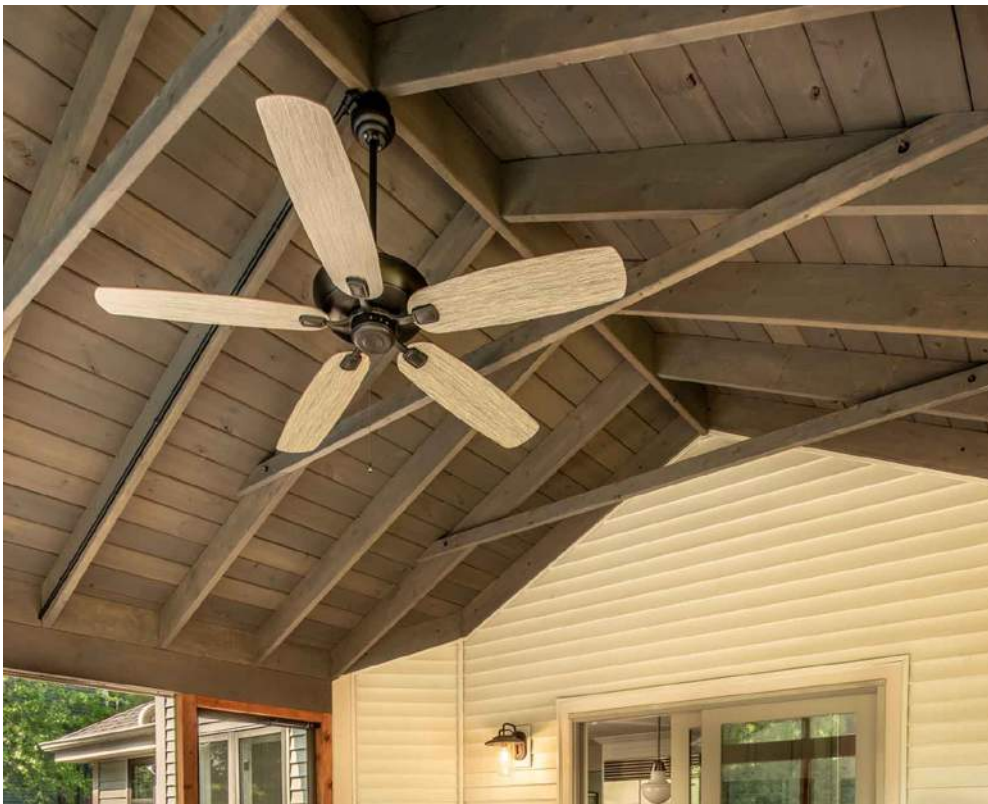
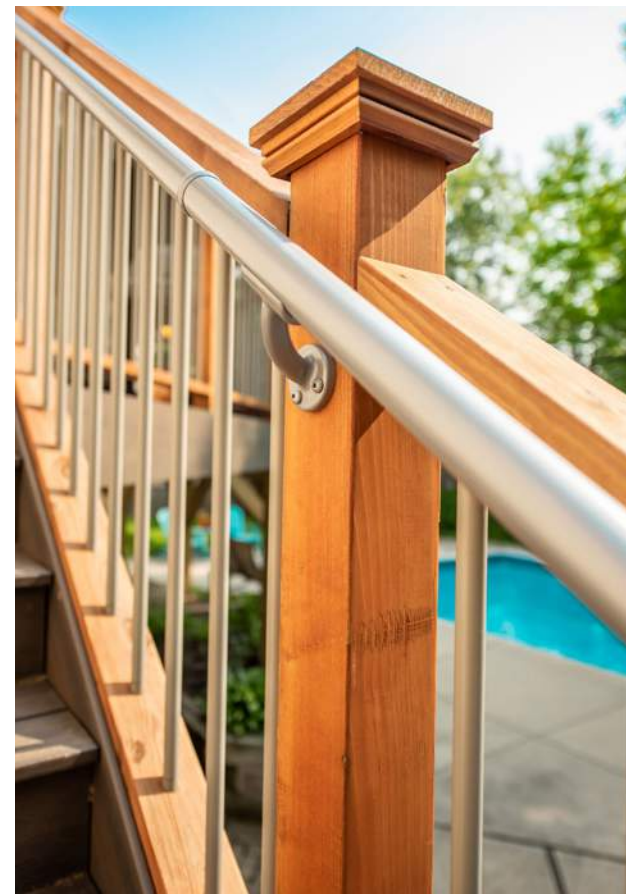
AFTER: THE STRUCTURE OF THE PORCH USES SOLID-SAWN DOUG FIR LUMBER, THAT HAS BEEN LEFT EXPOSED, AND A TONGUE AND GROOVE ROOF SHEATHING. THE RAILING SYSTEM WAS CONSTRUCTED OF ALUMINUM BALUSTERS AND HANDRAIL WITH CEDAR POSTS AND RAILING.

The evidence of superior craftsmanship is in the execution of a screened porch where all wood framing is exposed. Stained solid-sawn doug fir lumber was used for often-concealed headers, rafters and roof sheathing. Even the floor joists are exposed from the walk-out lower level. Attention was paid in every area of work in order to make our work beautiful without the added cost of installing materials that would provide a finished ceiling below the floor joists.

As a measure of cost-control and value engineering, we determined that the easiest way to get the look of the plank ceiling was NOT to use solid 2 x 6 T & G roof decking. Rather, we used standard 3/4" thick T & G boards, with another layer of OSB over the top, such that the shingle nails do not penetrate the exposed pine ceiling. This provided the desired look, the needed structure, and the best value for our clients.

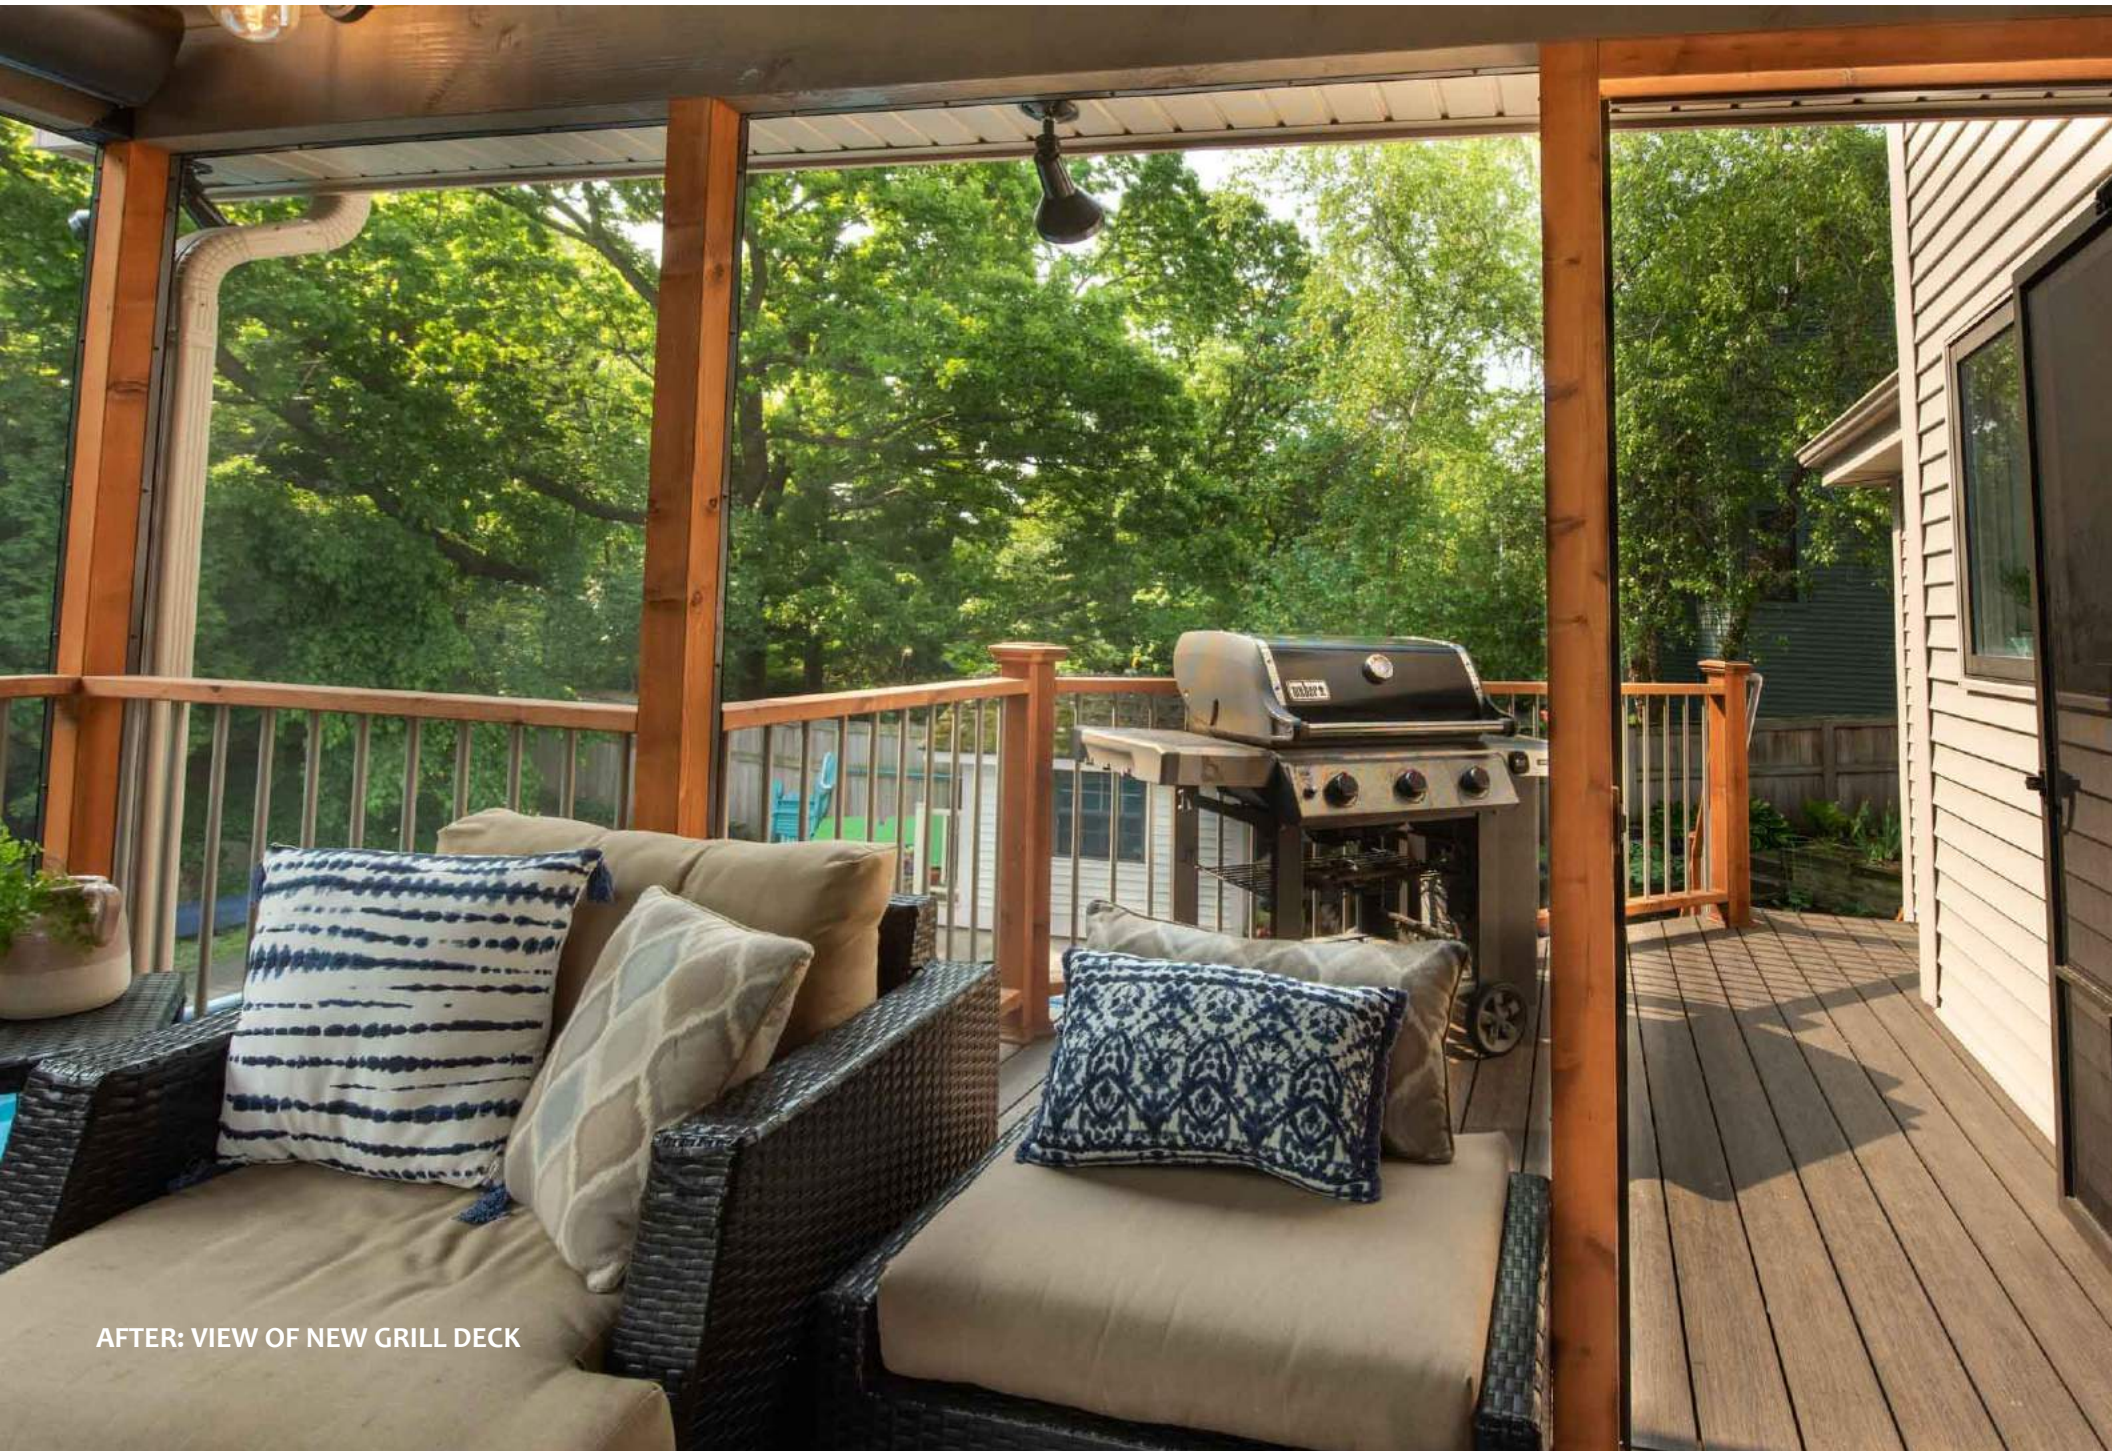
AFTER: VIEW OF NEW GRILL DECK

An important function of this project was the grilling deck. They knew that they did not need a large outdoor deck space, rather something that was just enough to place the grill, with adequate space around it, so that the heat does not damage any of the structure or siding.

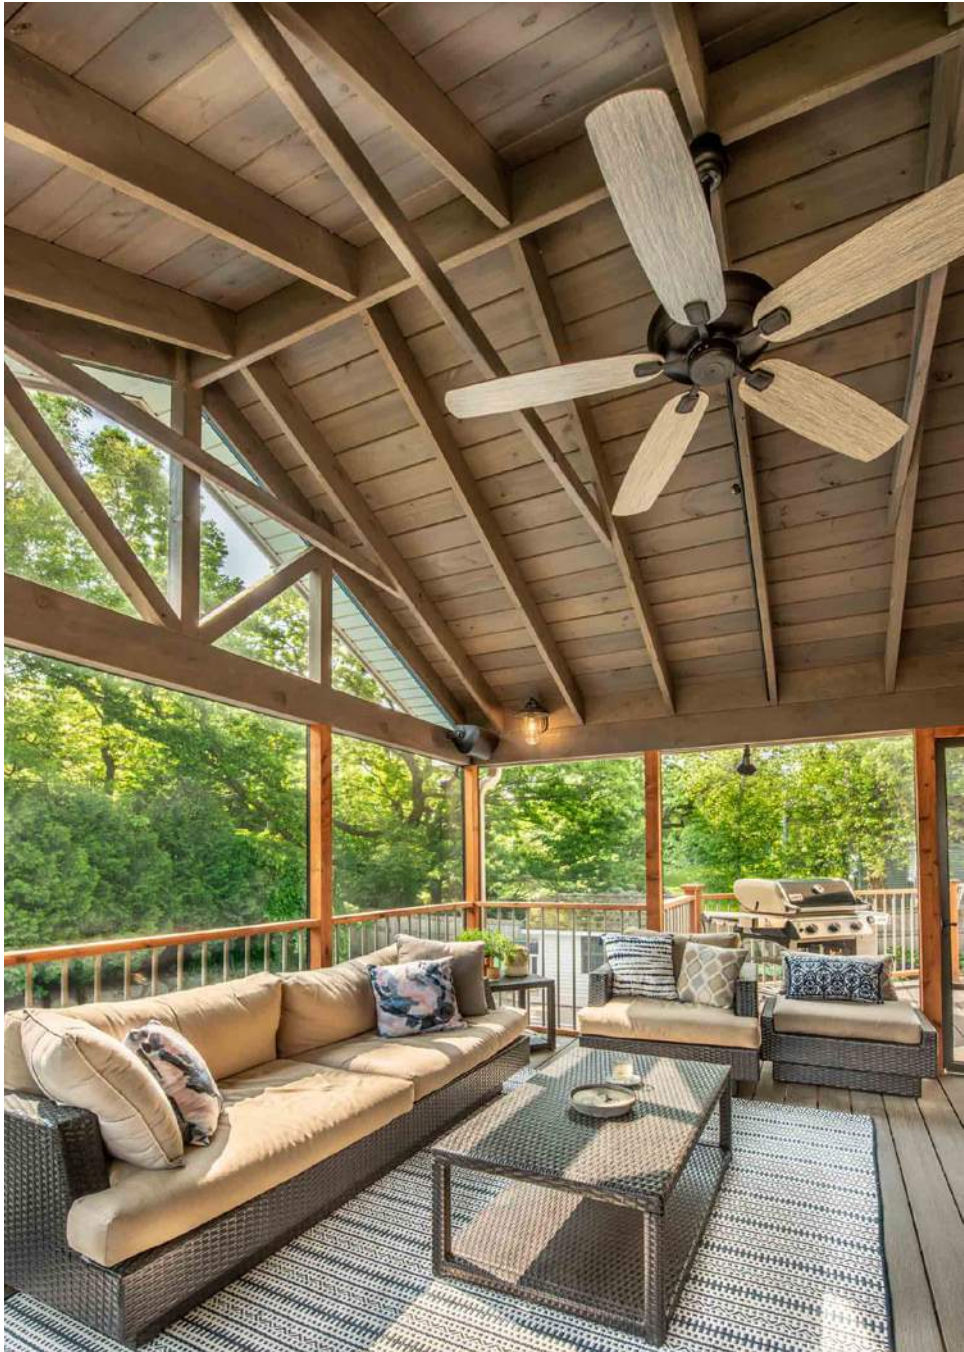
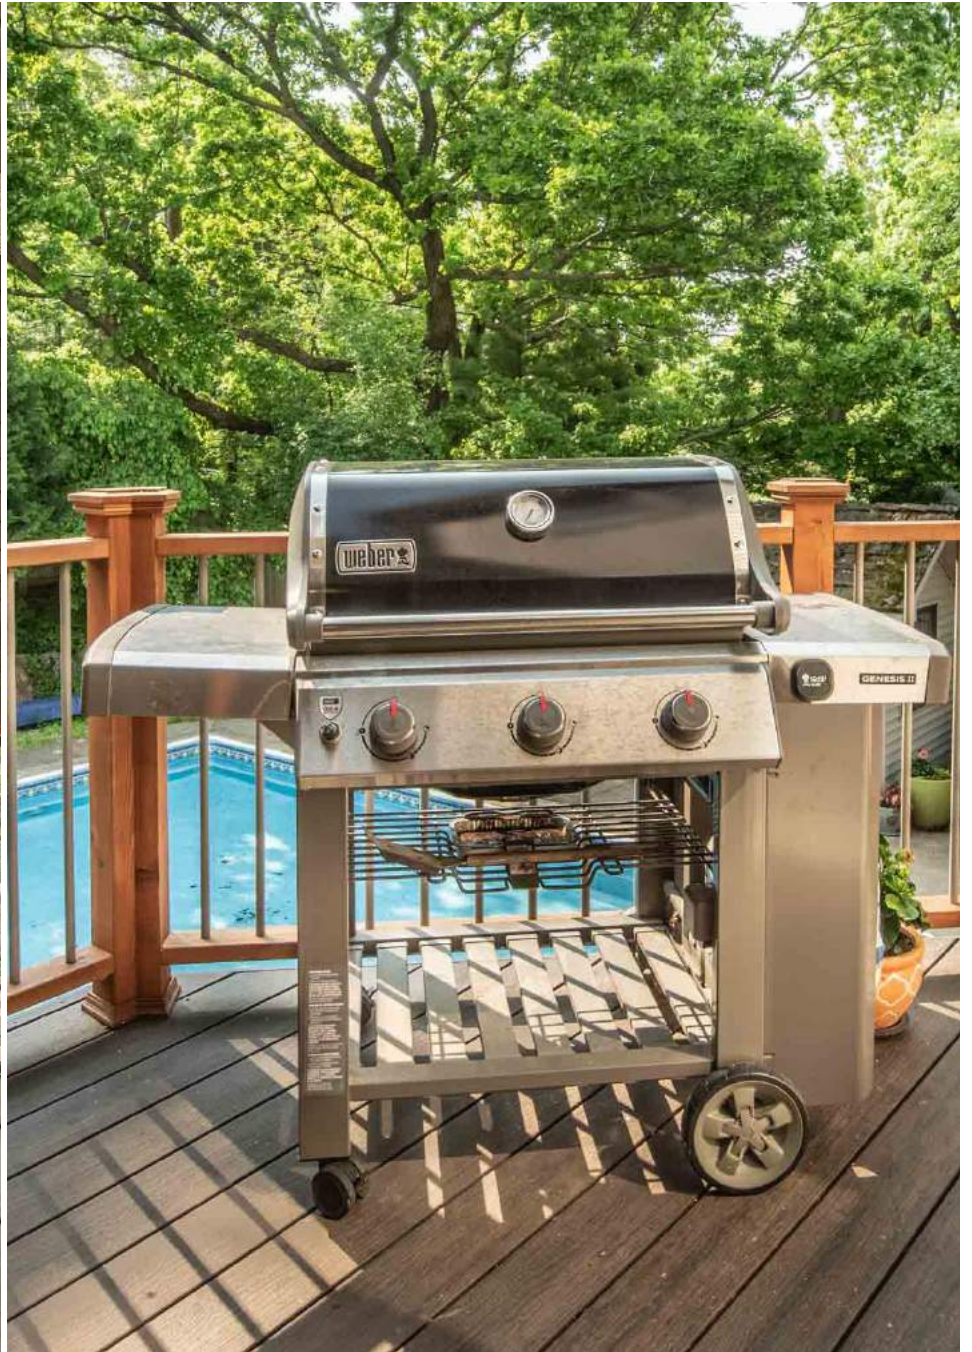
AFTER: SPACE THAT WOULD ACCOMMODATE THE GAS GRILL - THERE IS NOW PROPER SPACE FOR GRILLING, AND A CLEAR PATH FROM THE HOUSE, THROUGH THE PORCH, DOWN THE STAIRS, TO THE POOL.

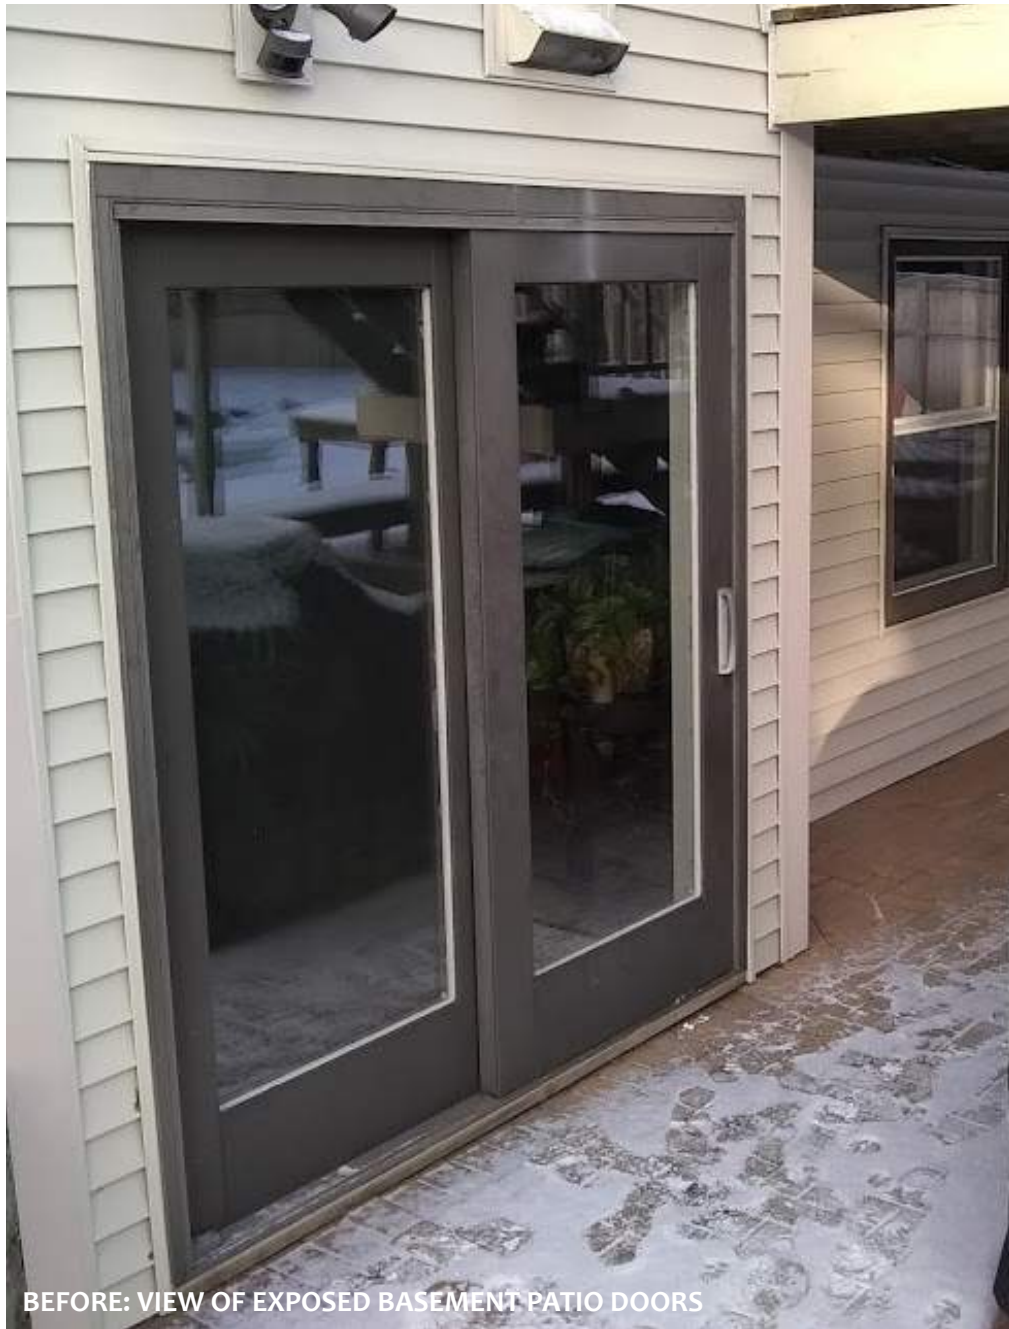
BEFORE: VIEW OF EXPOSED BASEMENT PATIO DOORS

One of the unique challenges of the deck was that the patio doors lead out from the exposed basement below and actually step up hill to the pool deck. So the design had to be very careful to allow for headroom, as well as respecting the views out of the windows and patio doors.

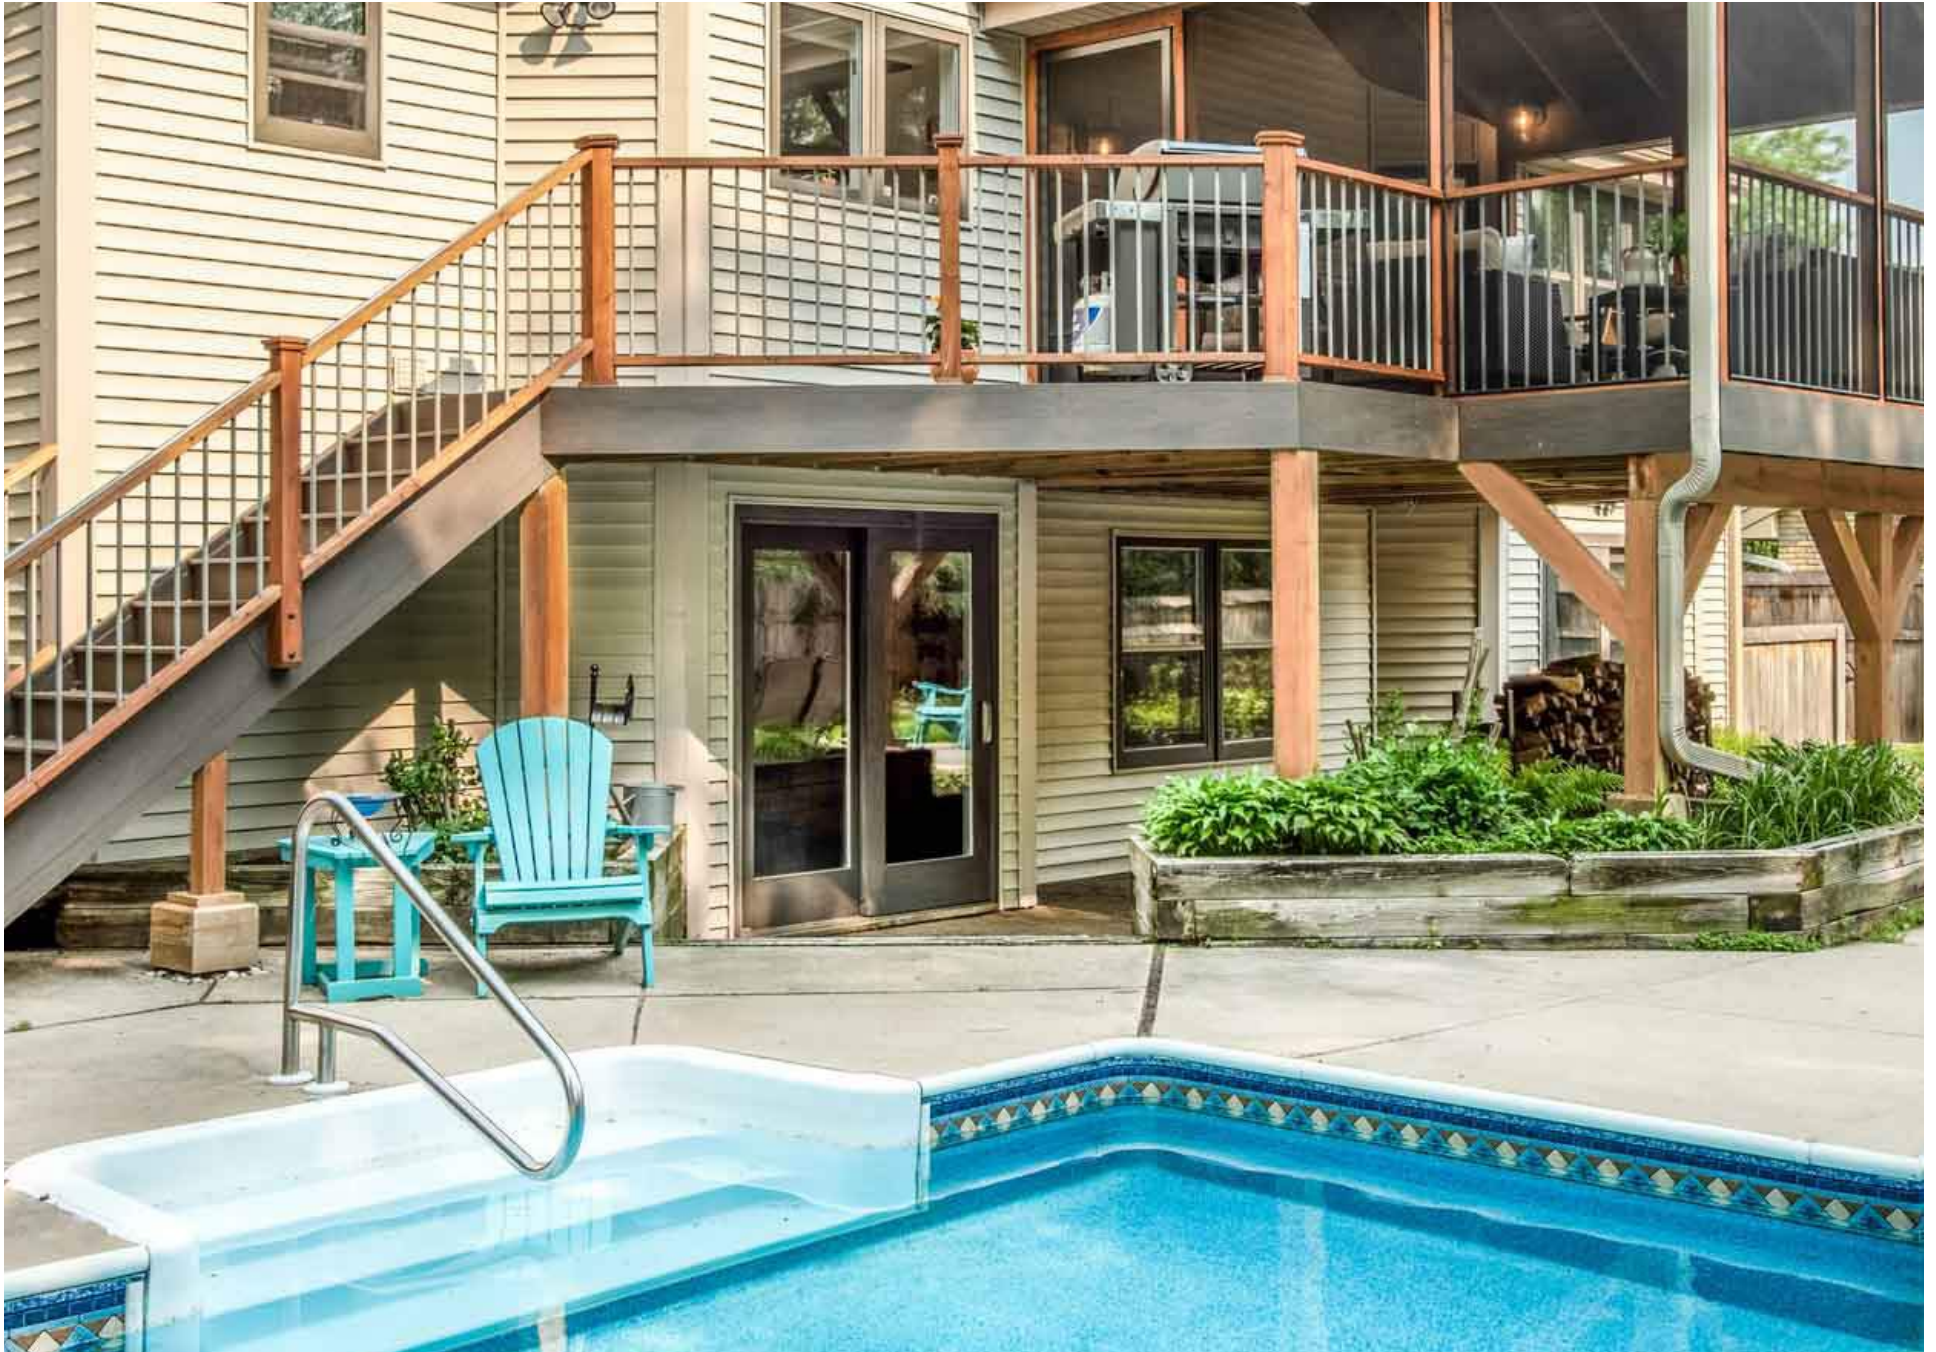
AFTER: VIEW OF EXPOSED BASEMENT PATIO DOORS WITH STEPS LEADING TO POOL. THE GRILL DECK OFFERS PLENTY OF HEADROOM, AND THE VIEW FROM THE EXISTING WINDOWS AND PATIO DOORS IS NOT RESTRICTED.

Because the home has a fully exposed basement, it was important for our design to accomplish all the goals above while taking care to not block the lower level windows and patio doors. The old deck was too small to accommodate all of the necessary functions. There is now proper space for grilling (without risk of melting any vinyl siding!) and a clear path from the house, through the porch, down the stairs, to the pool. We also carefully protected the necessary headroom as one walks from the pool area to the lower level patio doors and the changing room/bathroom just inside.

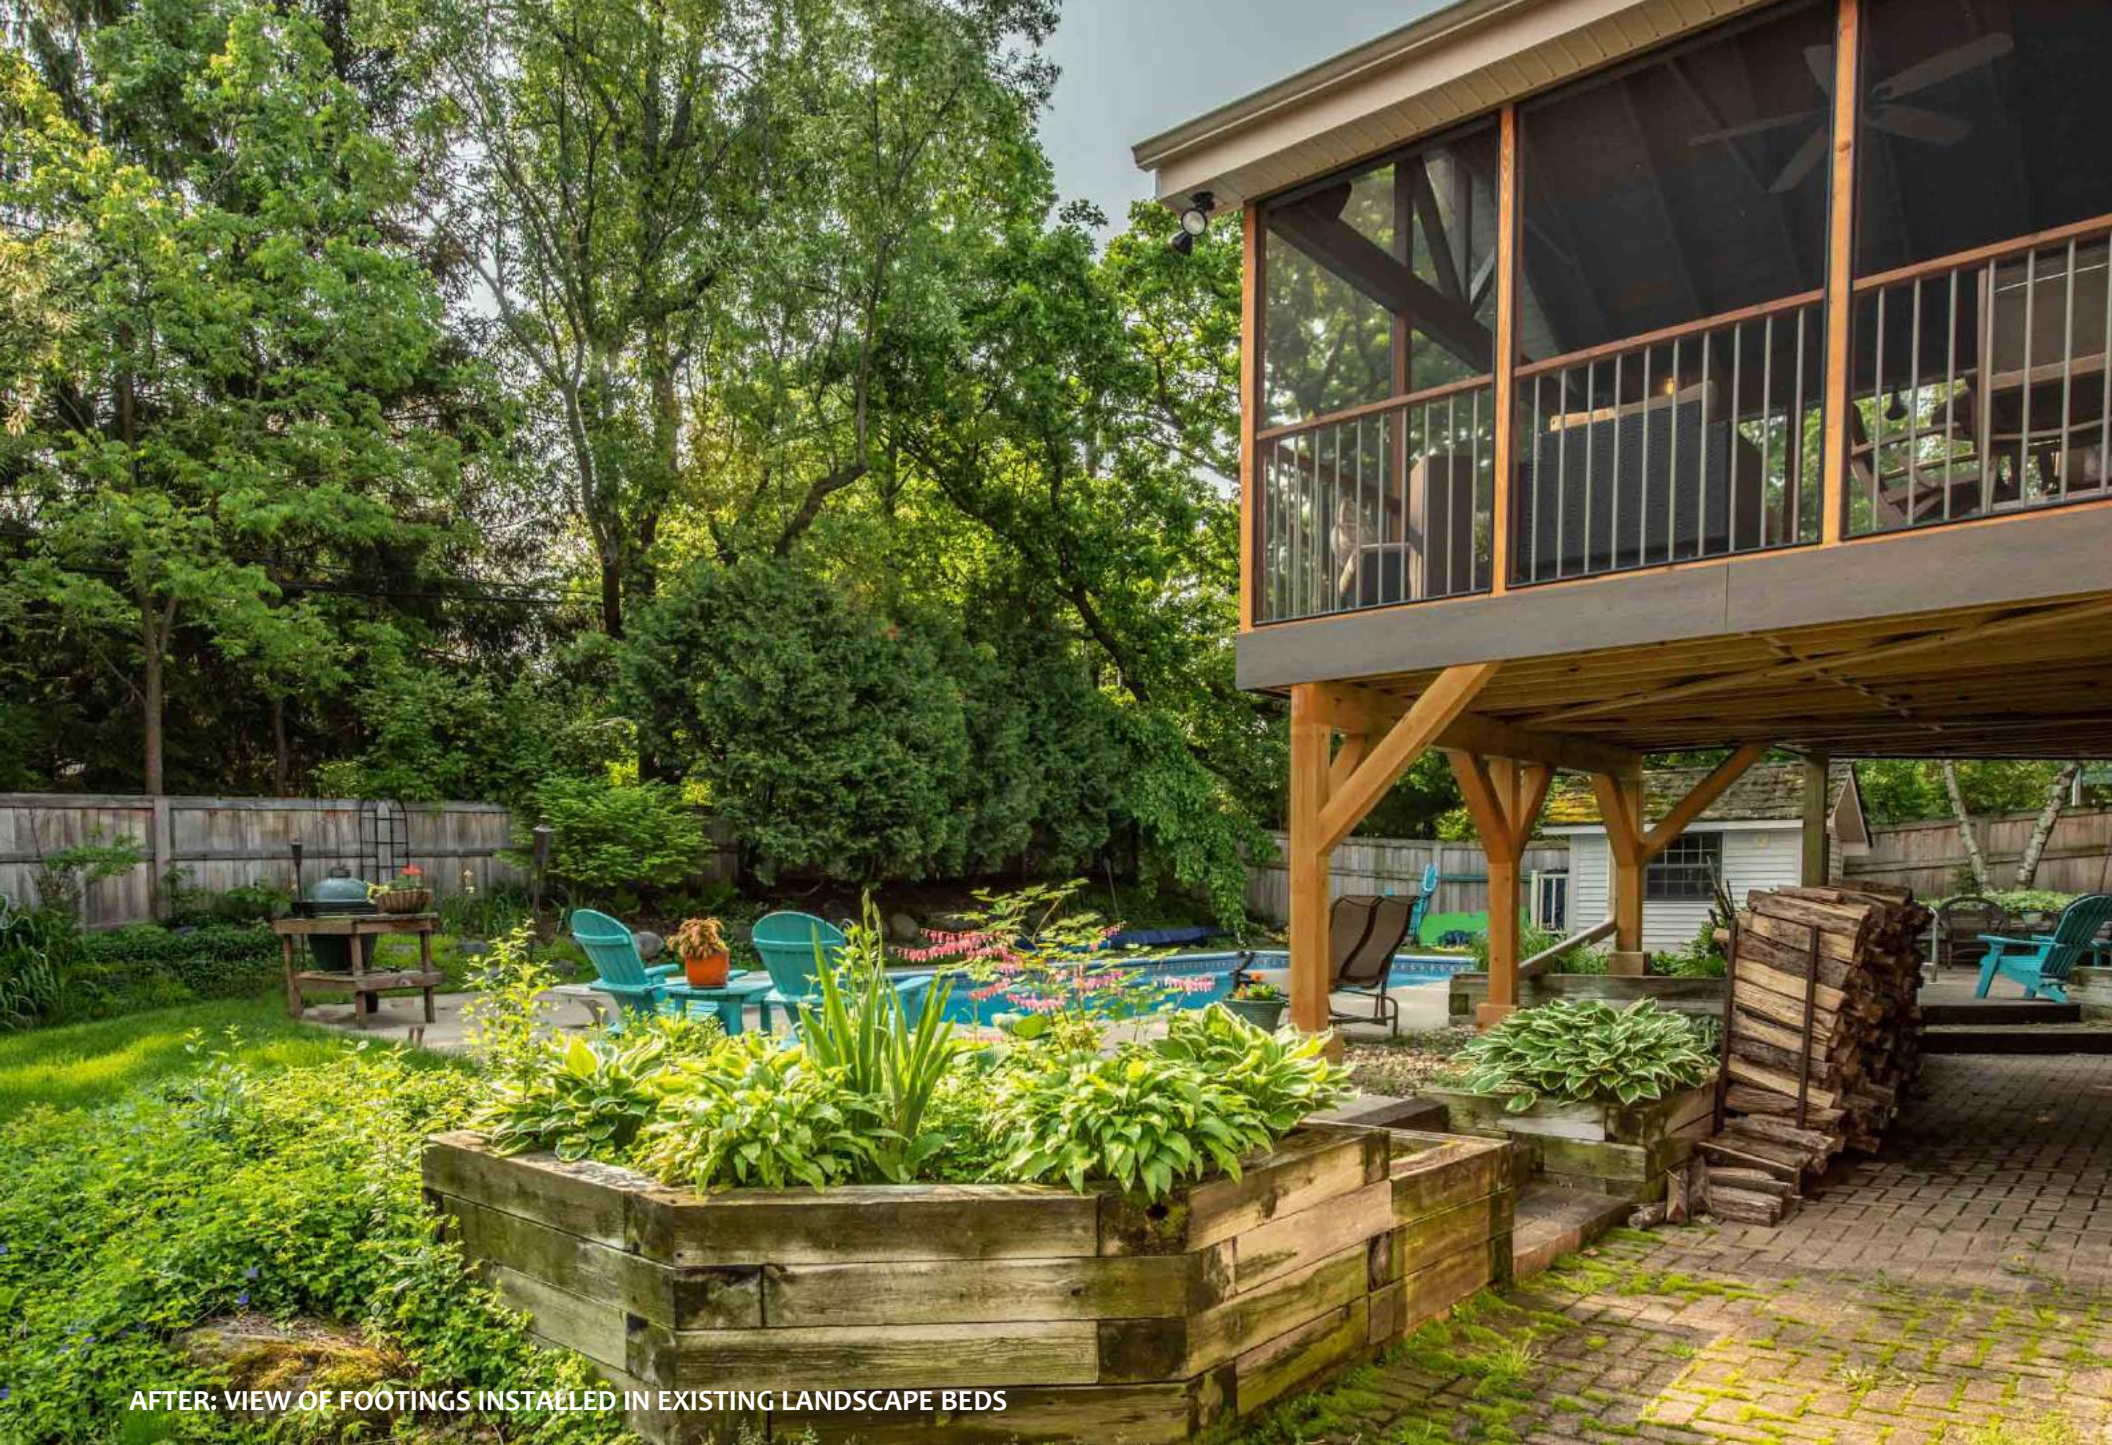
AFTER: VIEW OF FOOTINGS INSTALLED IN EXISTING LANDSCAPE BEDS

A further constraint was that we did not want to impact the concrete pool deck, so we installed all of the footings in the existing landscape beds.

We were working in a fenced pool area. Helical pier footings were carefully design, planned, and installed in existing landscaped areas to avoid any demo or re-pouring of the concrete pool deck. A single footing under the stairway required concrete cutting and the hole was concealed after construction.

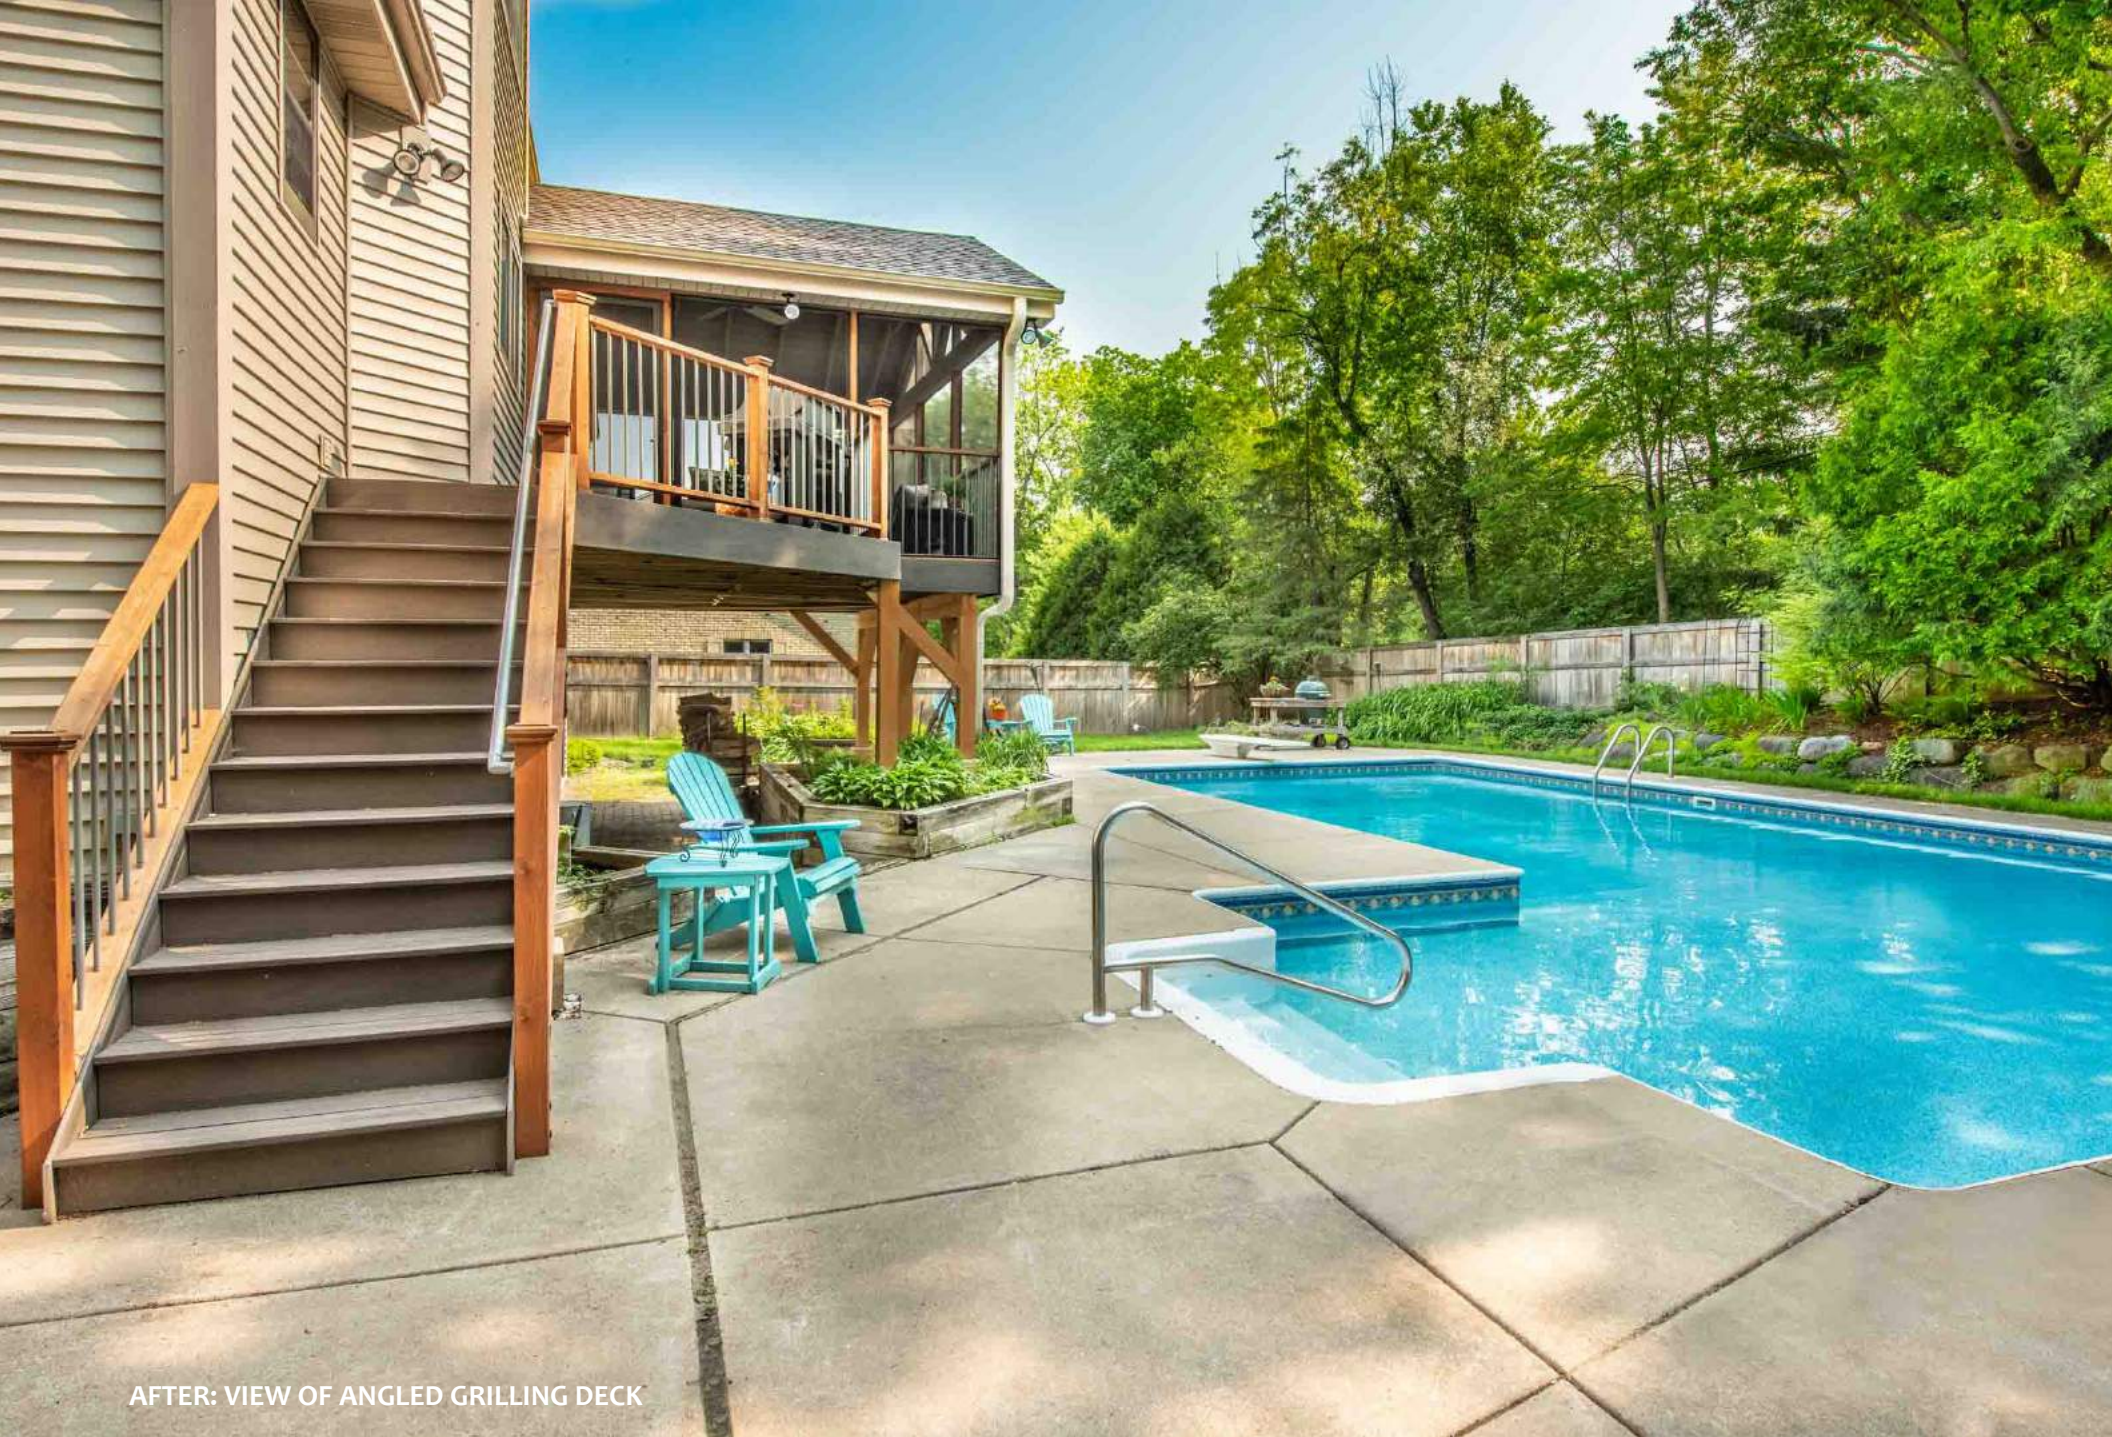
AFTER: VIEW OF ANGLED GRILLING DECK

These constraints led to the unique angle of the grilling deck, mimicking the shape of the landscaped area and steps below. The only footing which required concrete cutting in the pool deck was one hidden by the stairway.
