MONIAK RESIDENCE  
ENTIRE HOUSE REMODEL  
SUN PRAIRIE, WI  
2019

Project Category: 07-26 Entire House \$250,000 - \$500,000

Location: Sun Prairie, WI

Completion Date: September 2019

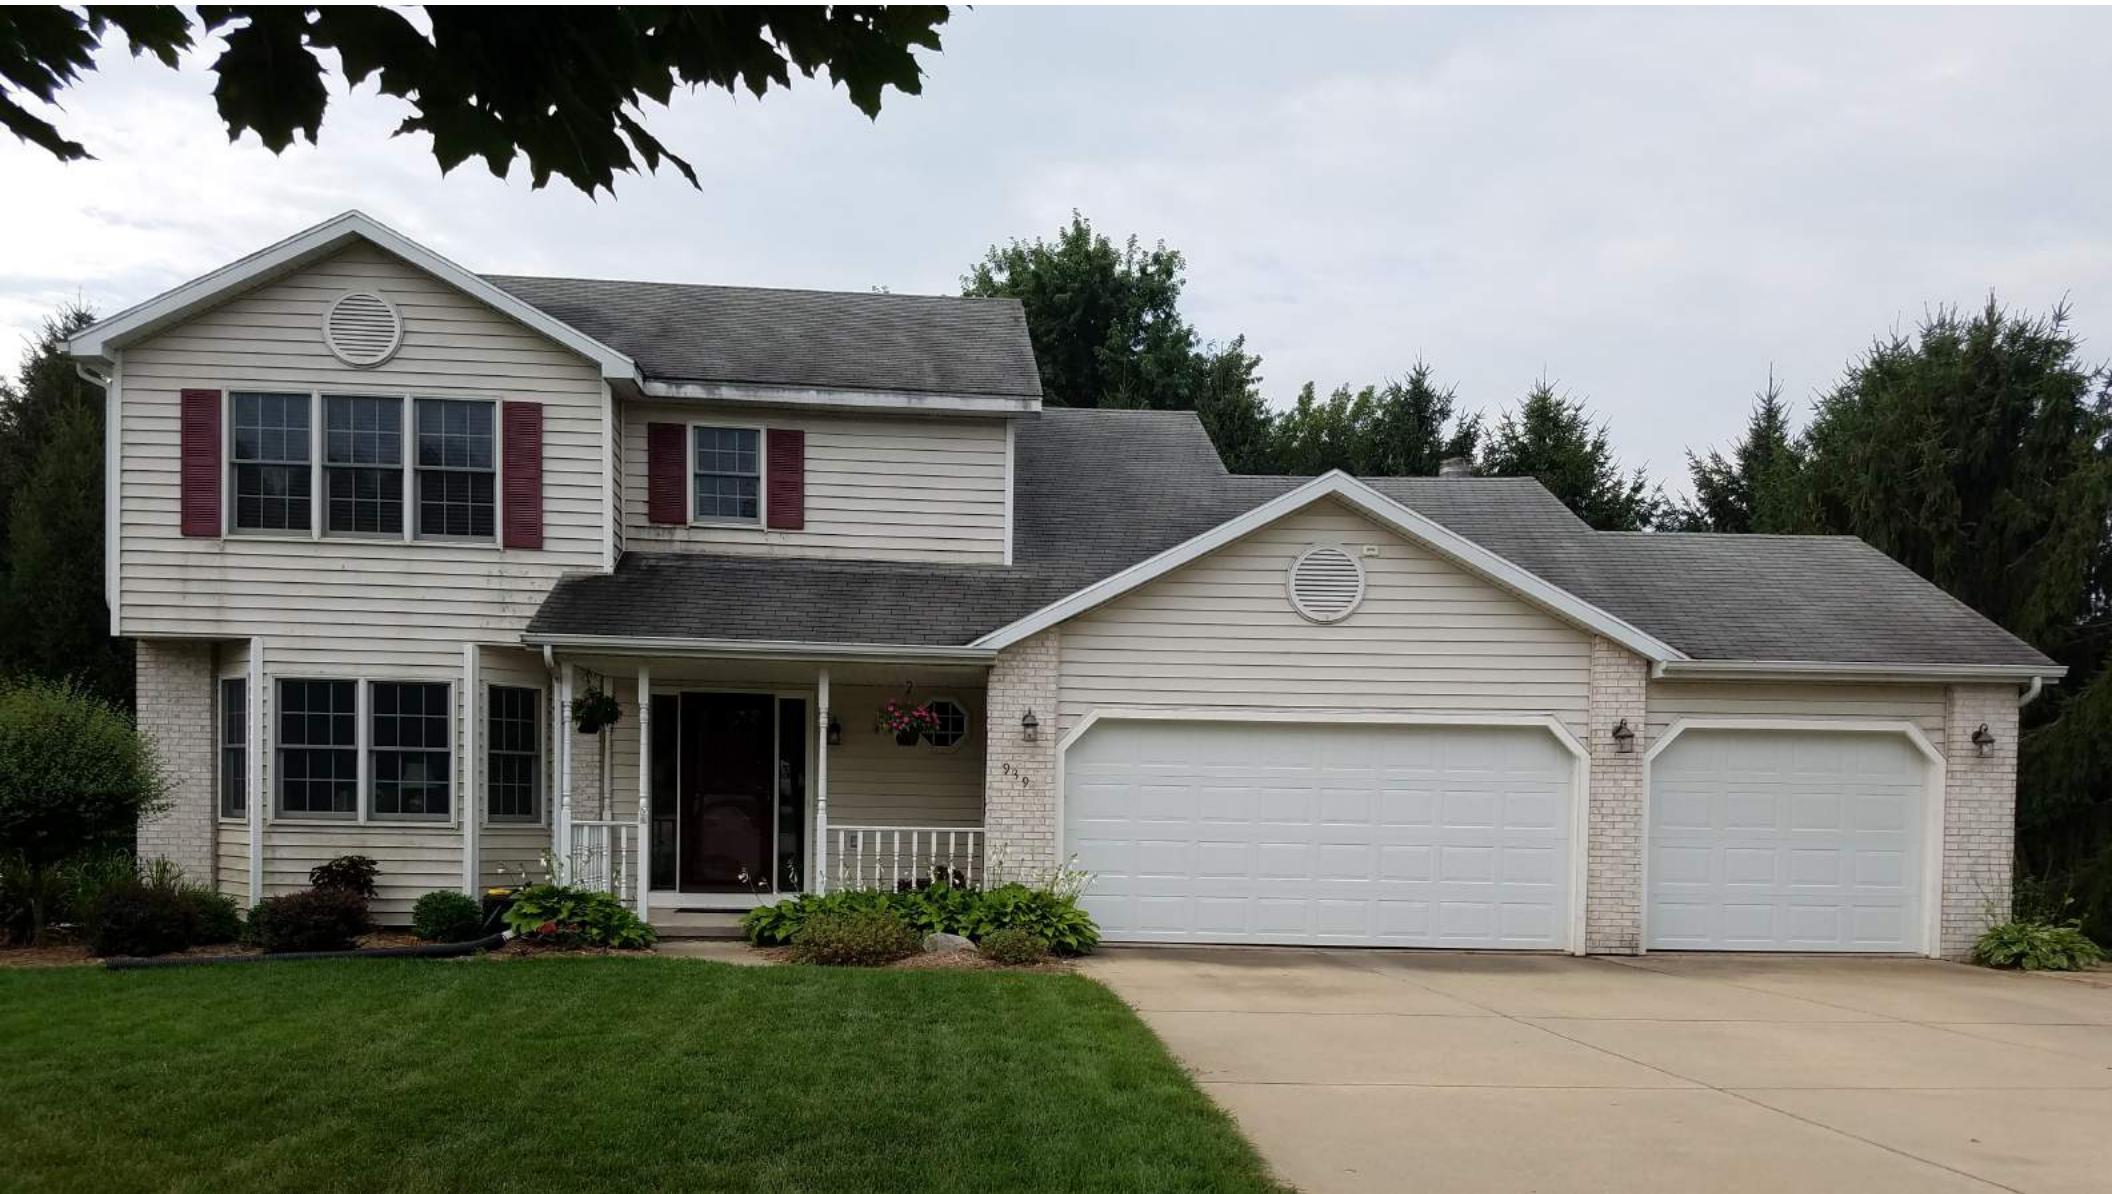
**BEFORE:** DATED, LIGHT-TONED FINISHES MADE THE HOME LOOK BLAND, TIRED, AND SHOWED A LOT OF WEAR AND DIRT. ADDITIONALLY, CHAMFERED GARAGE DOOR CORNERS, UNDERSIZED FRONT PORCH COLUMNS, AND DECORATIVE GABLE VENTS CLEARLY DATED THE HOME TO THE 1990S.

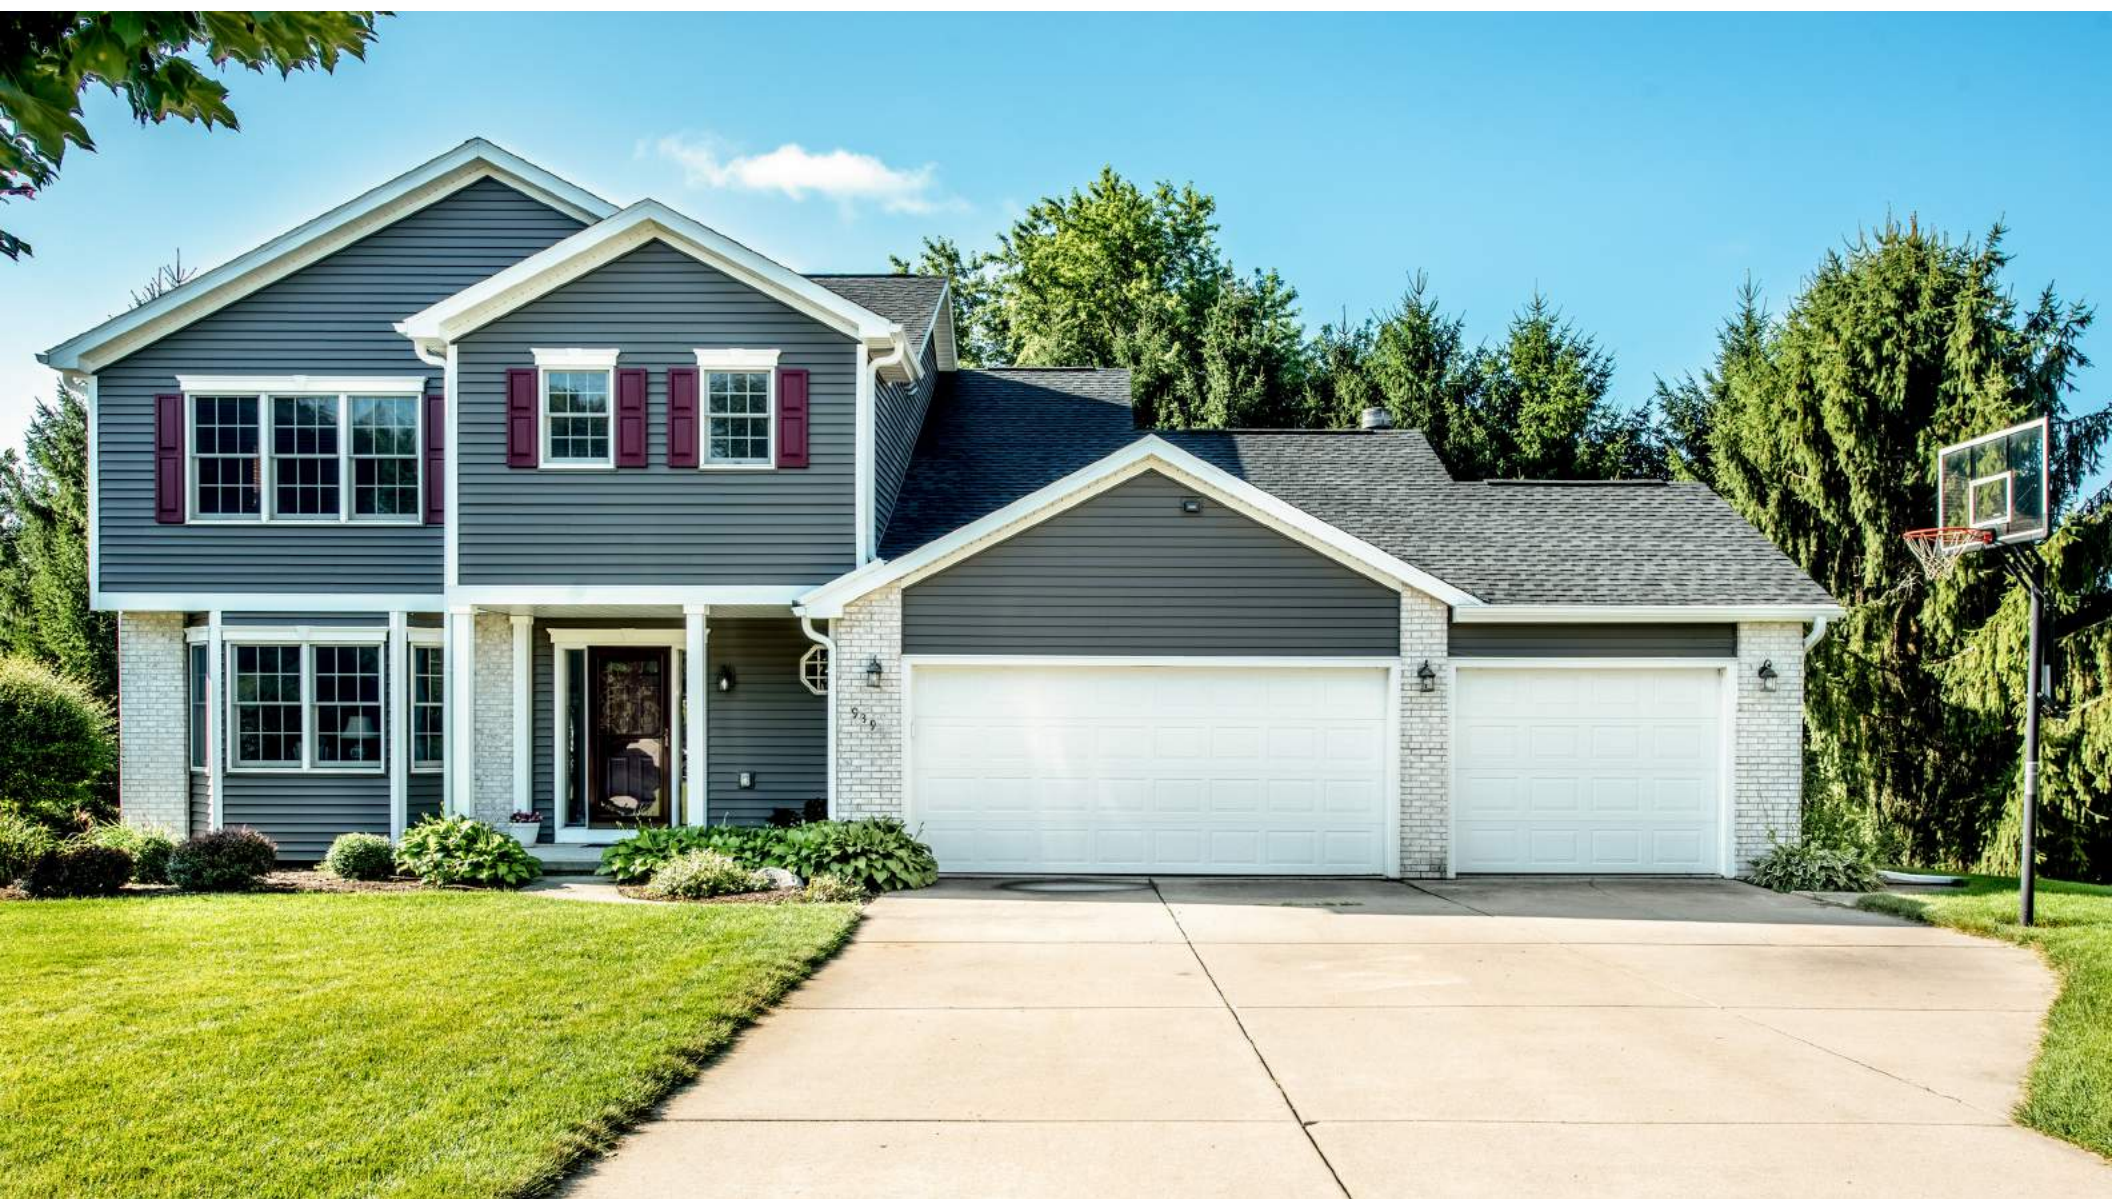
**AFTER:** A BOLD NEW SIDING COLOR, BOTH HORIZONTAL AND GABLE BANDING, WINDOW HEADERS, SQUARED-OFF GARAGE DOOR CORNERS, AND PROPERLY SIZED COLUMNS MAKE THIS HOME FEEL BRAND NEW. COLORS WERE SPECIFICALLY CHOSEN TO COORDINATE WITH THE EXISTING FRONT DOOR AND SHUTTER COLOR AND EXISTING BRICK.

The addition of the master suite met more than their expressed needs for a luxury bathroom. It went beyond their expectations by creating a more pleasing, symmetrical, balanced front elevation of their home. The additional window and doubled gabled roof provides a distinct and upscale look in this neighborhood of production-builder homes. New details such as the wide window trim, window headers, frieze boards and band trims are stunning.

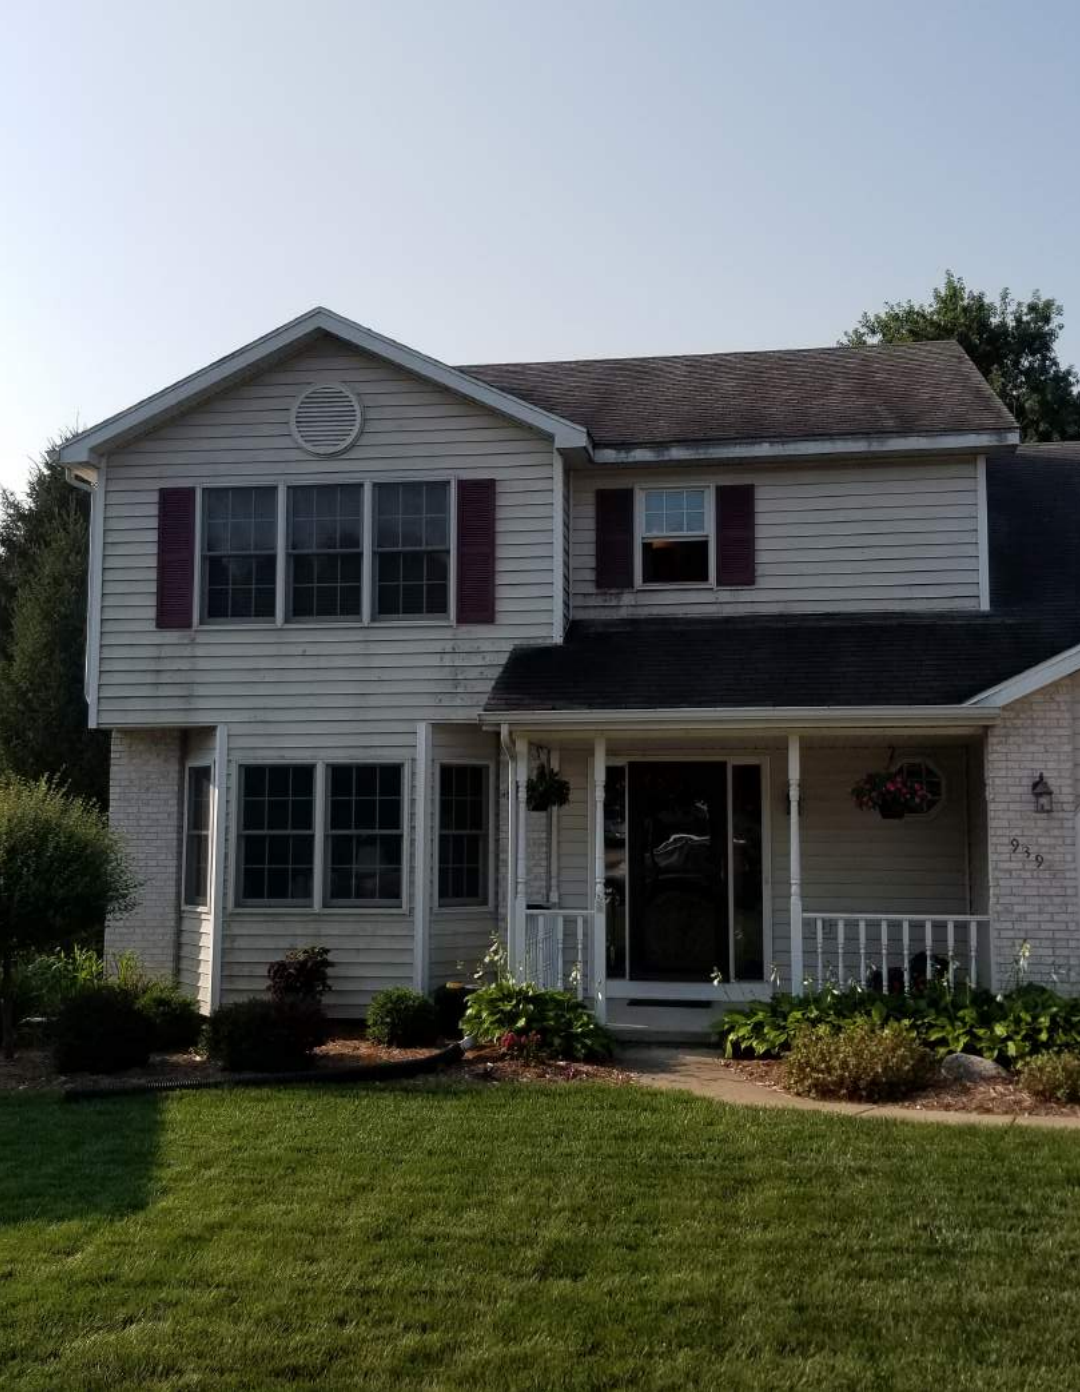
**BEFORE:** ASYMMETRICAL SECOND FLOOR WINDOW PLACEMENT AND A LOW FRONT PORCH CEILING PROVIDED AN UNDERWHELMING ENTRANCE TO THE HOME.

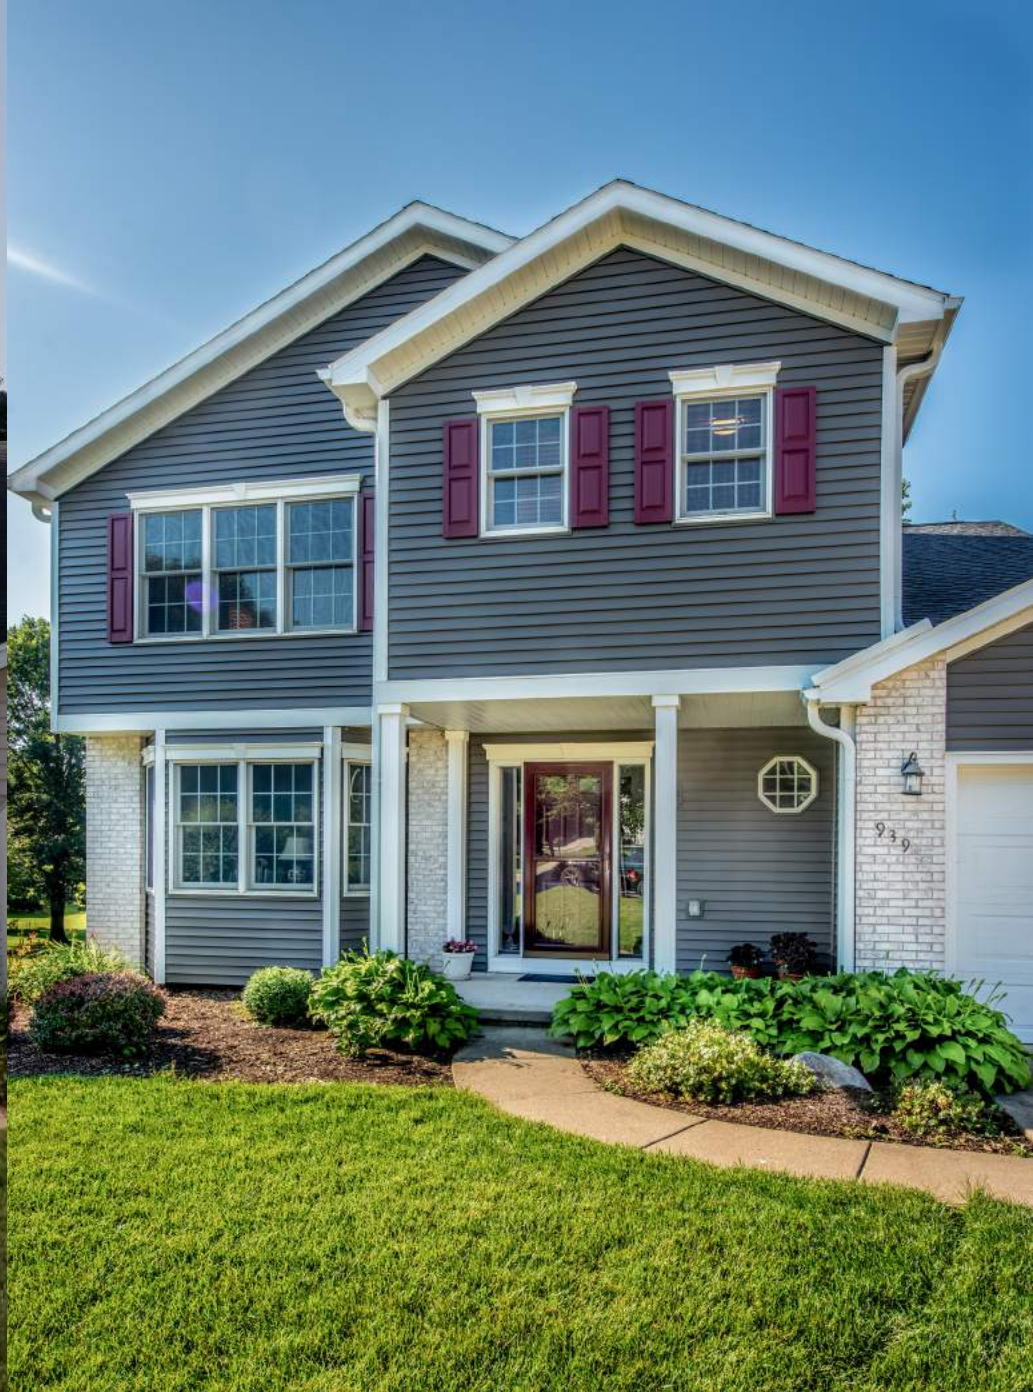
**AFTER:** THE NEW DOUBLE GABLED ROOFLINE AT THE MASTER BATHROOM ADDITION BRINGS THE HOME'S FACE FORWARD, ADDS BALANCE, AND HELPS TO DENOTE THE ENTRANCE.

In order to provide additional space for the master bathroom and closet, we expanded the second floor over the front porch. The foundation present was adequately able to support it, and so this extra square footage was a relative bargain compared to other options.

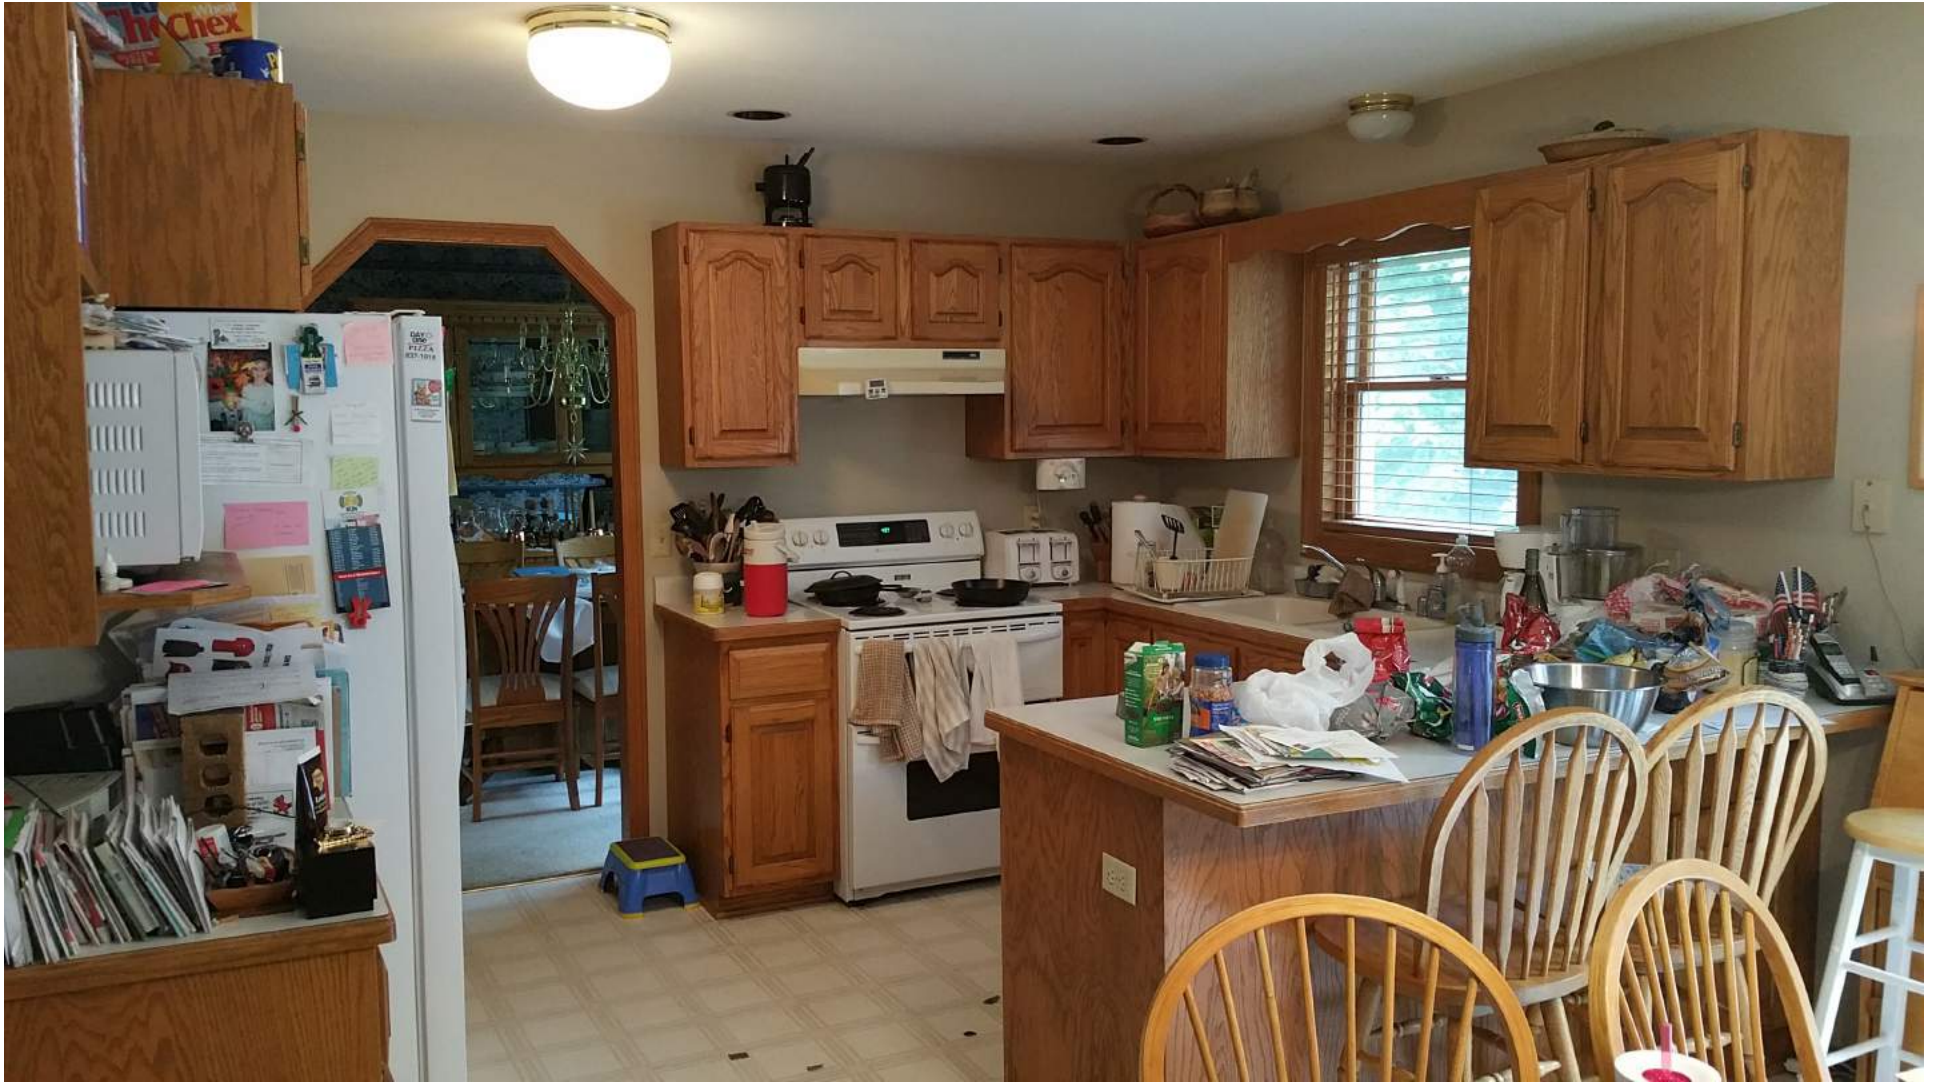
**BEFORE:** A U-SHAPED KITCHEN WITH 7'-0" HONEY OAK CABINETRY DID NOT MEET THE STORAGE CAPACITY THE CLIENTS NEEDED. FINISHES WERE OUTDATED AND THE CLIENTS DID NOT USE THE BREAKFAST BAR.

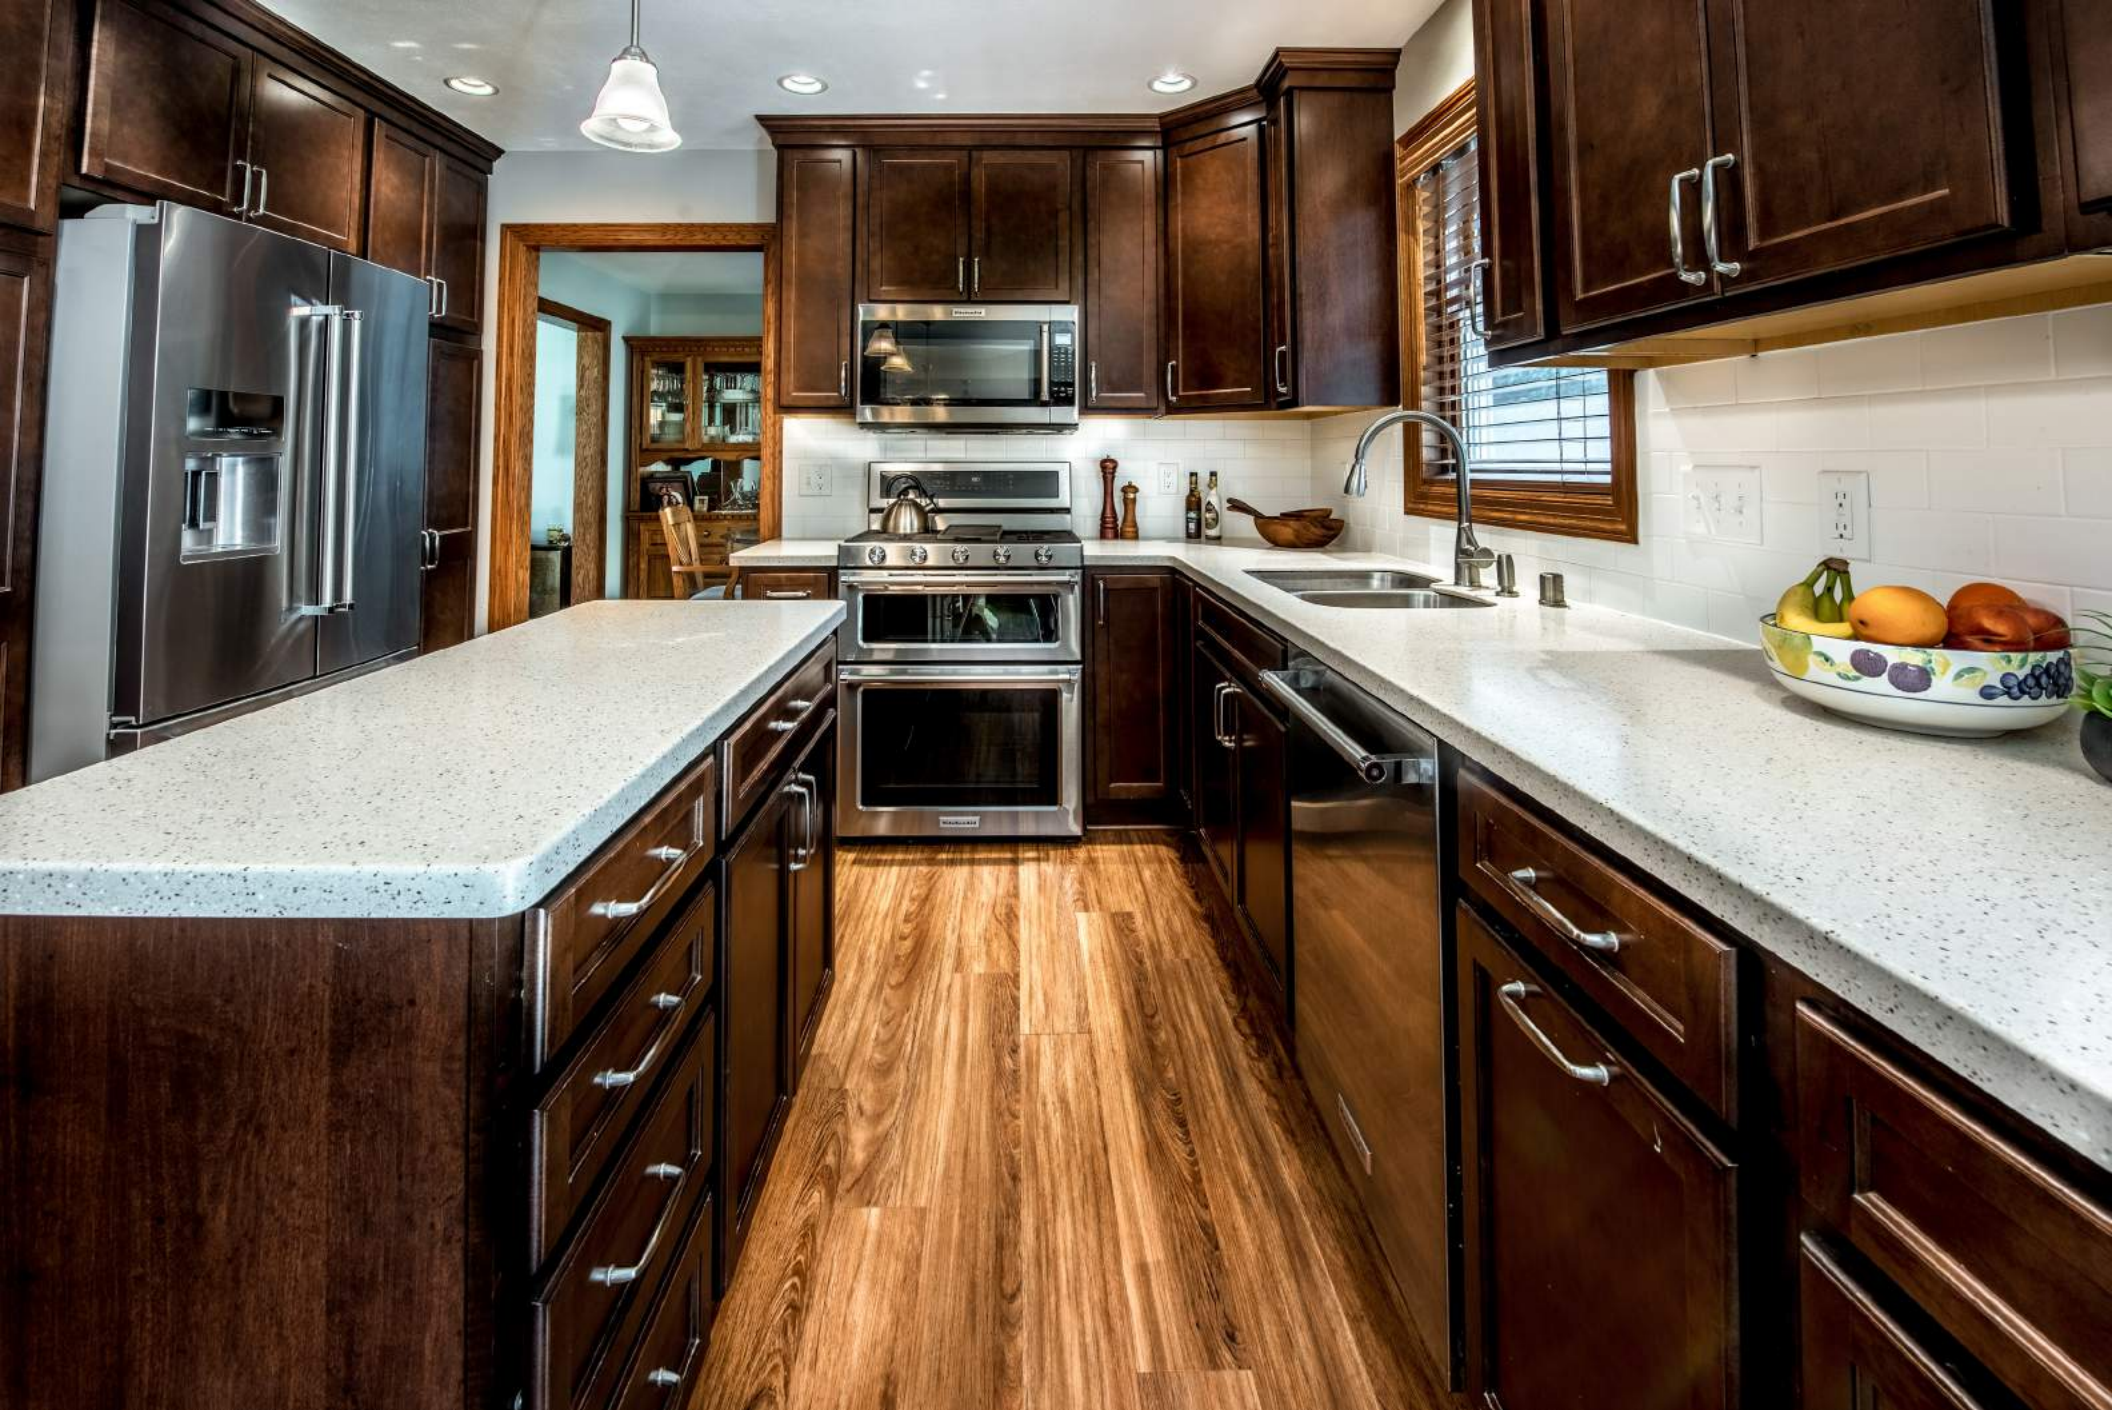
**AFTER:** NEW, MAPLE CABINETRY EXTENDING ALL THE WAY TO THE CEILING GAVE THE CLIENTS THE STORAGE SPACE THEY NEEDED. THE U-SHAPE WAS ABANDONED, AND THE CABINETRY EXTENDED TO THE FOOTPRINT OF THE EXISTING BREAKFAST BAR. A MUCH SOUGHT-AFTER ISLAND WAS INSTALLED, ALLOWING FOR GREATER FLOW THROUGHOUT THE KITCHEN.

In the kitchen, we exceeded their expectations by completely altering the flow with the addition of an island and double range, allowing for less stress around the holidays with a house full of family. The cabinetry selections, going all the way to the ceiling, have provided our clients the storage space they needed, creating a tidier, more relaxing kitchen.

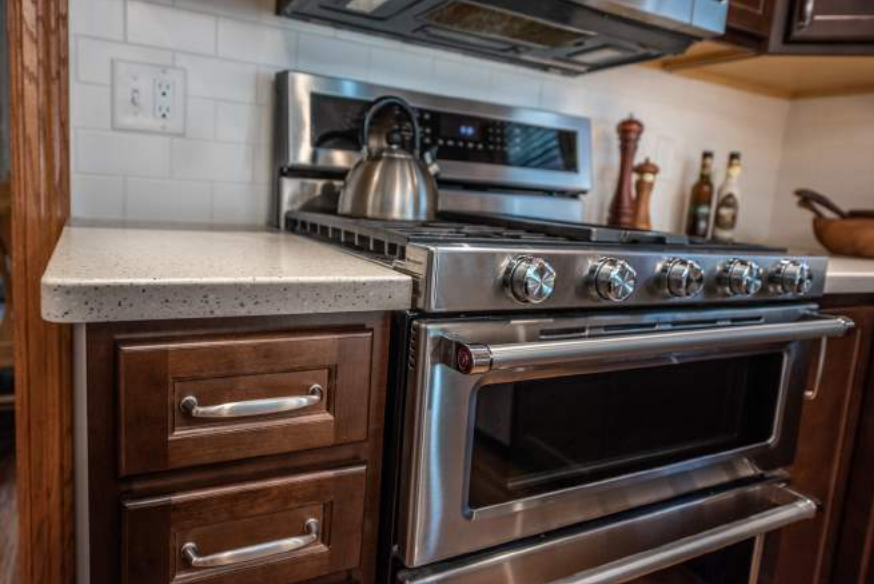
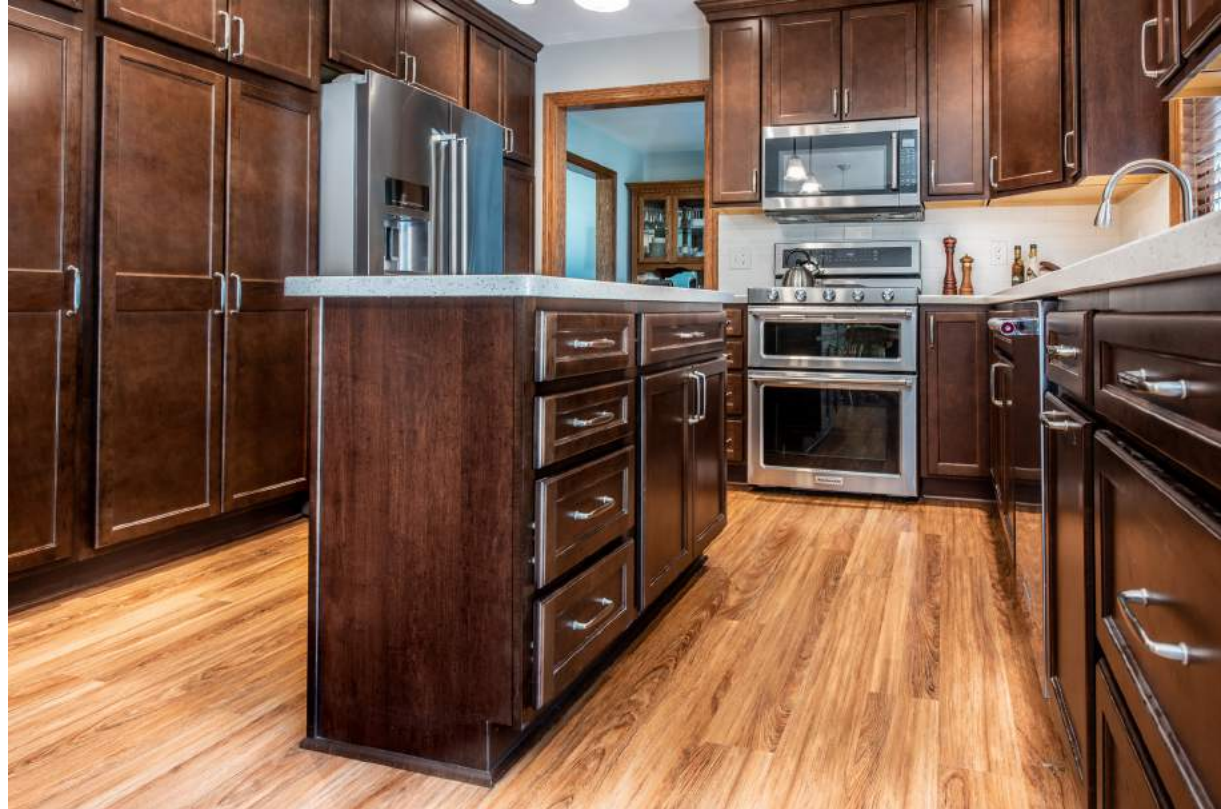
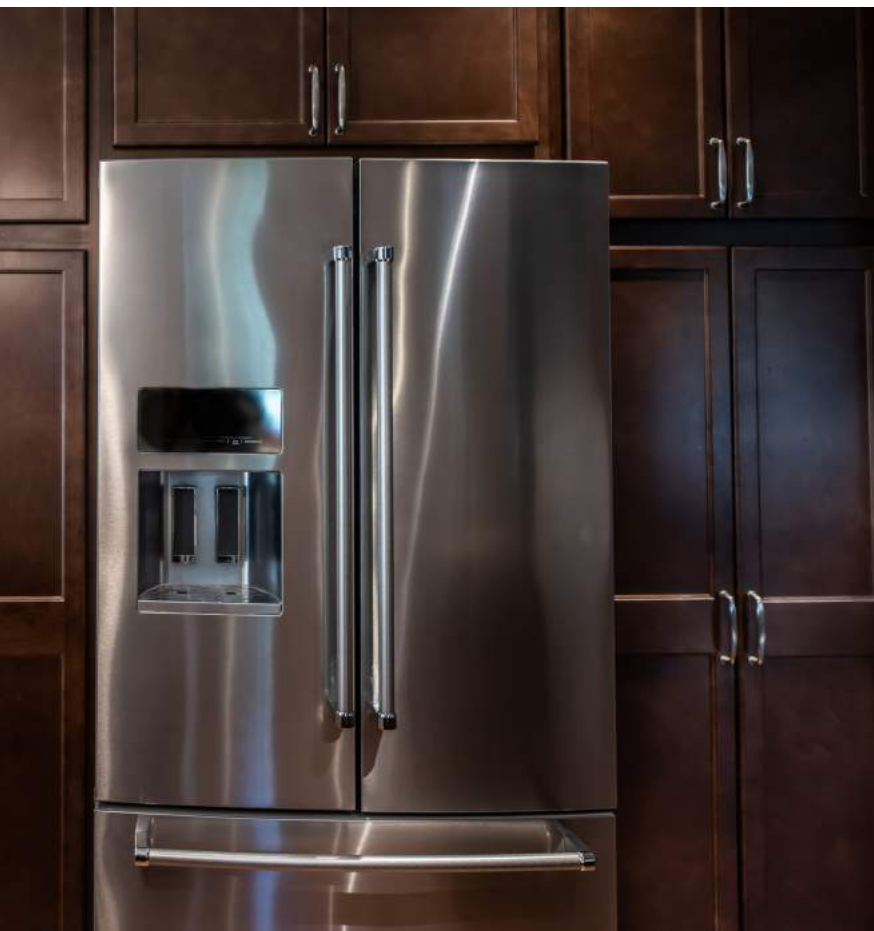
**AFTER:** THE NEW APPLIANCE PACKAGE INCLUDED A DOUBLE OVEN DUAL-FUEL RANGE AND AN OVER THE RANGE MICROWAVE THAT INCREASED THE FUNCTIONALITY OF THE KITCHEN BY ALLOWING MORE ROOM FOR CABINETRY.

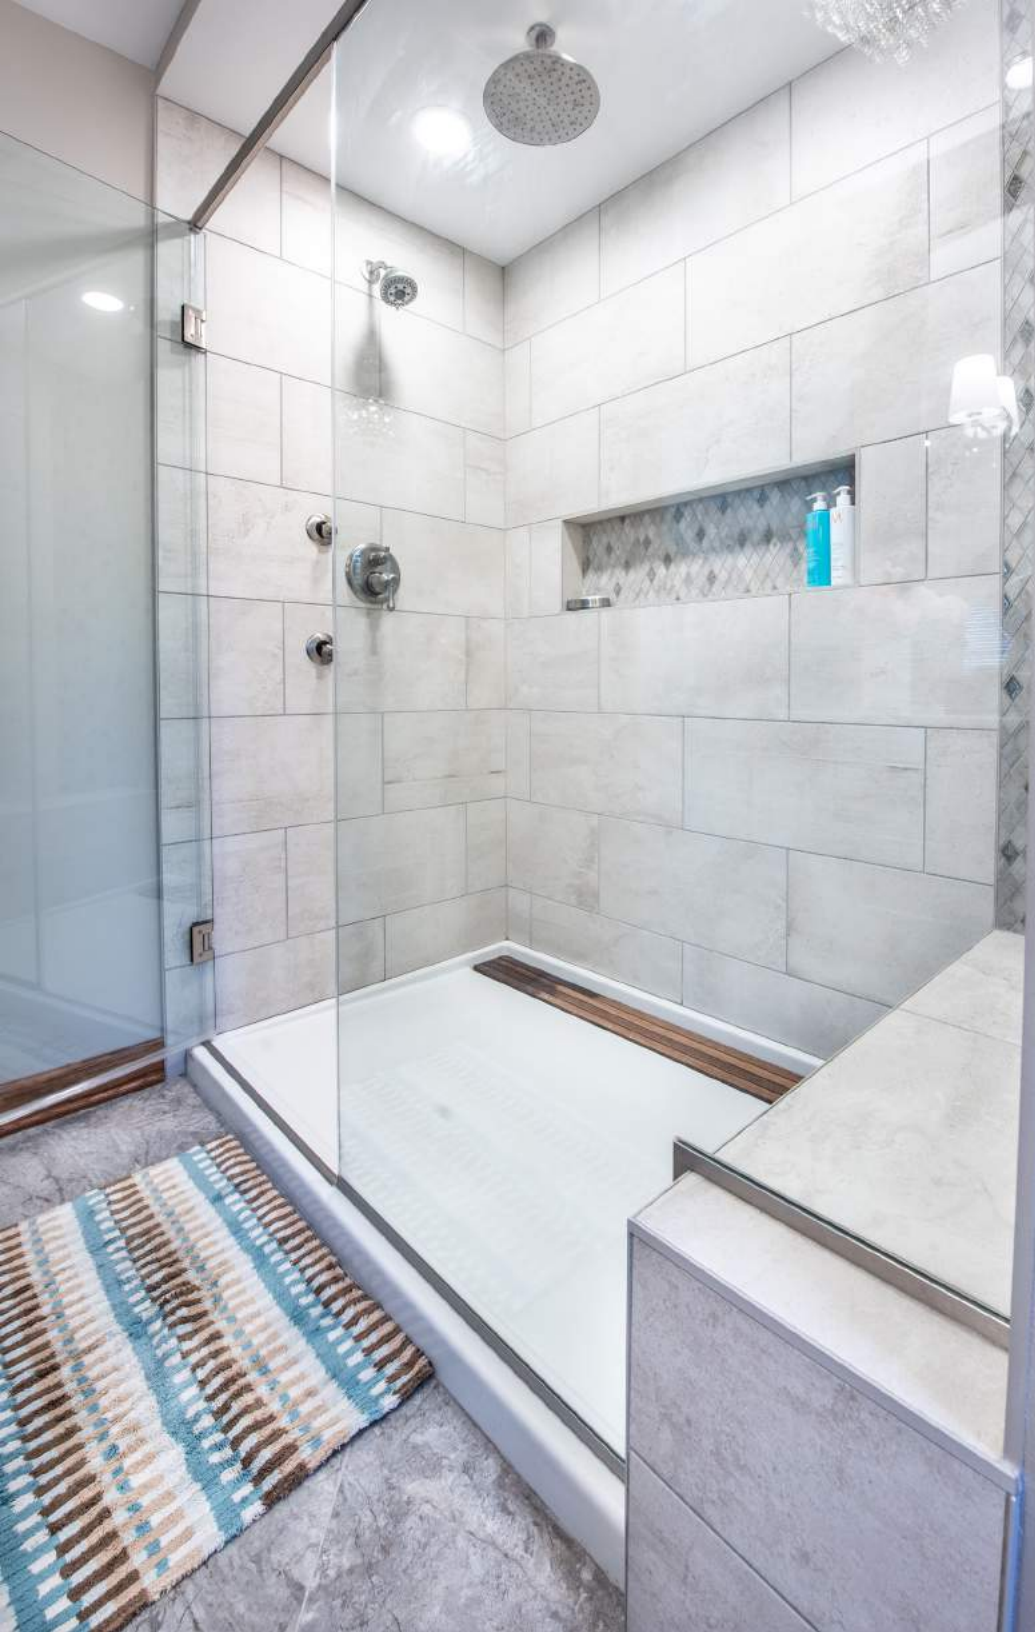
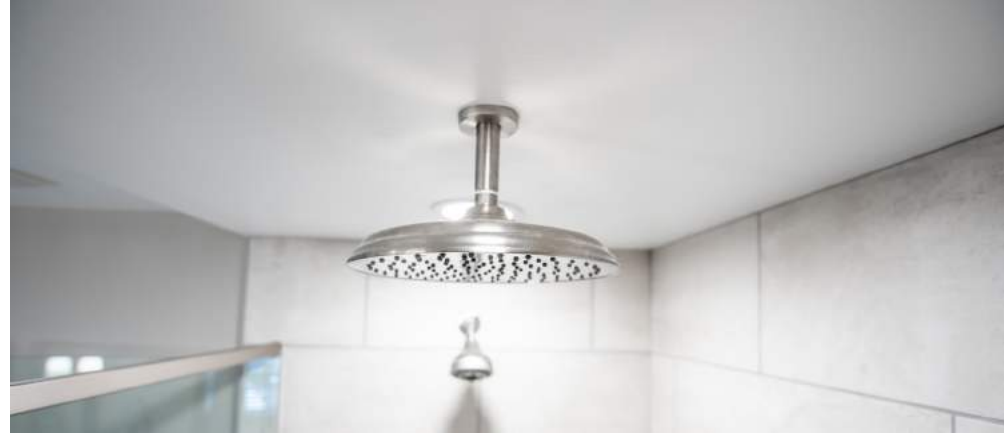
**AFTER:** VIEW OF NEW TILE WALK-IN SHOWER WITH OVERSIZED NICHE, RAINSHOWER HEAD, BODY JETS, AND LINEAR DRAIN.

**AFTER:** THE NEW SECOND MASTER WALK-IN CLOSET LOCATED IN THE BATHROOM SUITE ALLOWS FOR THE CLIENT TO GET FULLY READY IN THE MORNING WITHOUT DISTURBING THEIR SPOUSE.

A very particular tile design was created for the master bathroom shower. We were able to come up with and execute a balanced, non-symmetrical design for a client who craves symmetry. The shower incorporated an acrylic pre-fabricated base with a custom tile bench. Deciding upon the placement of the tiled niche was important, as it is the focal point of the room. With the bench creating an asymmetrical look, we balanced out the wall with a vertical stripe using the same tile mosaic from the niche, installed the depth of the bench. Then, in order to balance out the vertical stripe on the back wall, an additional vertical stripe was designed to create a grounded corner.

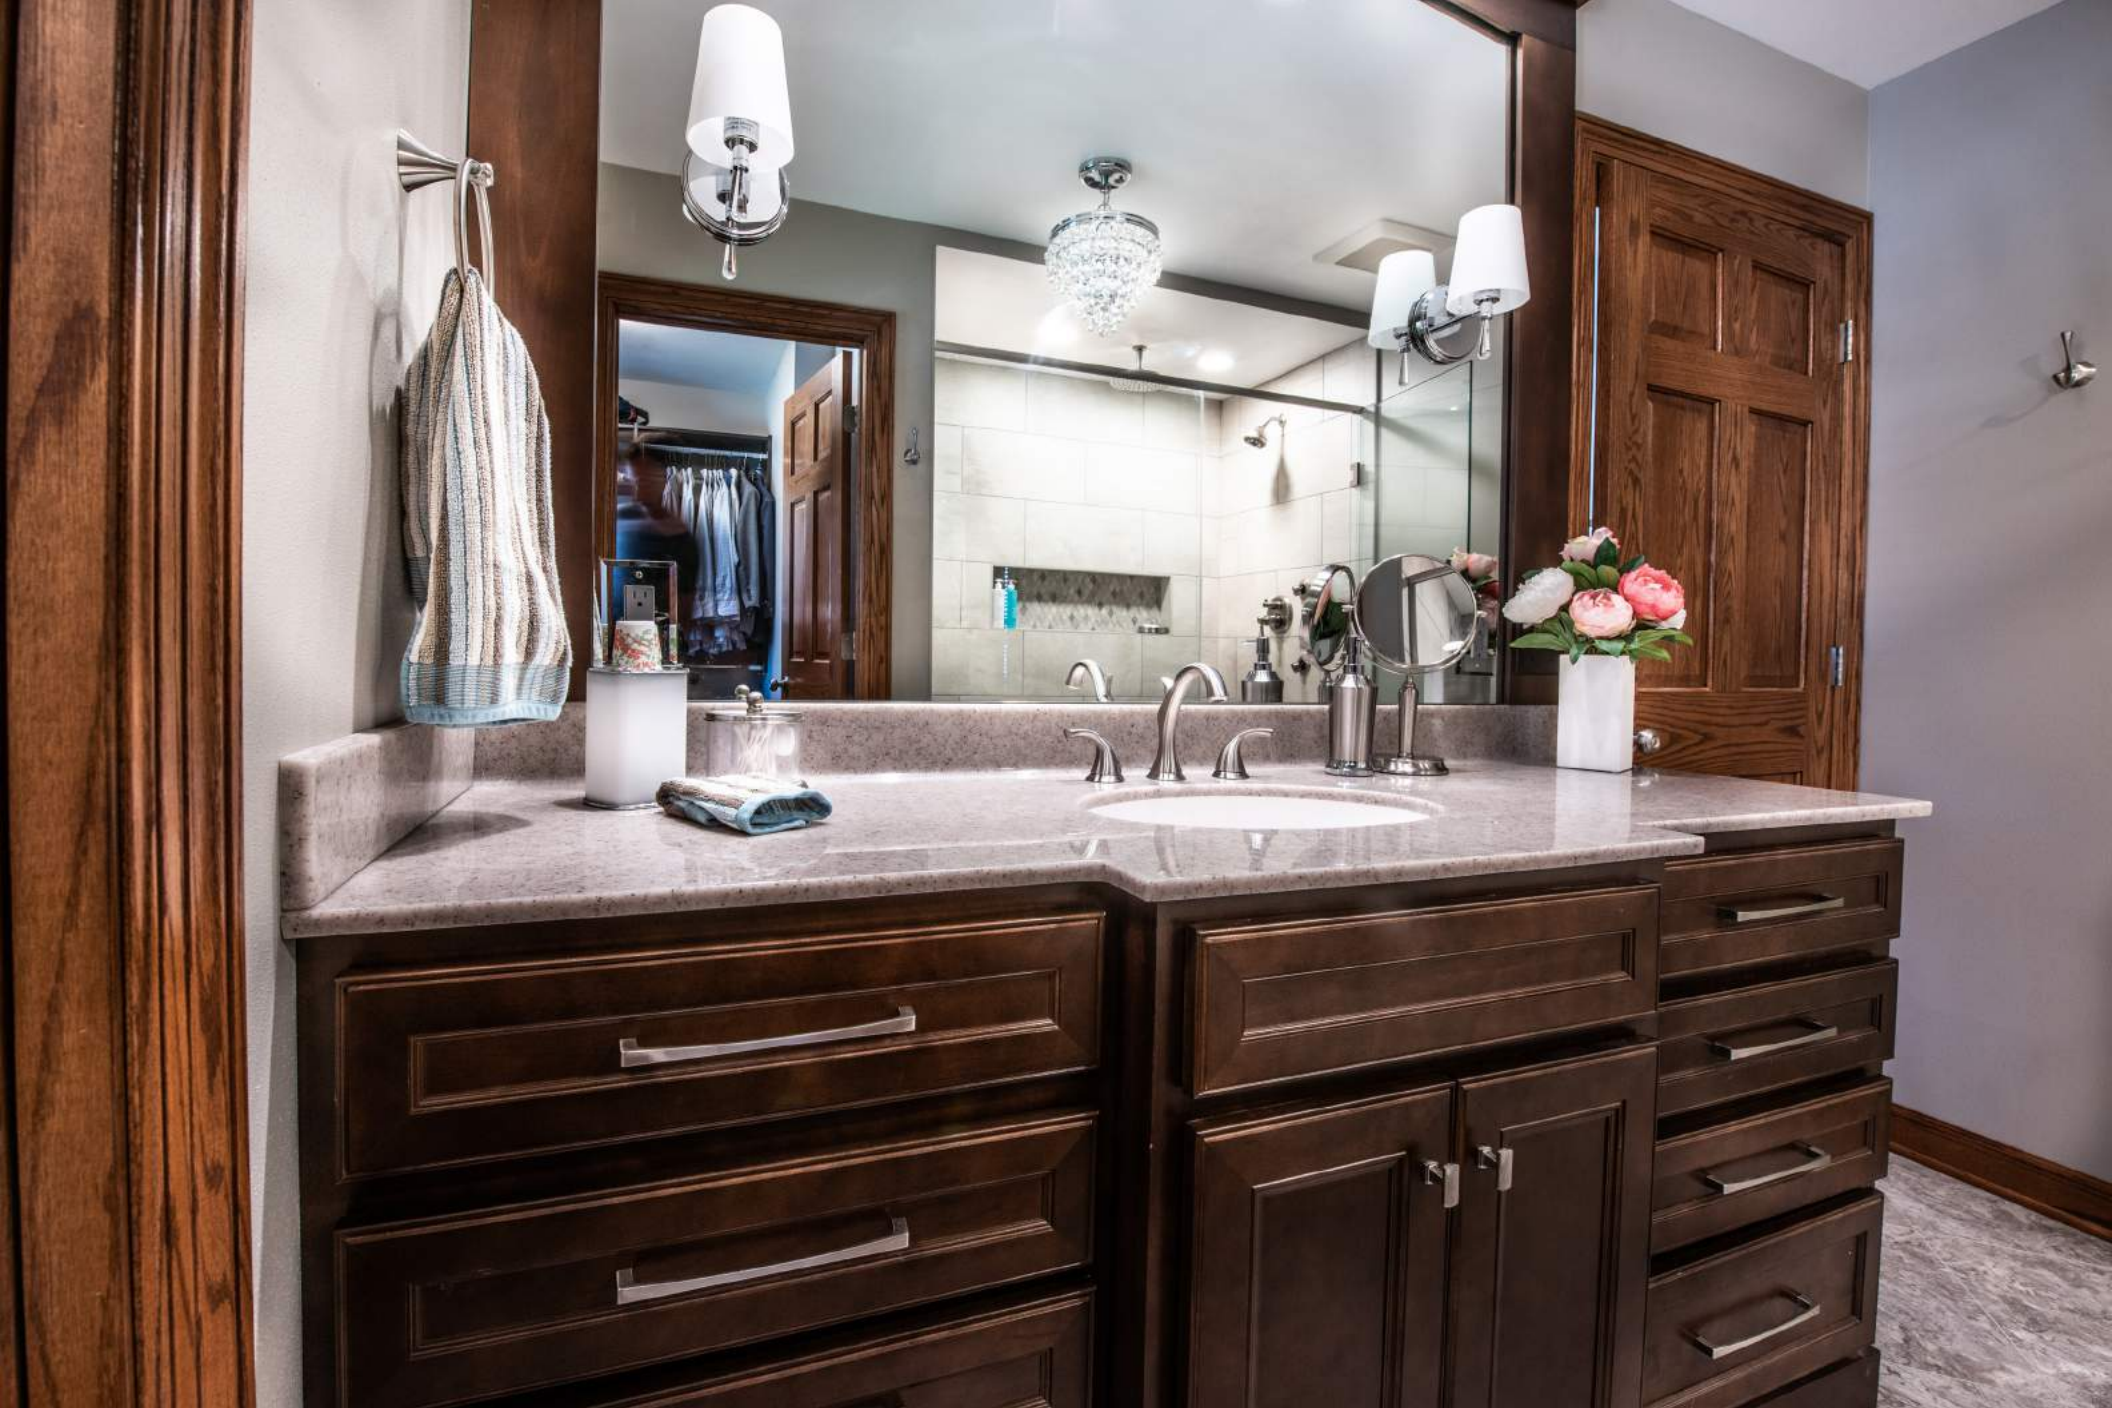
**AFTER:** A SINGLE SINK ALLOWS FOR MORE USABLE COUNTER SPACE. THE CUSTOM VANITY MIRROR IS FRAMED WITH AN ARCHED TOP AND THROUGH MIRROR SCONCES.

Additionally, in order to exceed expectations for our client's need for symmetry, the through mirror sconces and outlets were designed and installed immaculately. Instead of a pre-cut hole, they were cut through the mirror on site to ensure perfect symmetry.
