MONIAK RESIDENCE  
ENTIRE HOUSE REMODEL  
SUN PRAIRIE, WI  
2019

Project Category: 07-26 Entire House \$250,000 - \$500,000

Location: Sun Prairie, WI

Completion Date: September 2019

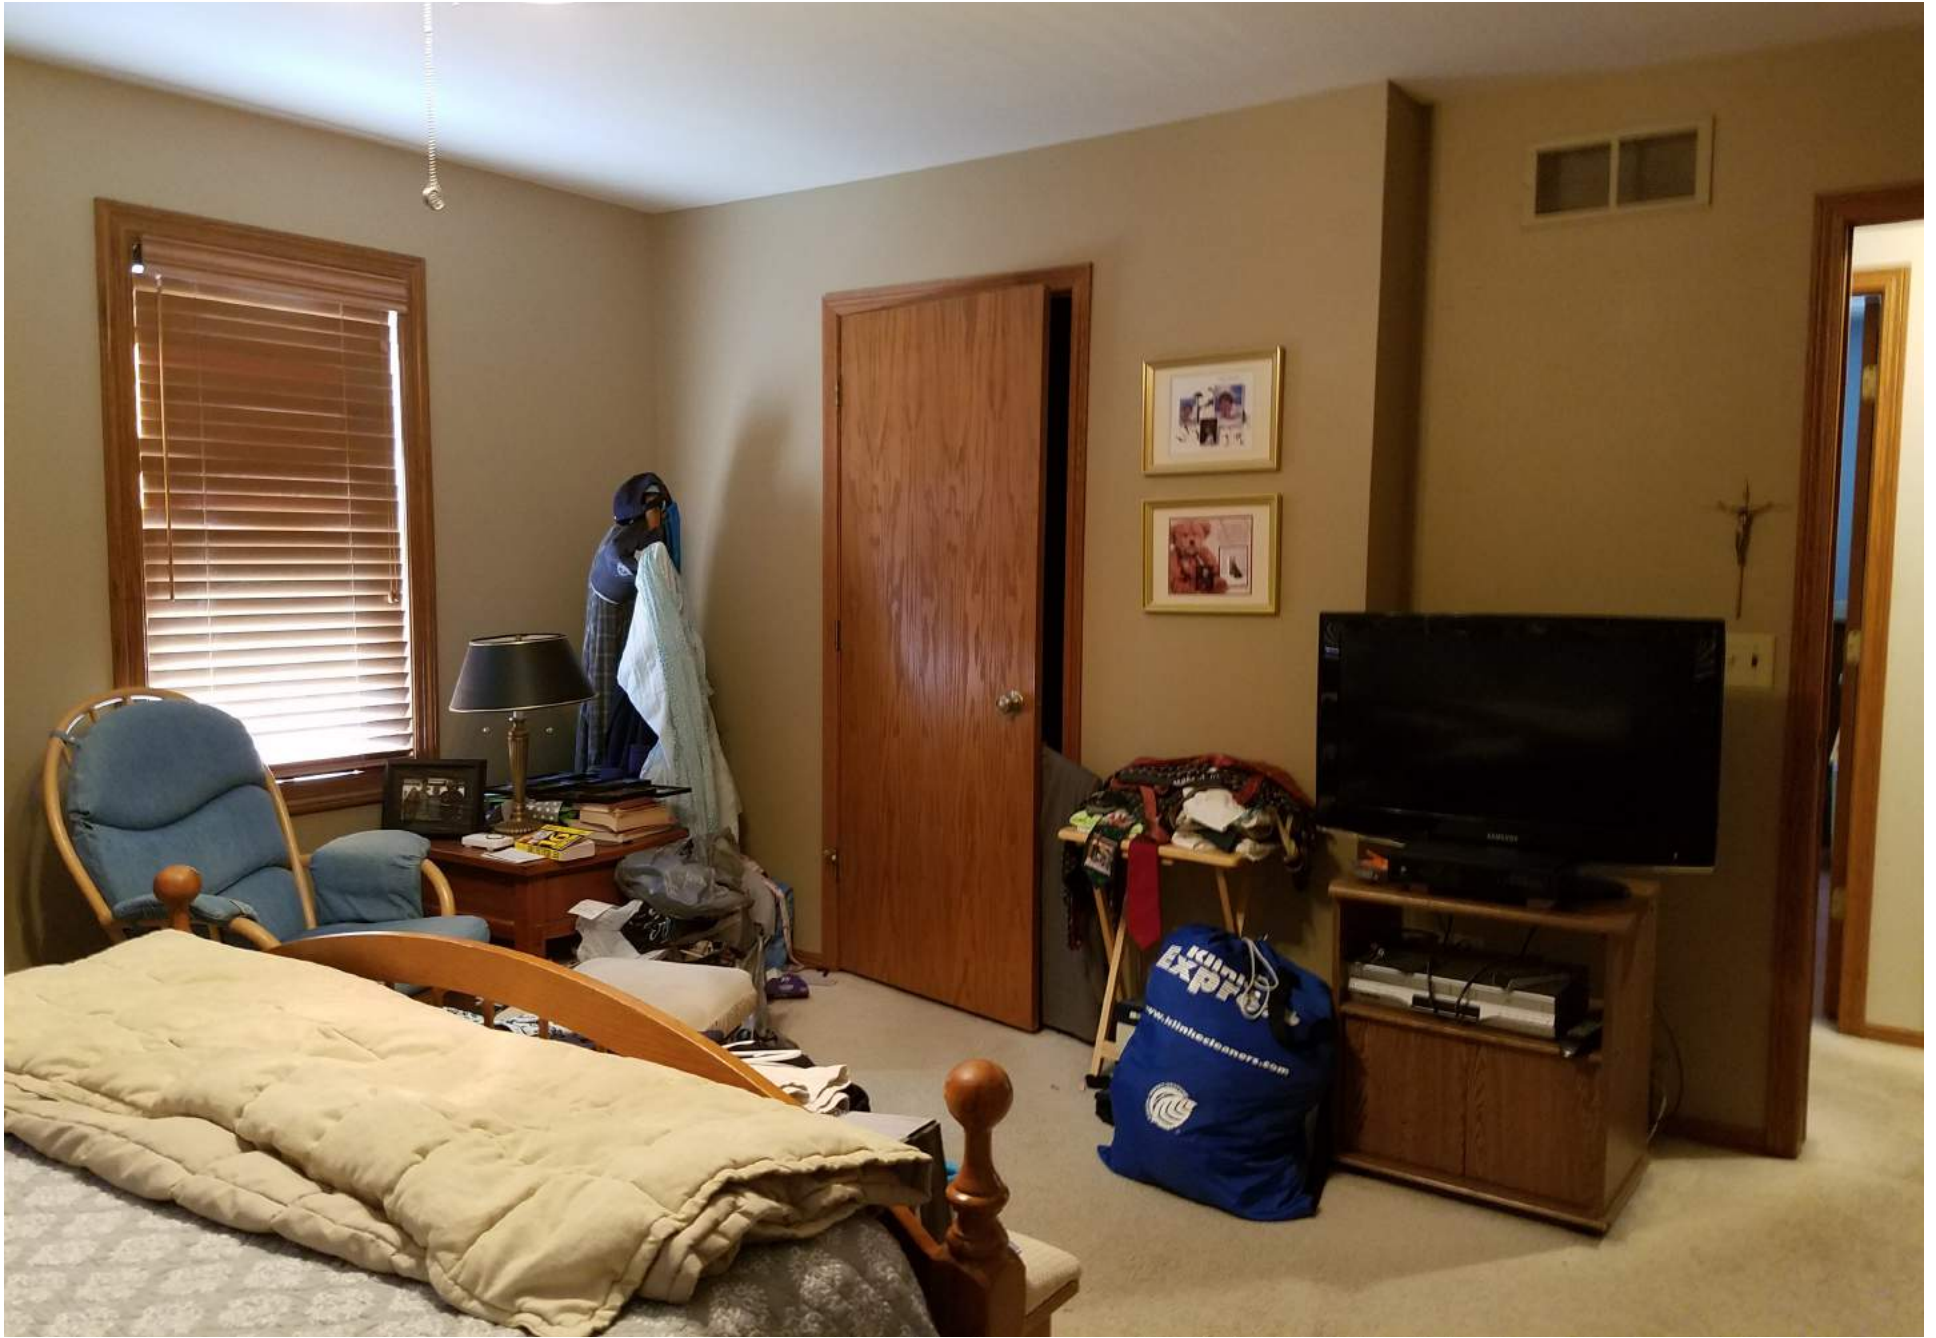
**BEFORE:** THE EXISTING MASTER BEDROOM HAD A JOG IN THE WALL NEAR THE DOOR, MAKING FURNITURE PLACEMENT DIFFICULT.

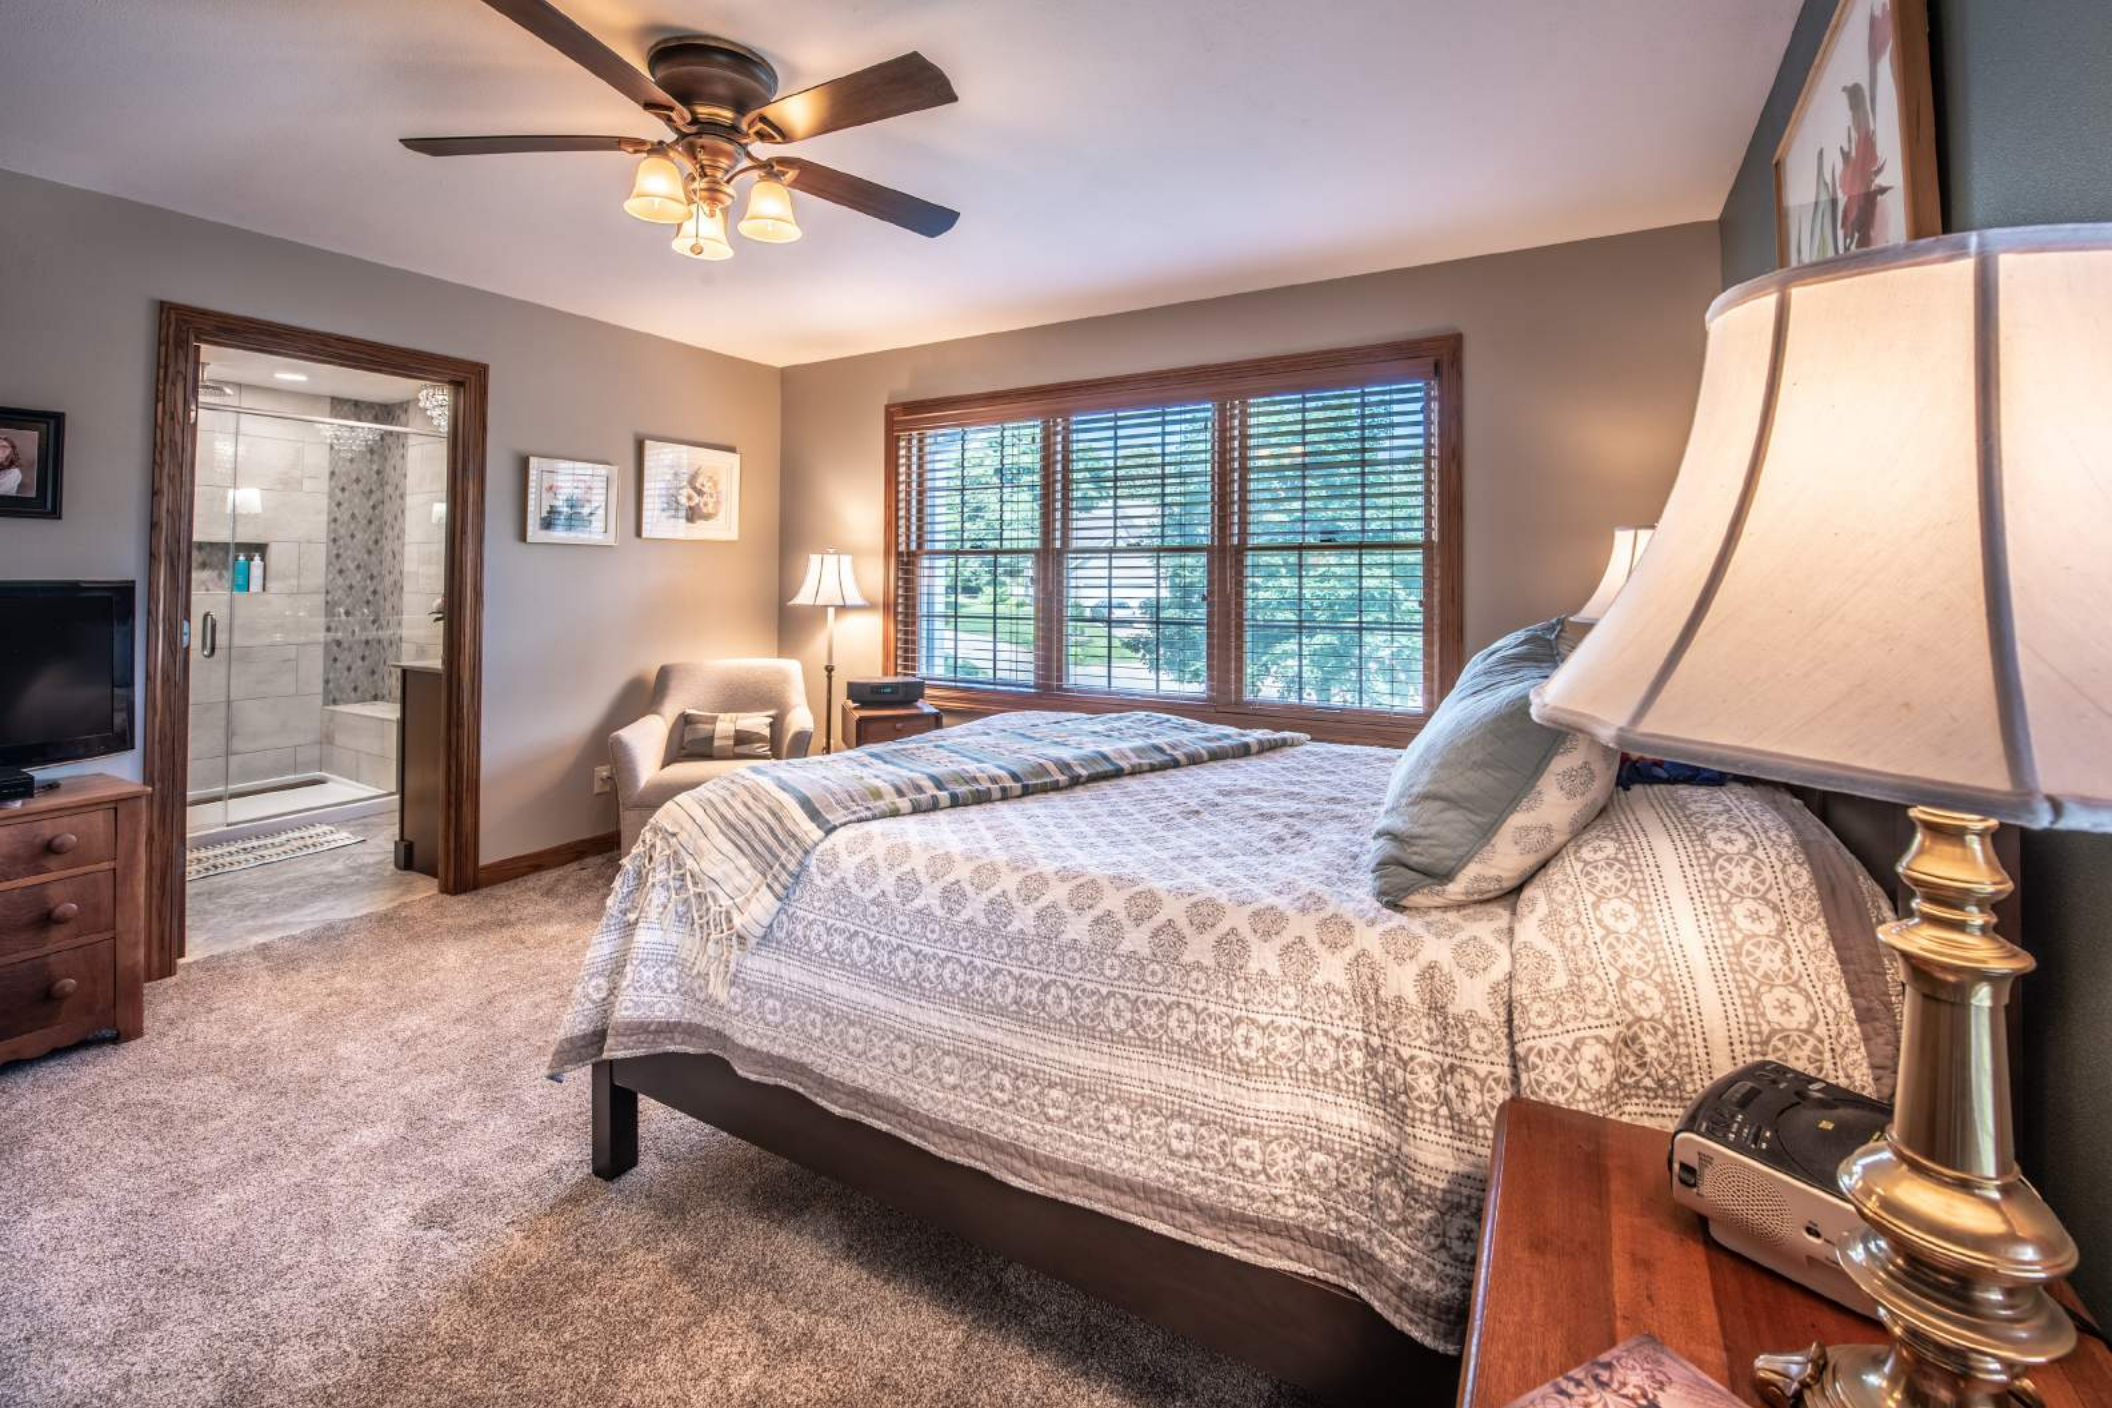
**AFTER:** VIEW TOWARD THE MASTER BATHROOM SUITE FROM THE MASTER BEDROOM. NOT PICTURED: THE JOG IN THE WALL WAS STRAIGHTENED, ALLOWING FOR A MORE FLEXIBLE FURNITURE ARRANGEMENT.

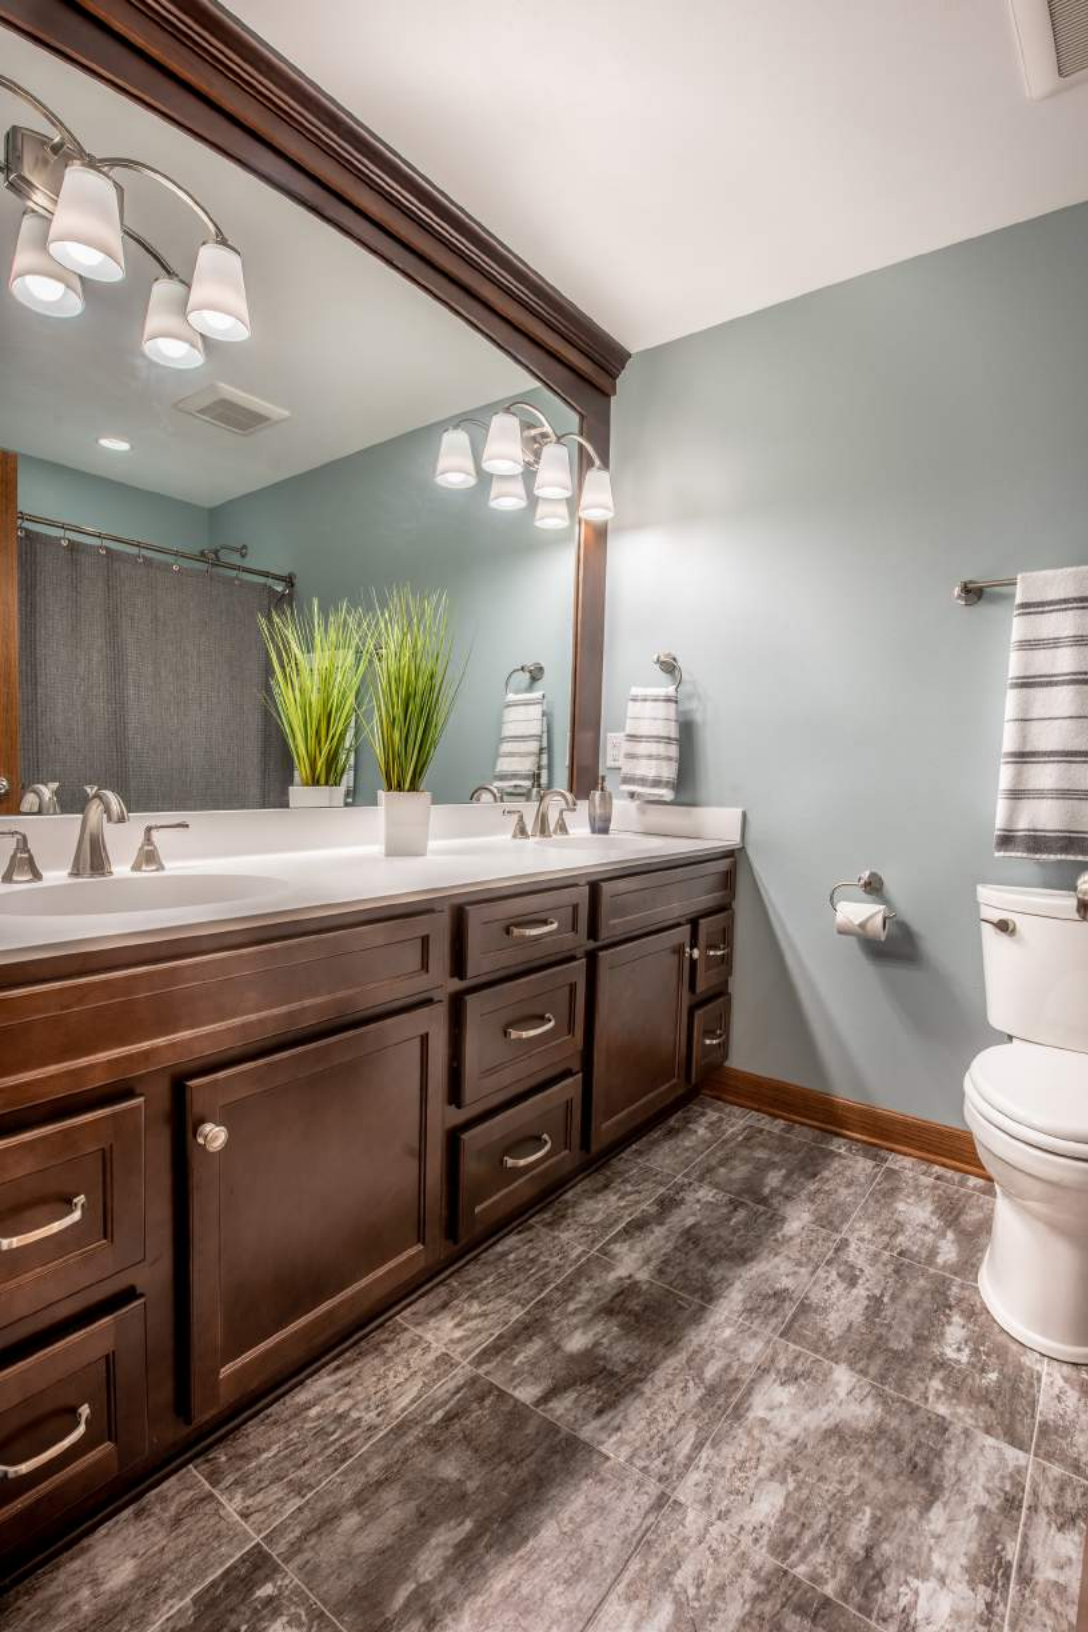
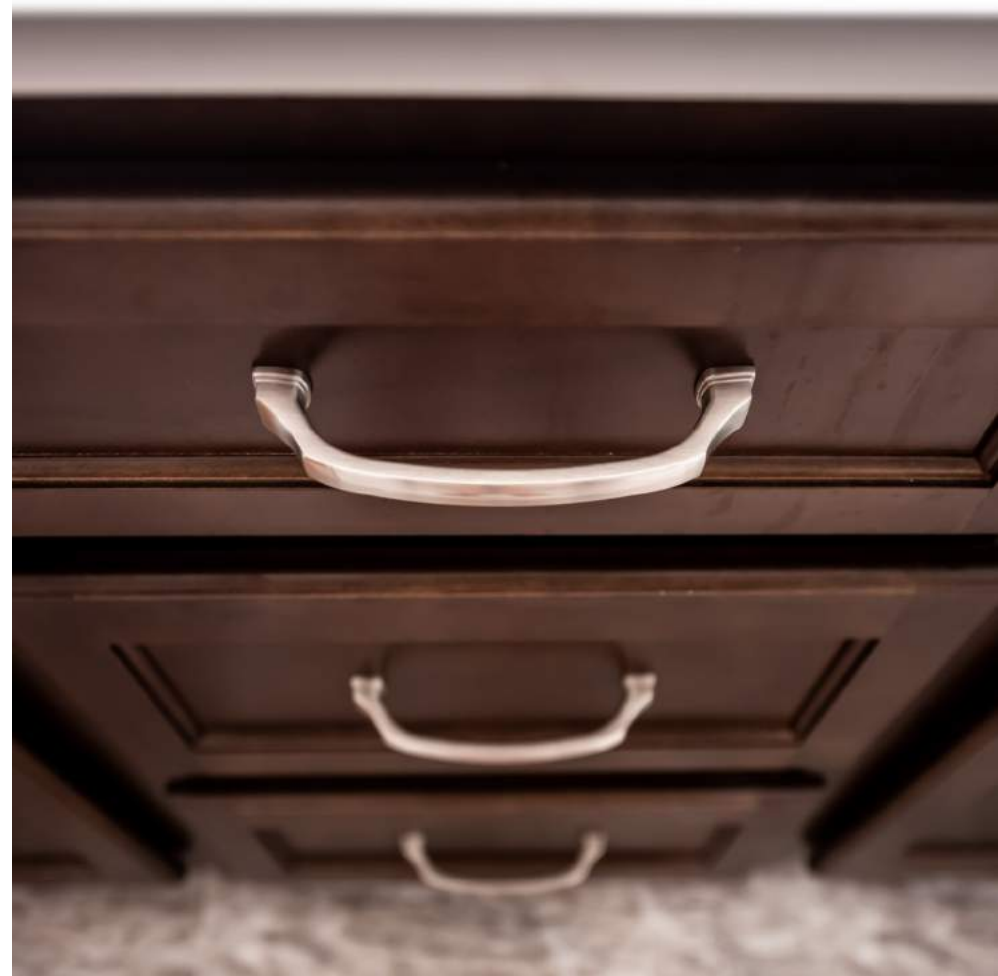
**AFTER:** VIEW OF THE KIDS BATHROOM. FINISHES WERE CAREFULLY SELECTED, FROM THE OVERSIZED, CUSTOM FRAMED MIRROR WITH THROUGH GLASS LIGHTING, TO THE DRAWER PULLS THAT WON'T CATCH POCKETS OR CORDS. CABINETRY WAS CHOSEN IN THE SAME FINISH AS THE KITCHEN TO RETAIN A COHESIVE FEEL THROUGHOUT THE HOME.

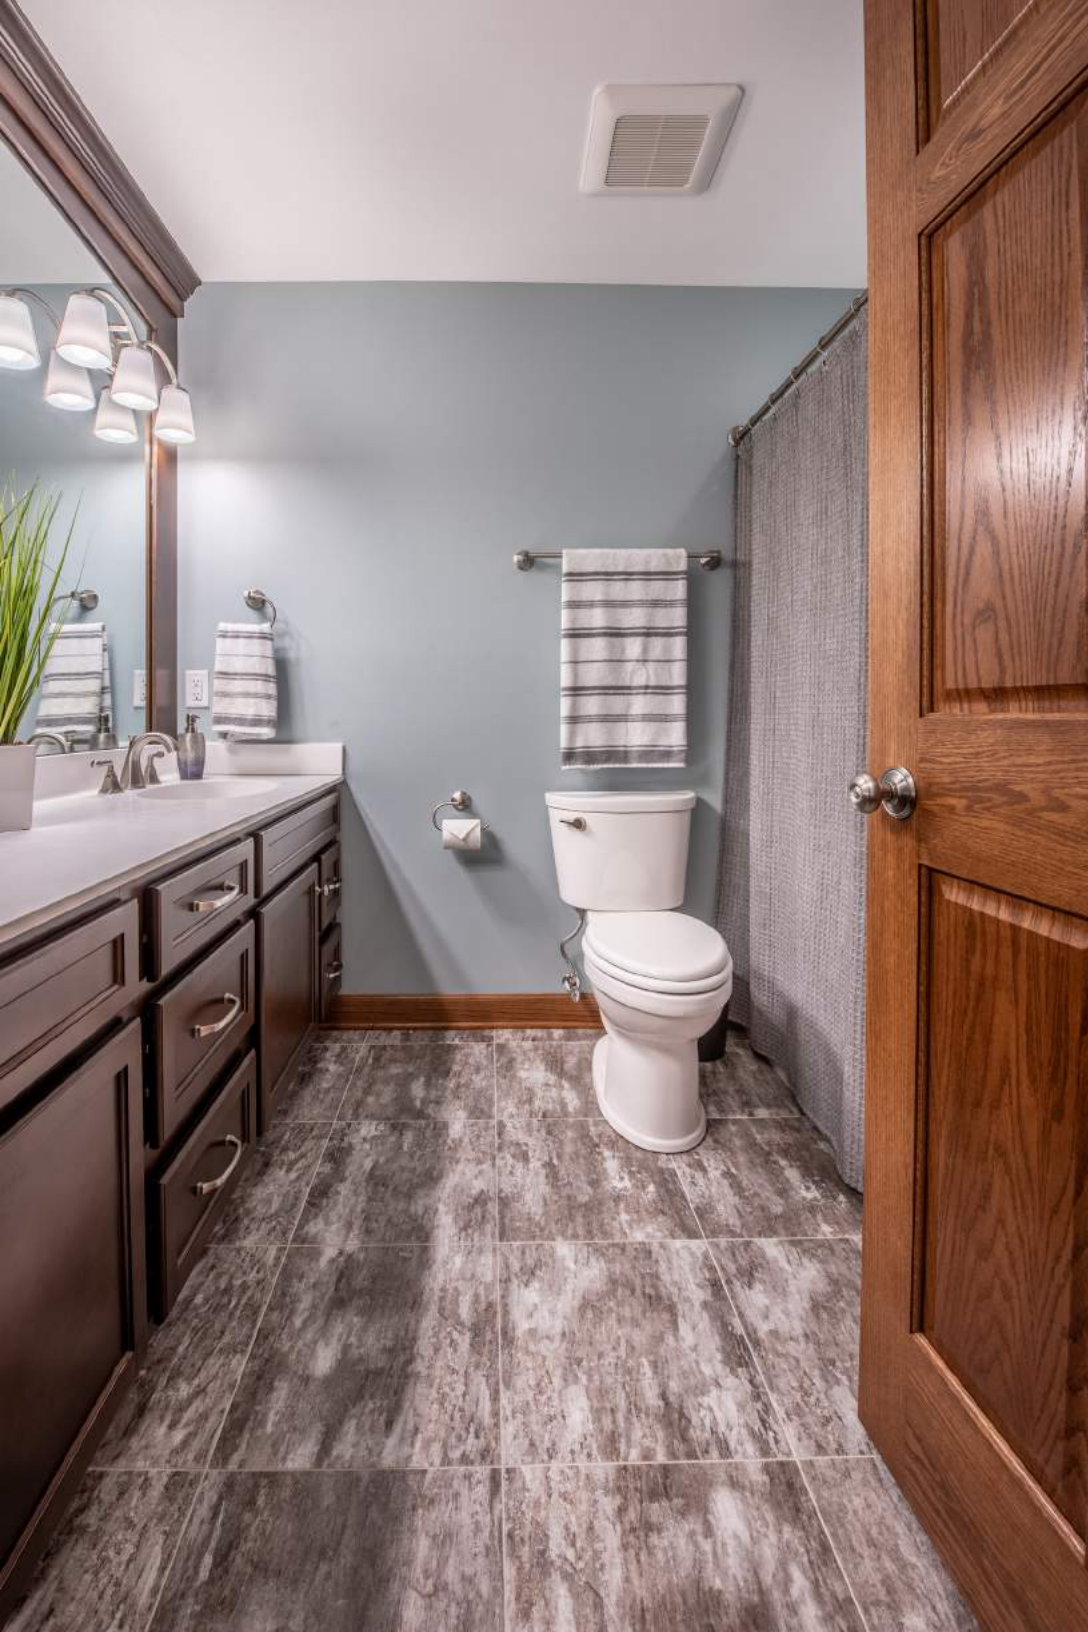
**AFTER:** VIEW OF THE KIDS BATHROOM. NEW LUXURY VINYL TILE FEELS WARM UNDER FOOT. ALL NEW SOLID CORE 6-PANEL DOORS REPLACED EXISTING HOLLOW CORE FLUSH DOORS.

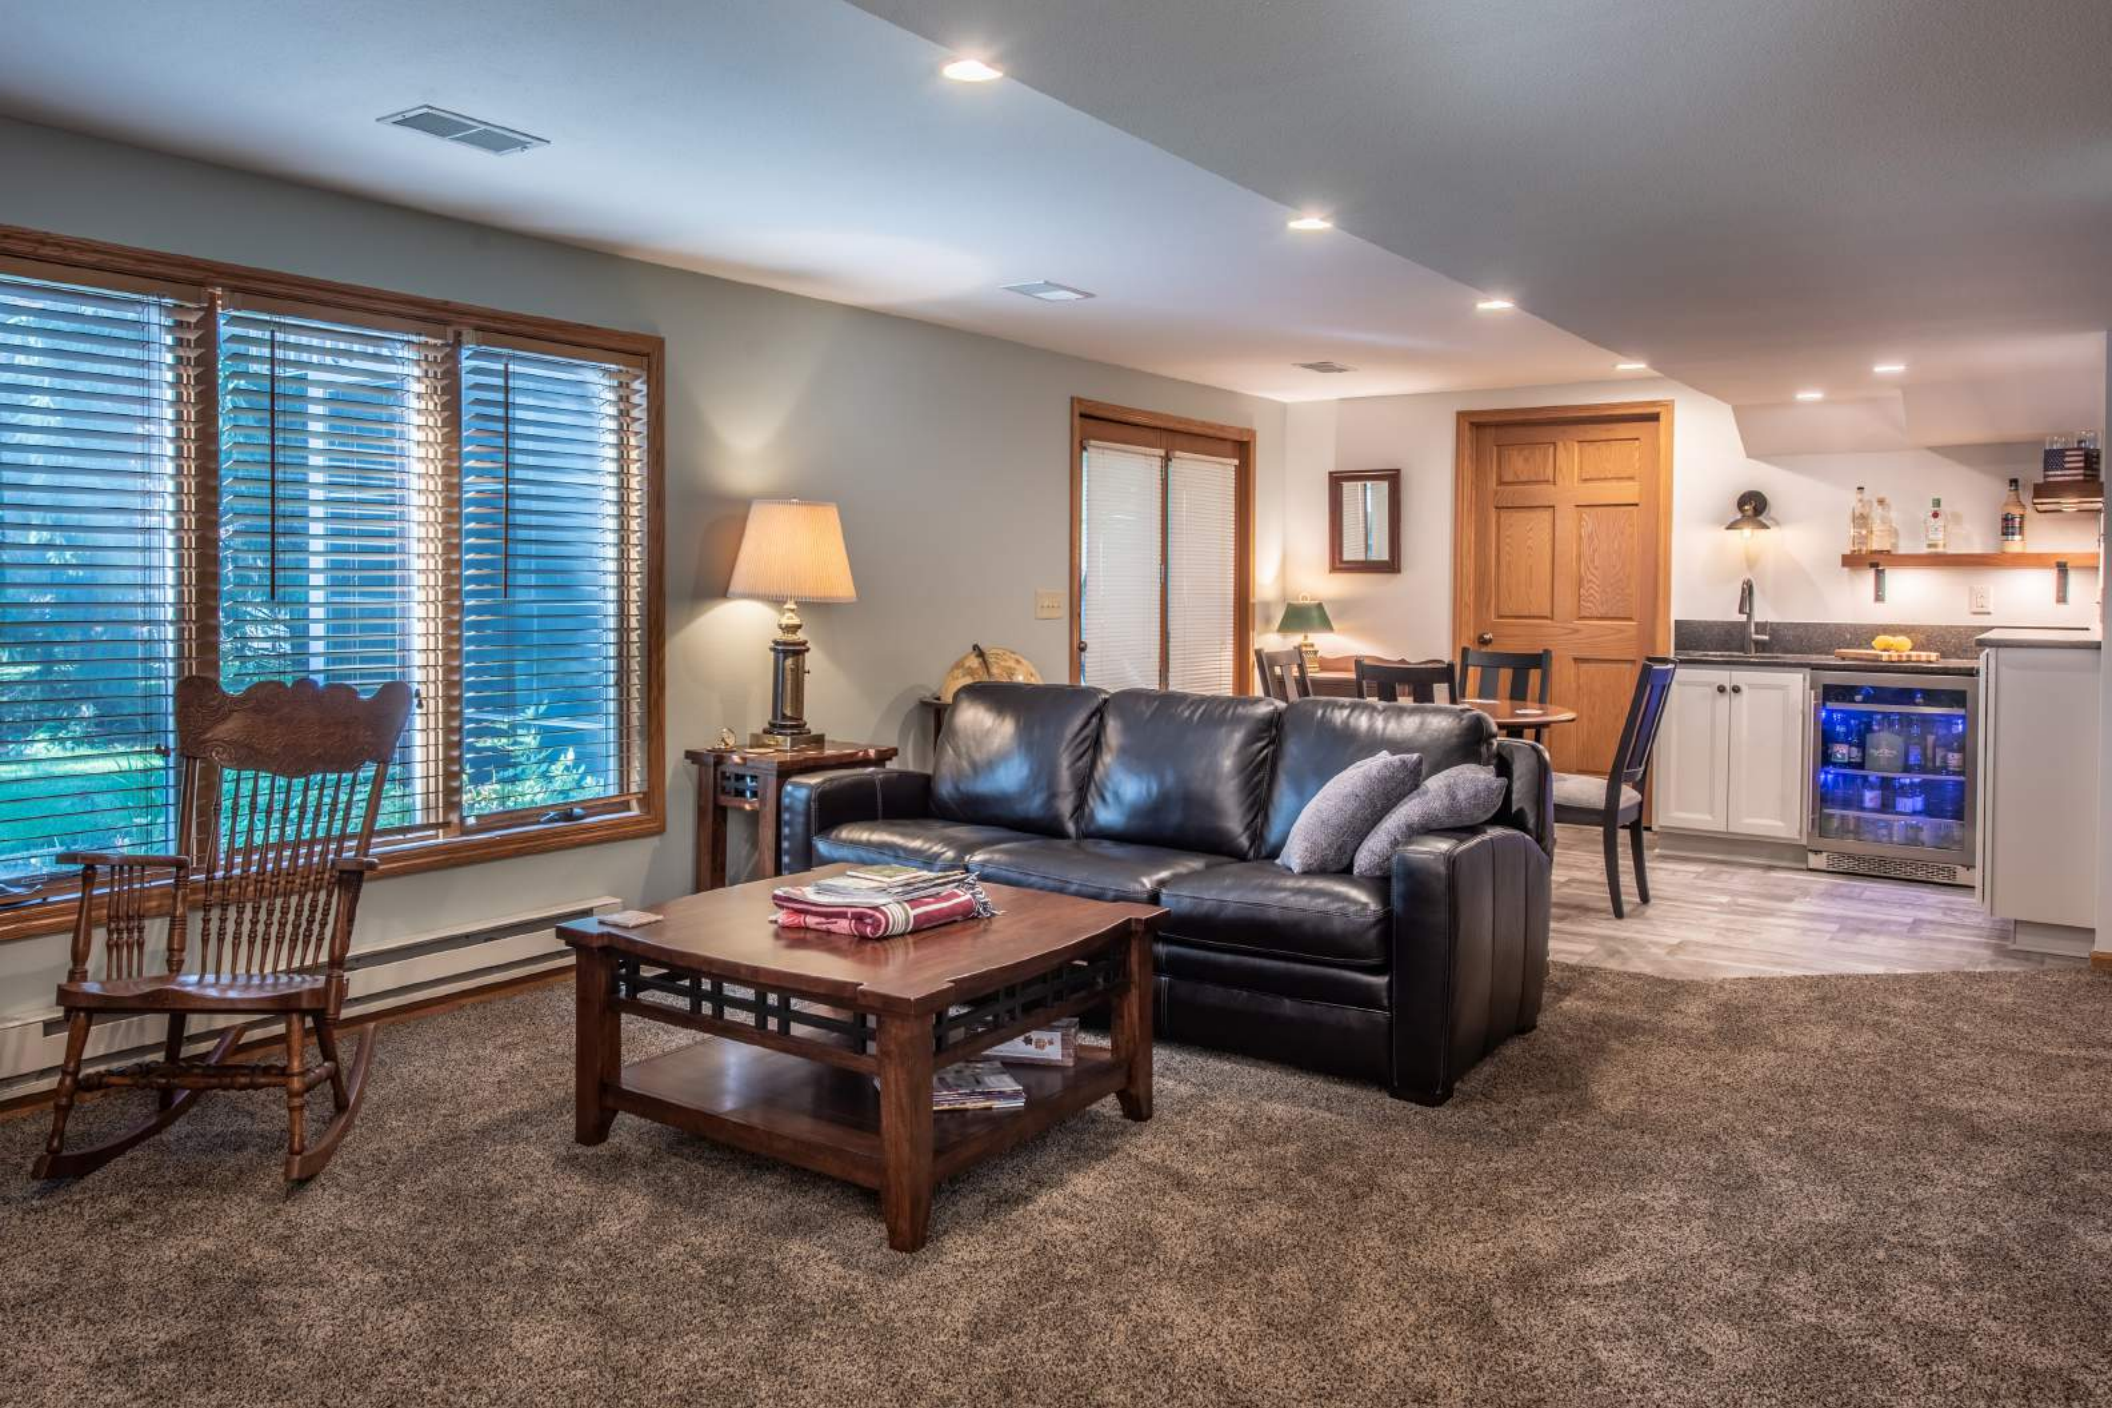
**AFTER:** VIEW OF THE BASEMENT TOWARD THE MECHANICAL ROOM. STORAGE CORNER HAS BEEN REMODELED INTO A BEVERAGE CENTER.

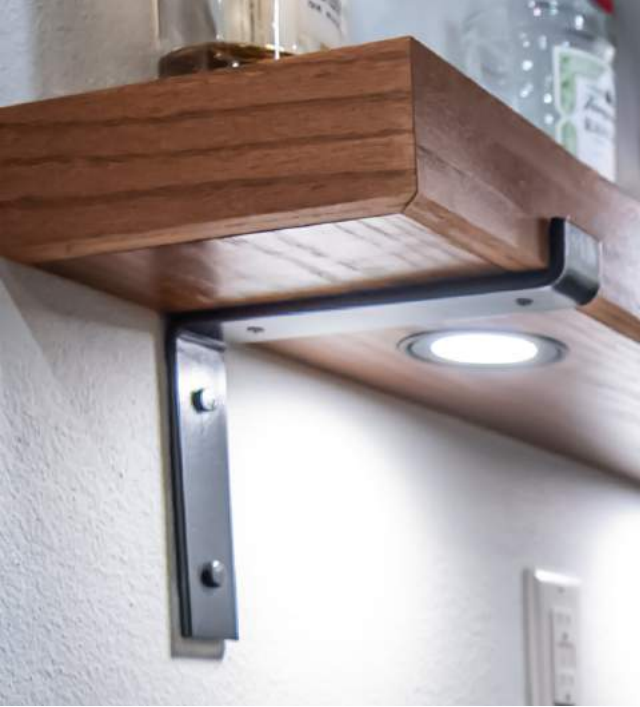
**AFTER (ABOVE):** DETAIL OF CUSTOM MADE FLOATING SHELVES WITH EXPOSED BRACKETS AND INTEGRATED LIGHTING.

The basement no longer feels like the forgotten beige storage space that it had been acting as. It is now a place to get together with friends and family; to host. The masculine vibe with iron brackets and floating shelves, an industrial sconce over the sink, and varied grays throughout the space are gorgeous.

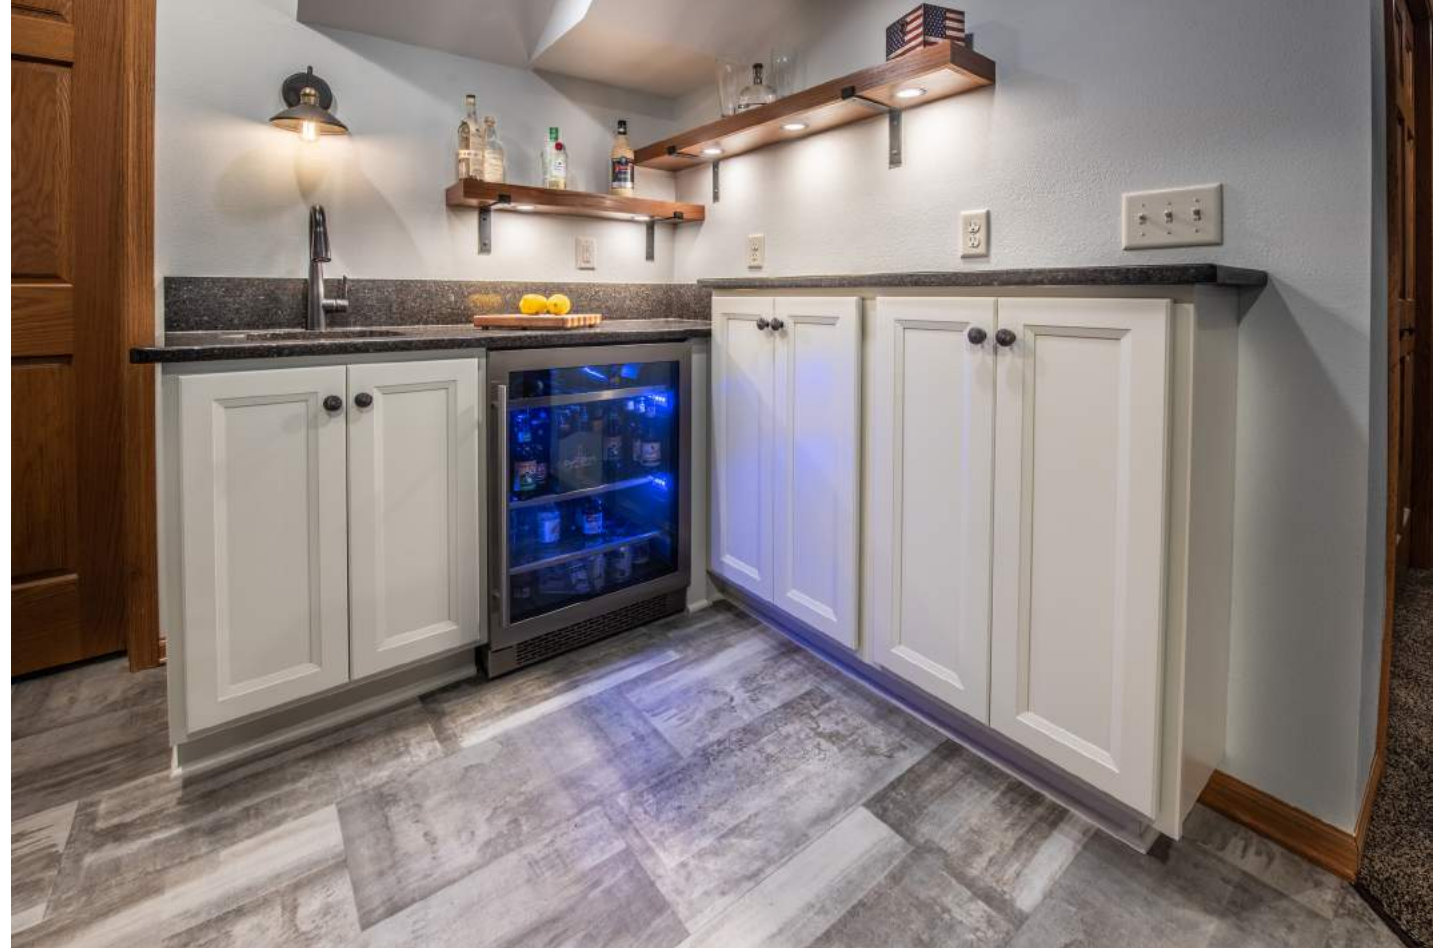
**AFTER (ABOVE):** THE BEVERAGE CENTER WAS DESIGNED WITH KITCHEN HEIGHT CABINETRY ON THE LEFT FOR PREP, AND BAR HEIGHT STORAGE ALONG THE WALL TO THE RIGHT TO PROVIDE FOR A PLACE TO LEAN AND PLACE DRINKS WHILE SOCIALIZING. THIS CONFIGURATION PROMOTES INTERACTION AND BEST UTILIZES THE FLOOR SPACE. THE CLIENT ORIGINALLY INTENDED FOR A FORMAL BAR IN THIS AREA, BUT AFTER WORKING THROUGH THE TRUE INTENDED FUNCTION OF THE SPACE, A BEVERAGE CENTER WAS DECIDED UPON FOR ITS CASUAL APPEAL AND EASE OF REGULAR USE.

Lastly, the countertop in the basement beverage center has a single clean line to it. With the cabinetry at 36" and at 42", the backsplash of the lower cabinetry was designed at 6" to align with the no backsplash area at the upper cabinetry. The horizontal and vertical pieces fit together like a glove.
