Project Category: Residential Interior Element

Residential Interior: \$30,000 and Over

Completion Date: March 16, 2020

Location: Madison, WI

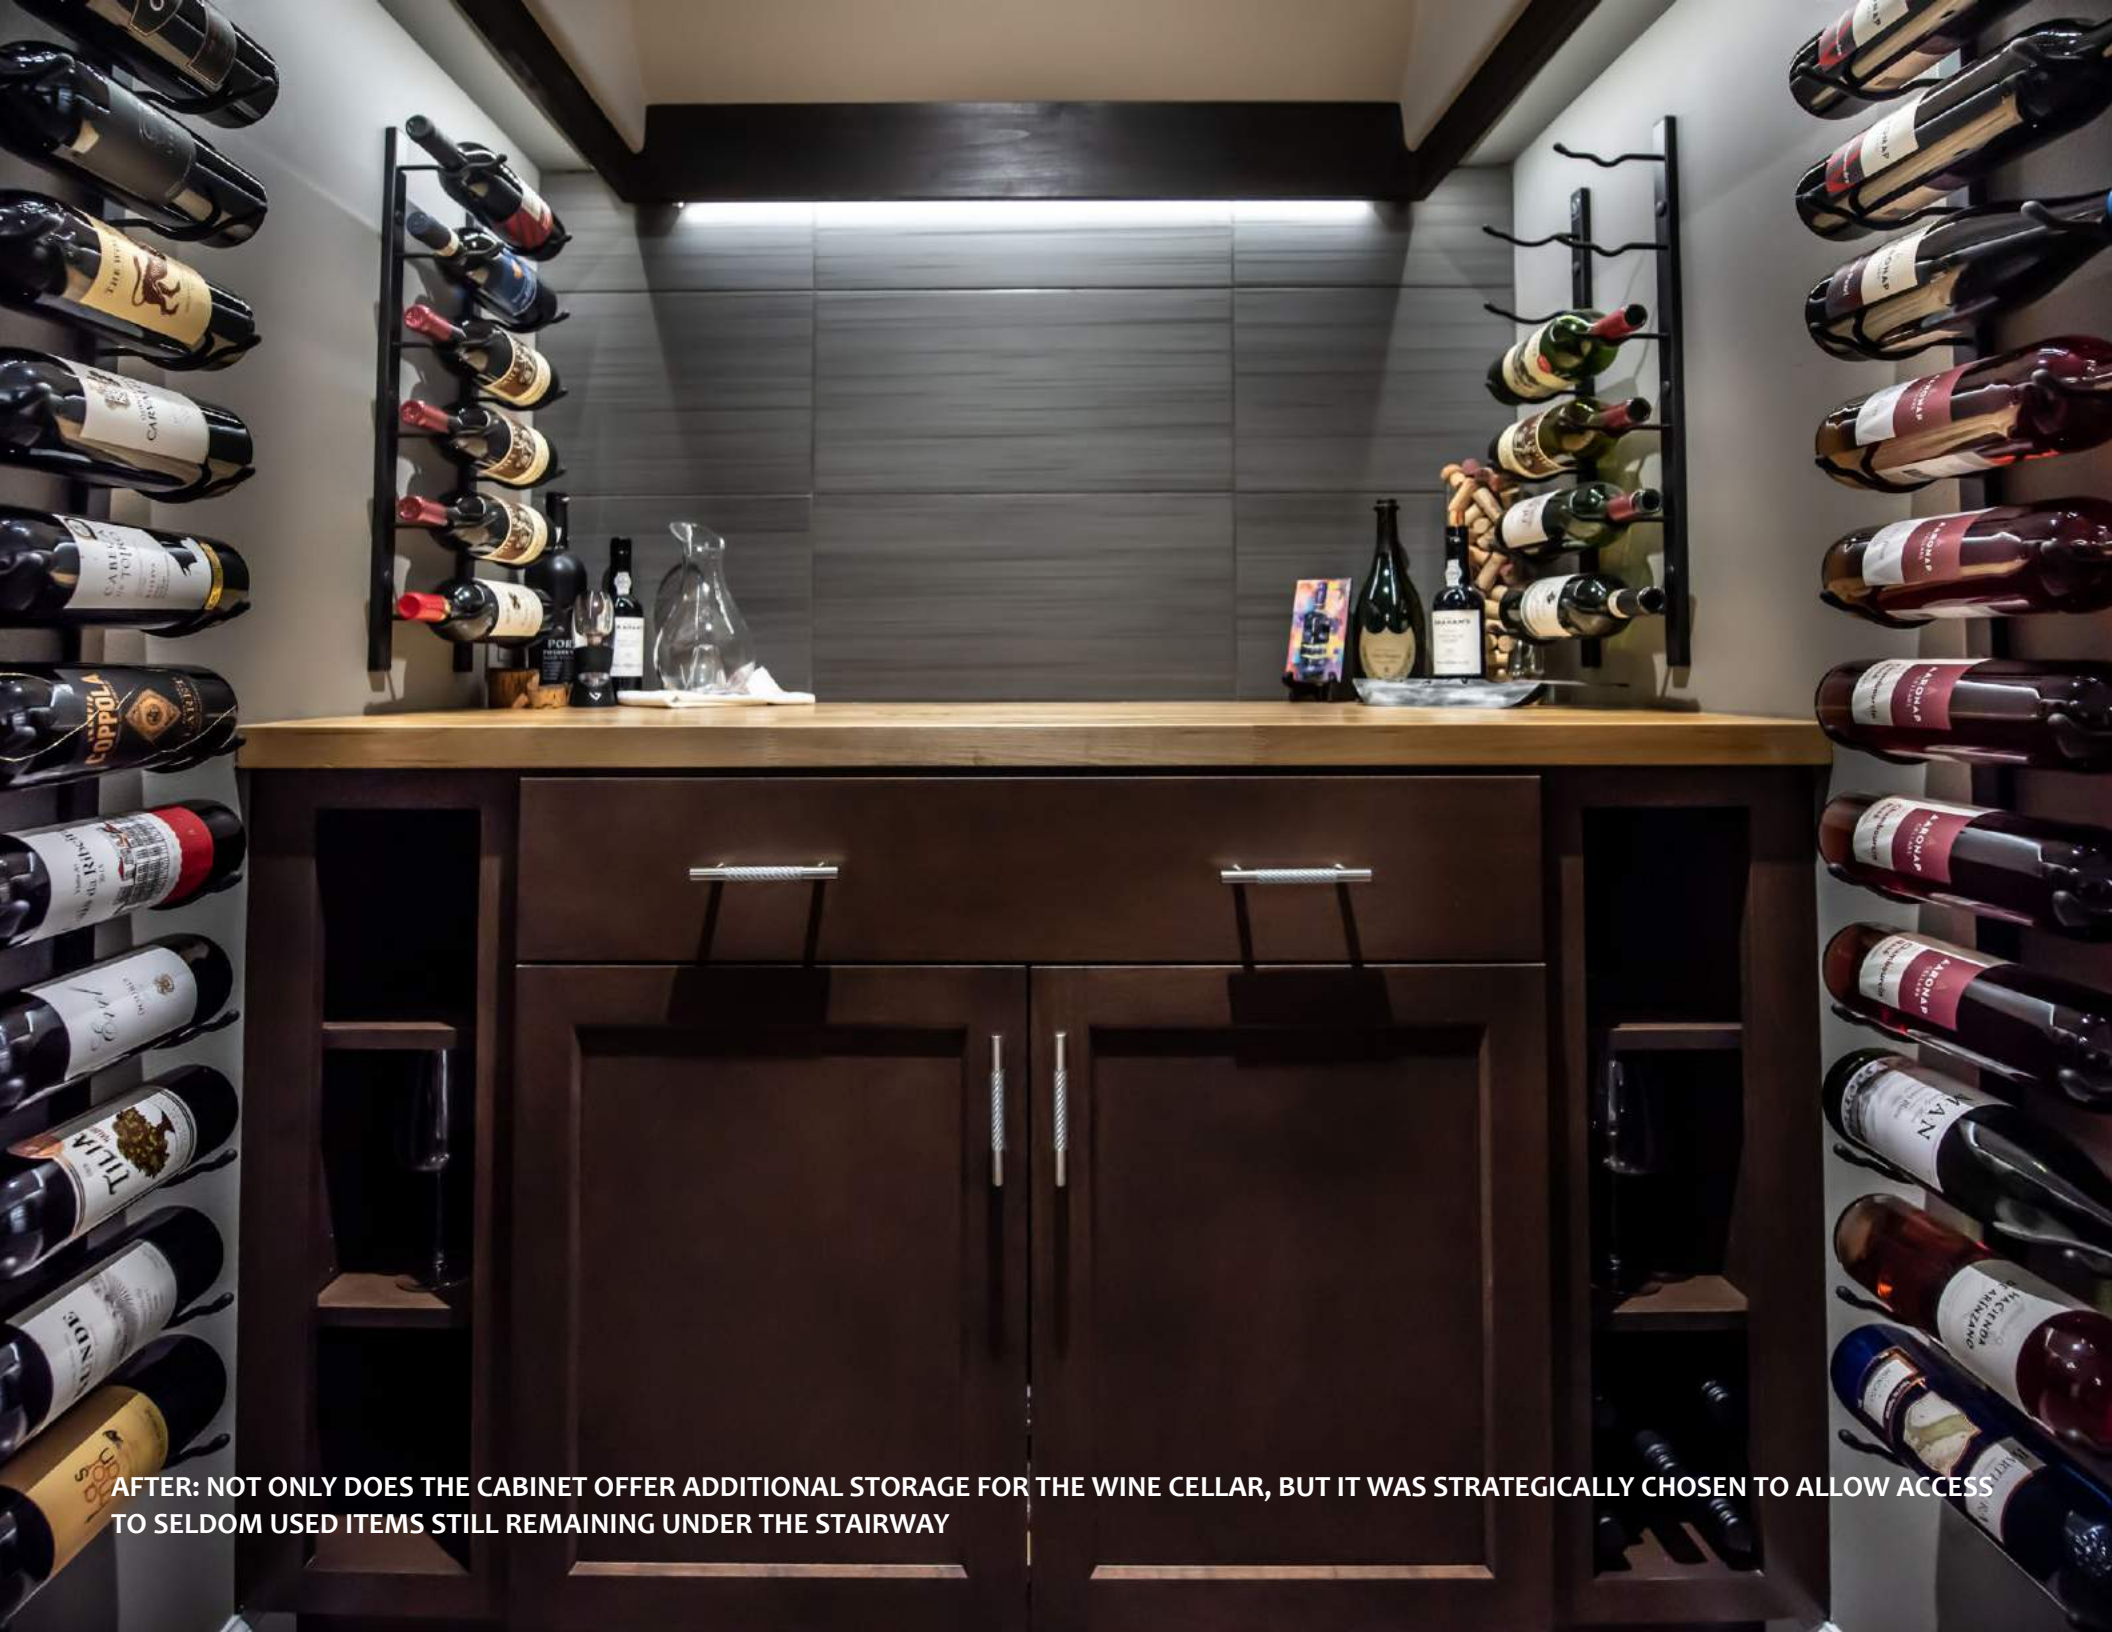
AFTER: NOT ONLY DOES THE CABINET OFFER ADDITIONAL STORAGE FOR THE WINE CELLAR, BUT IT WAS STRATEGICALLY CHOSEN TO ALLOW ACCESS TO SELDOM USED ITEMS STILL REMAINING UNDER THE STAIRWAY

The alcove space was rather nonfunctional before the project started. Now it is the perfect location for the fully stocked bar, and the area under the stairway has been converted into a wine cellar. But the space under the rest of the stairway is not lost or wasted: a custom oversized access panel inside the cabinet allows the clients to access occasionally-used items stored below the stairway landing. A butcher block countertop in the wine cellar gives guests easy access to snacks during events. The home gained features that it never before had, and the appeal of the entire lower level has been enhanced.

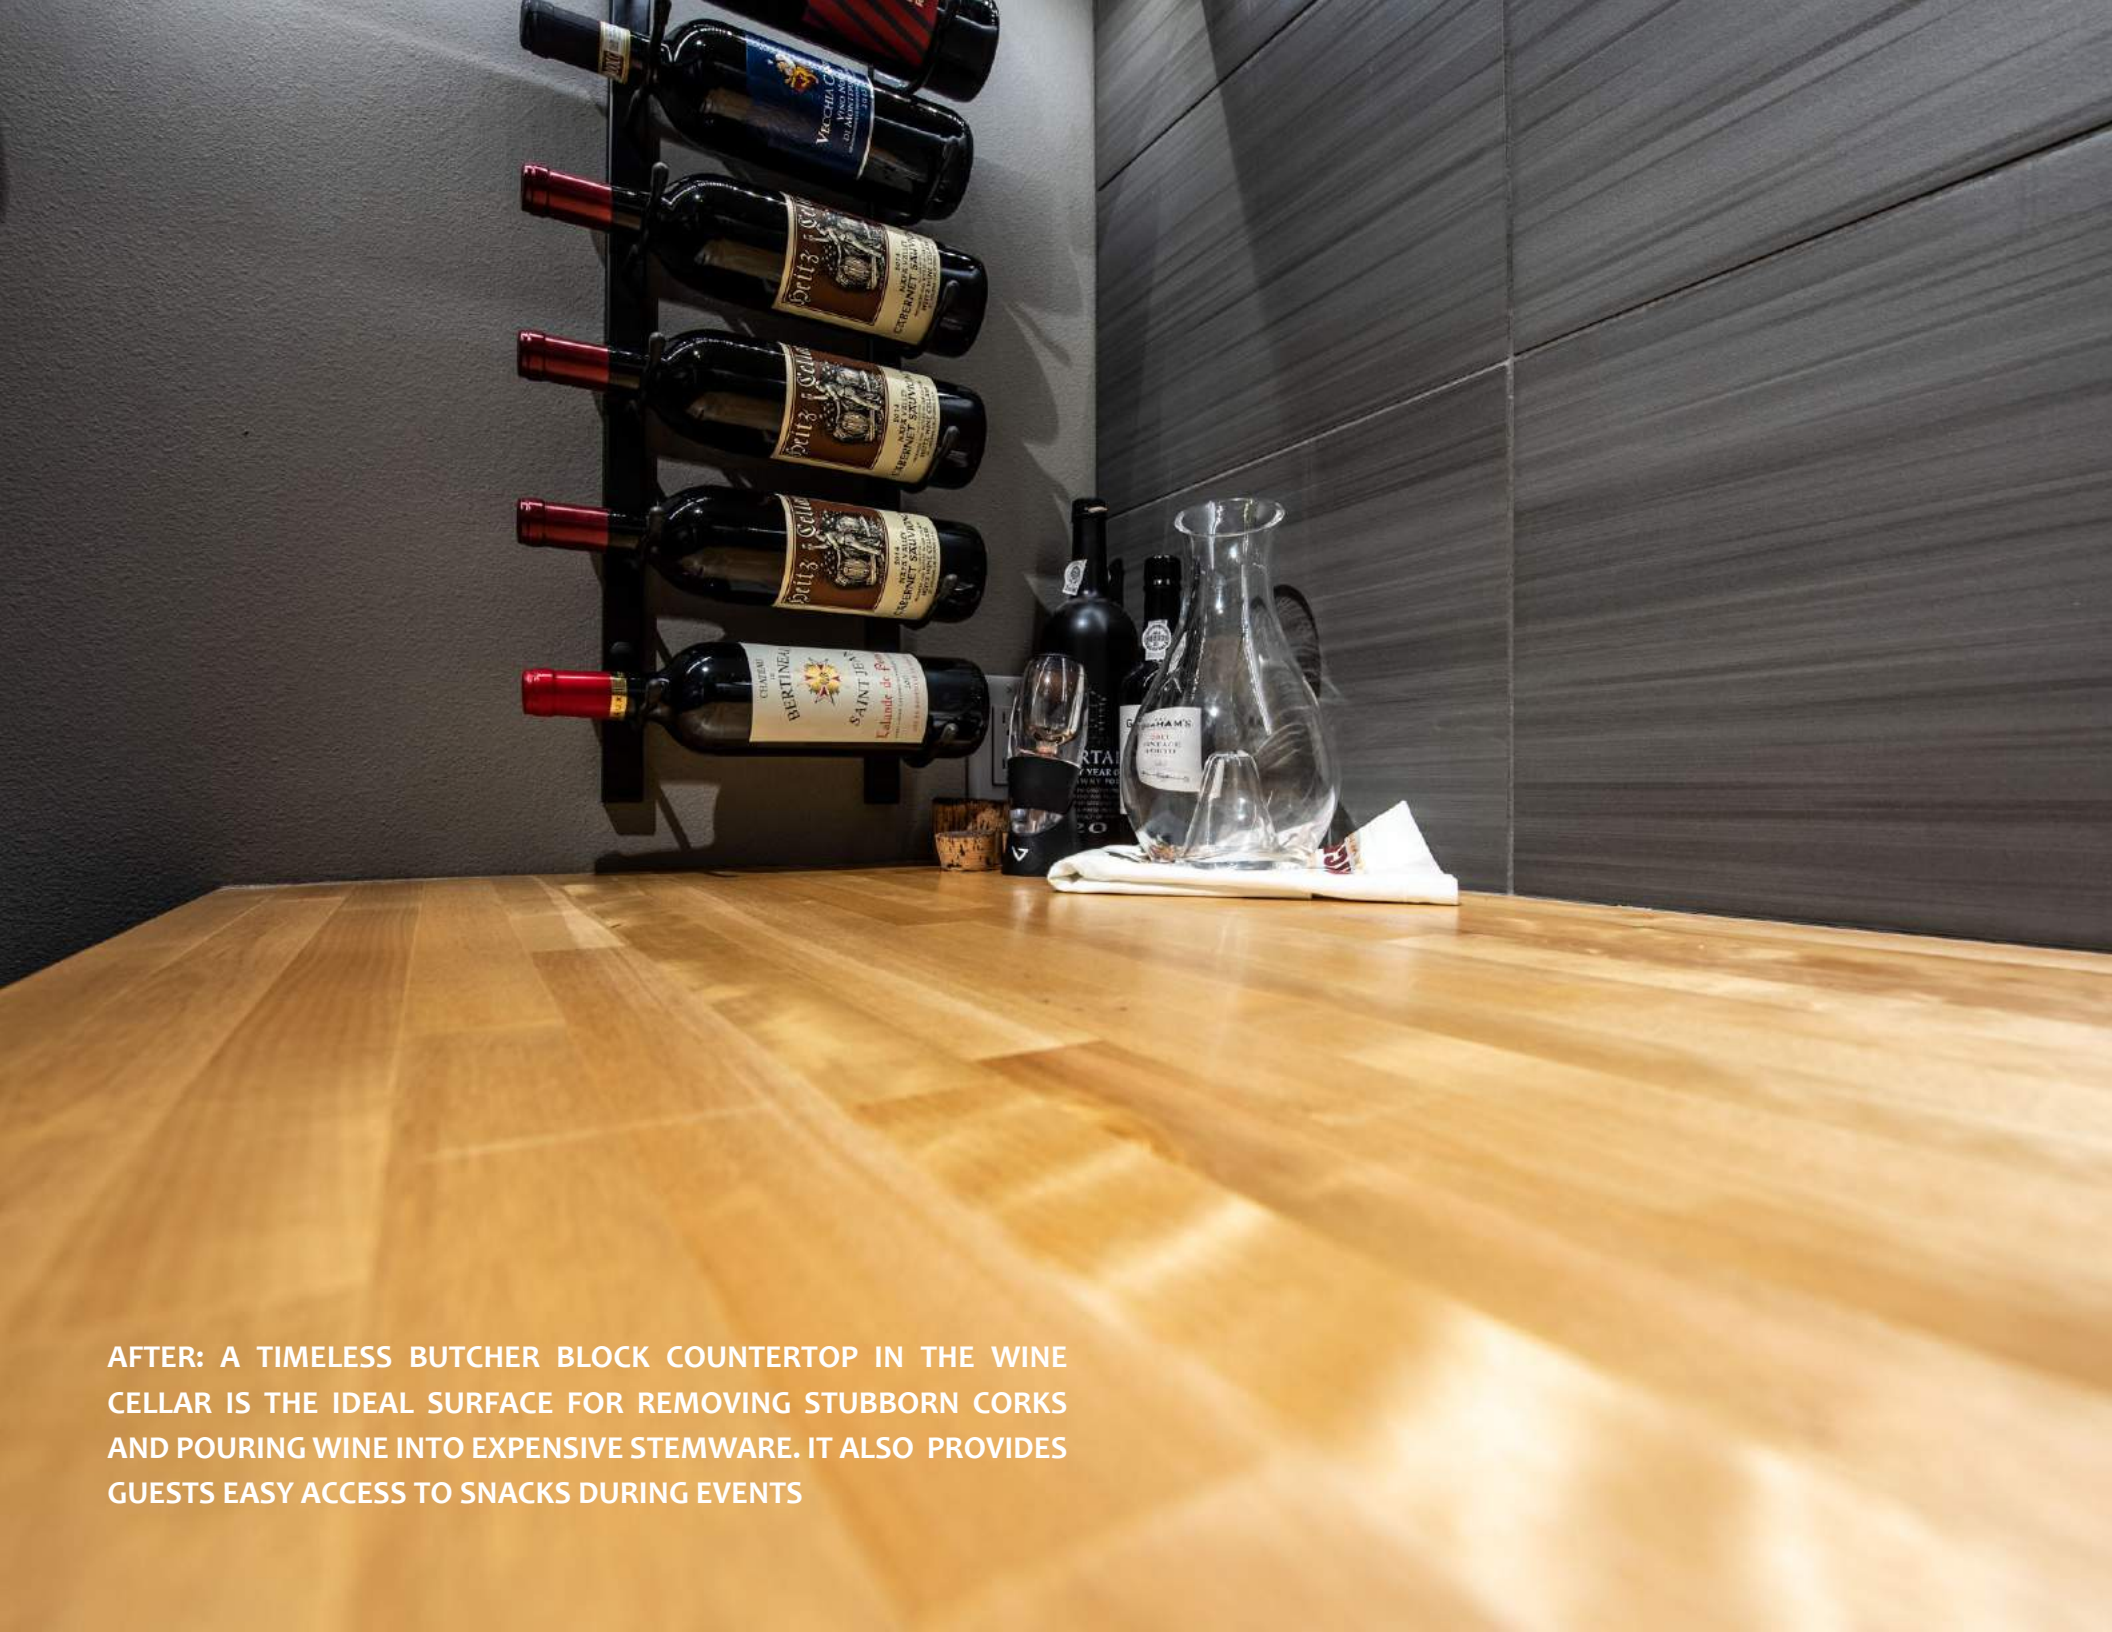
AFTER: A TIMELESS BUTCHER BLOCK COUNTERTOP IN THE WINE CELLAR IS THE IDEAL SURFACE FOR REMOVING STUBBORN CORKS AND POURING WINE INTO EXPENSIVE STEMWARE. IT ALSO PROVIDES GUESTS EASY ACCESS TO SNACKS DURING EVENTS

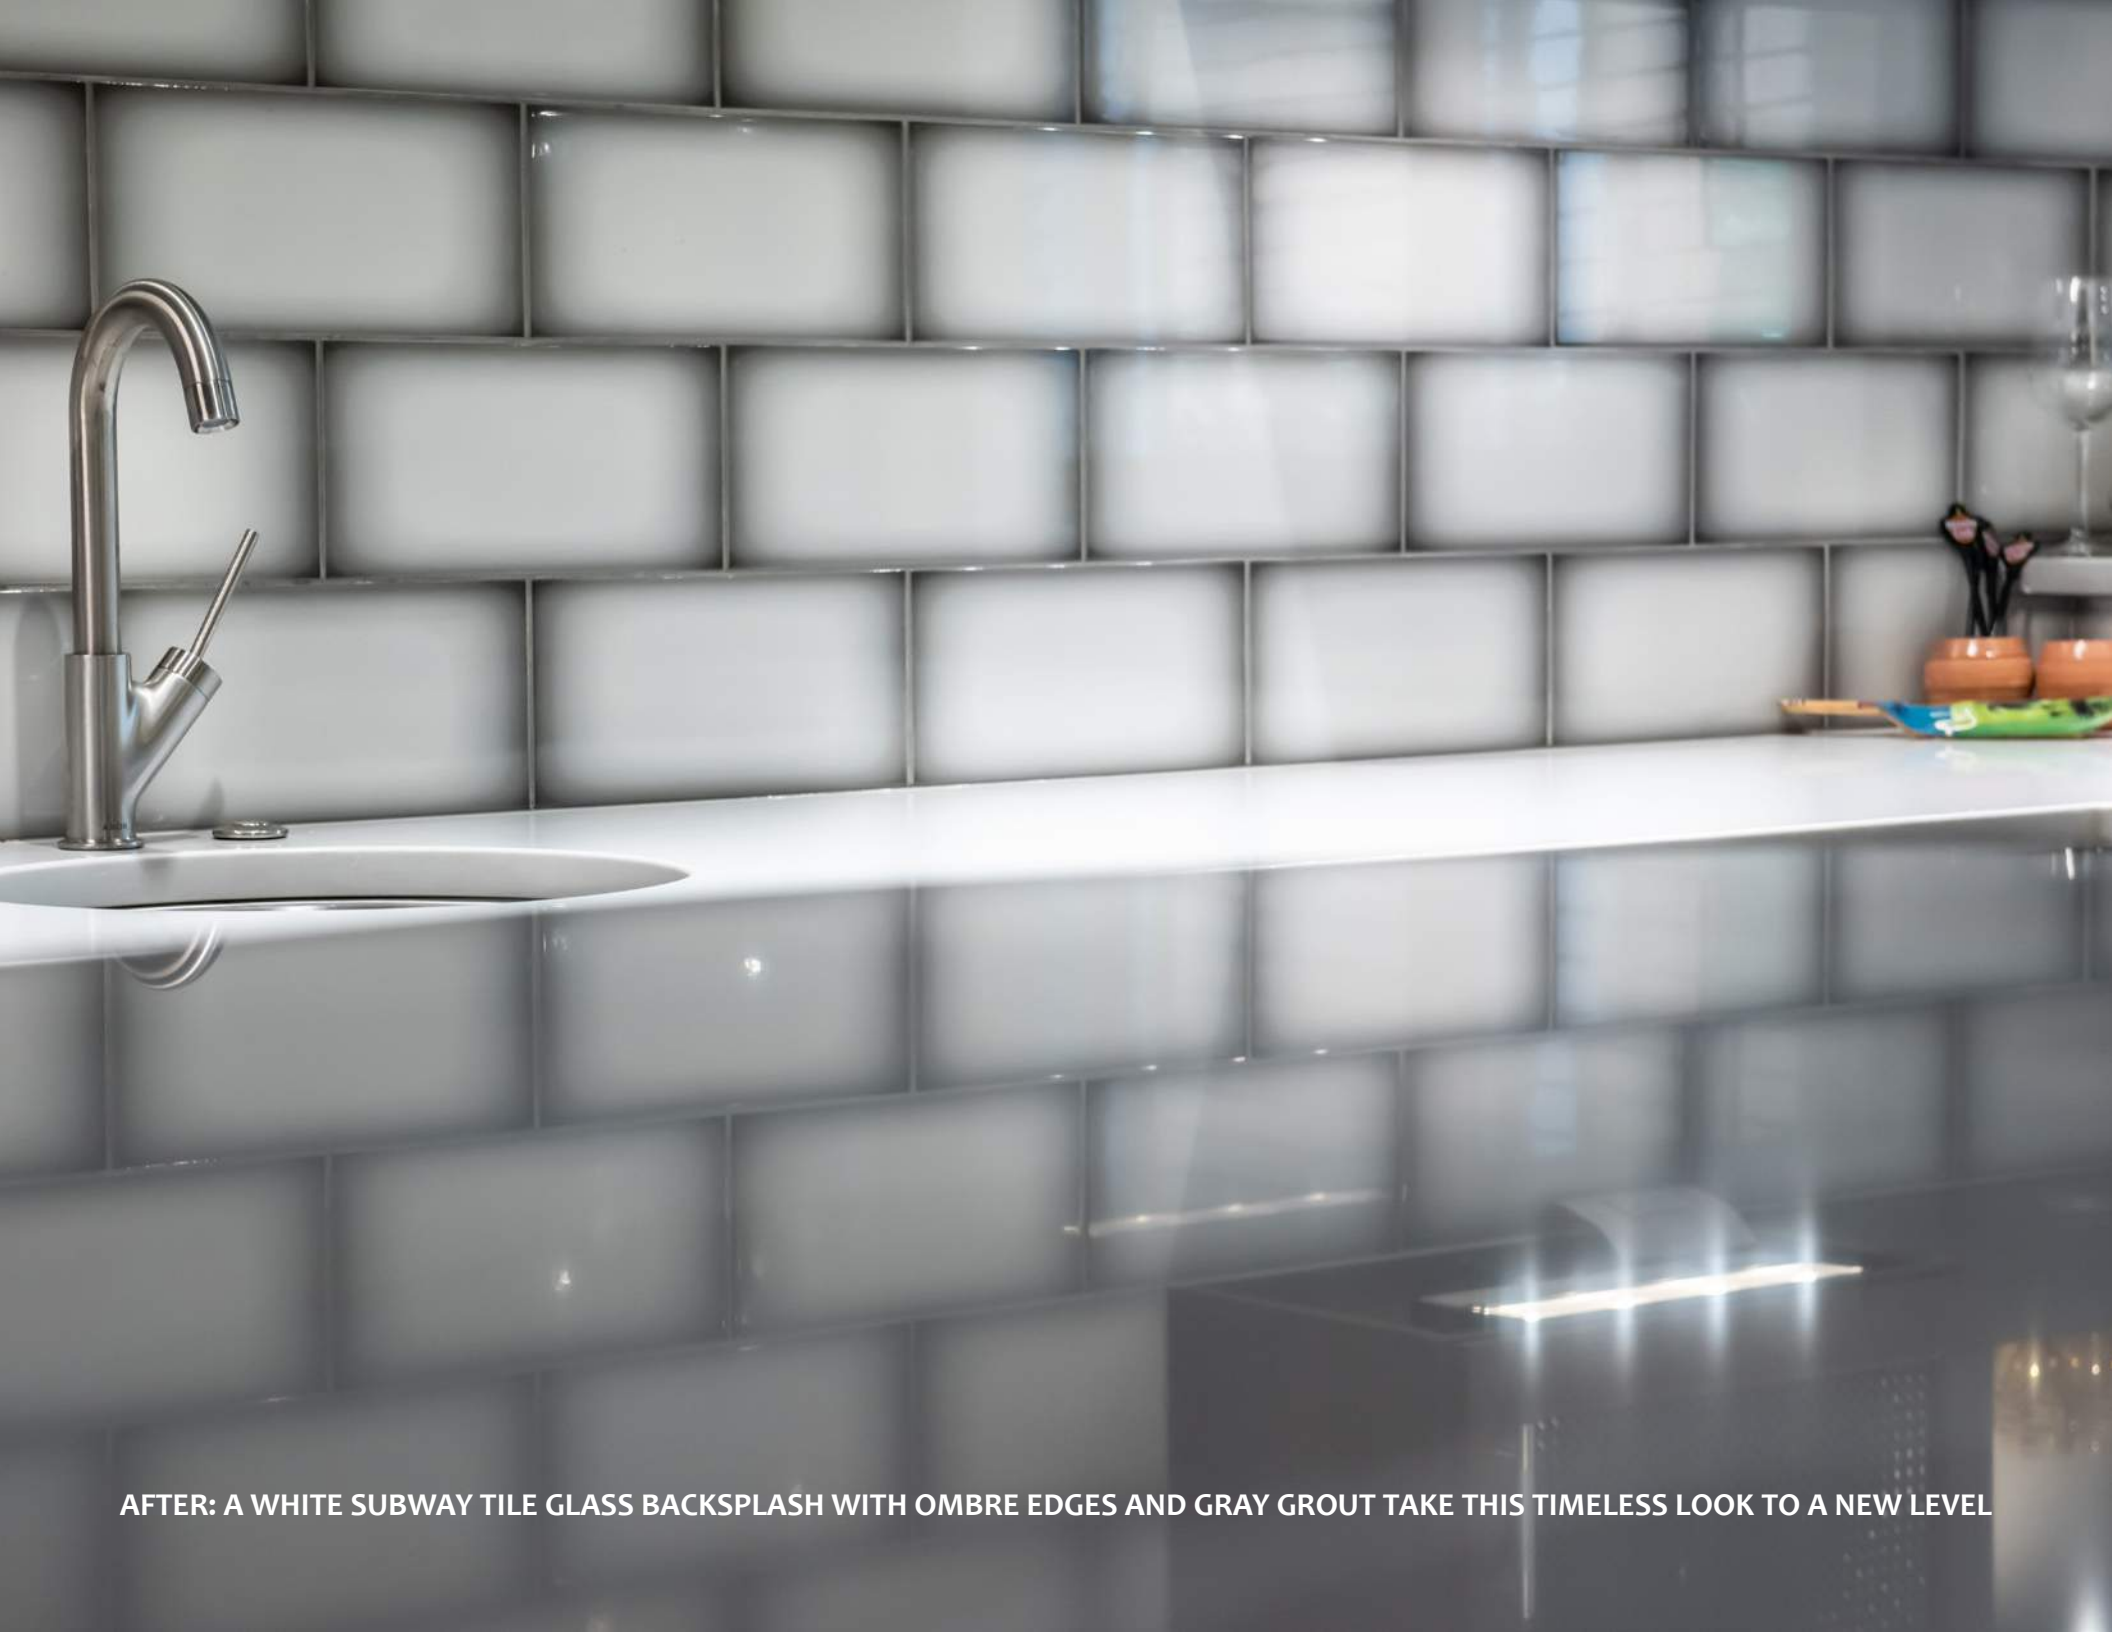
AFTER: A WHITE SUBWAY TILE GLASS BACKSPLASH WITH OMBRE EDGES AND GRAY GROUT TAKE THIS TIMELESS LOOK TO A NEW LEVEL

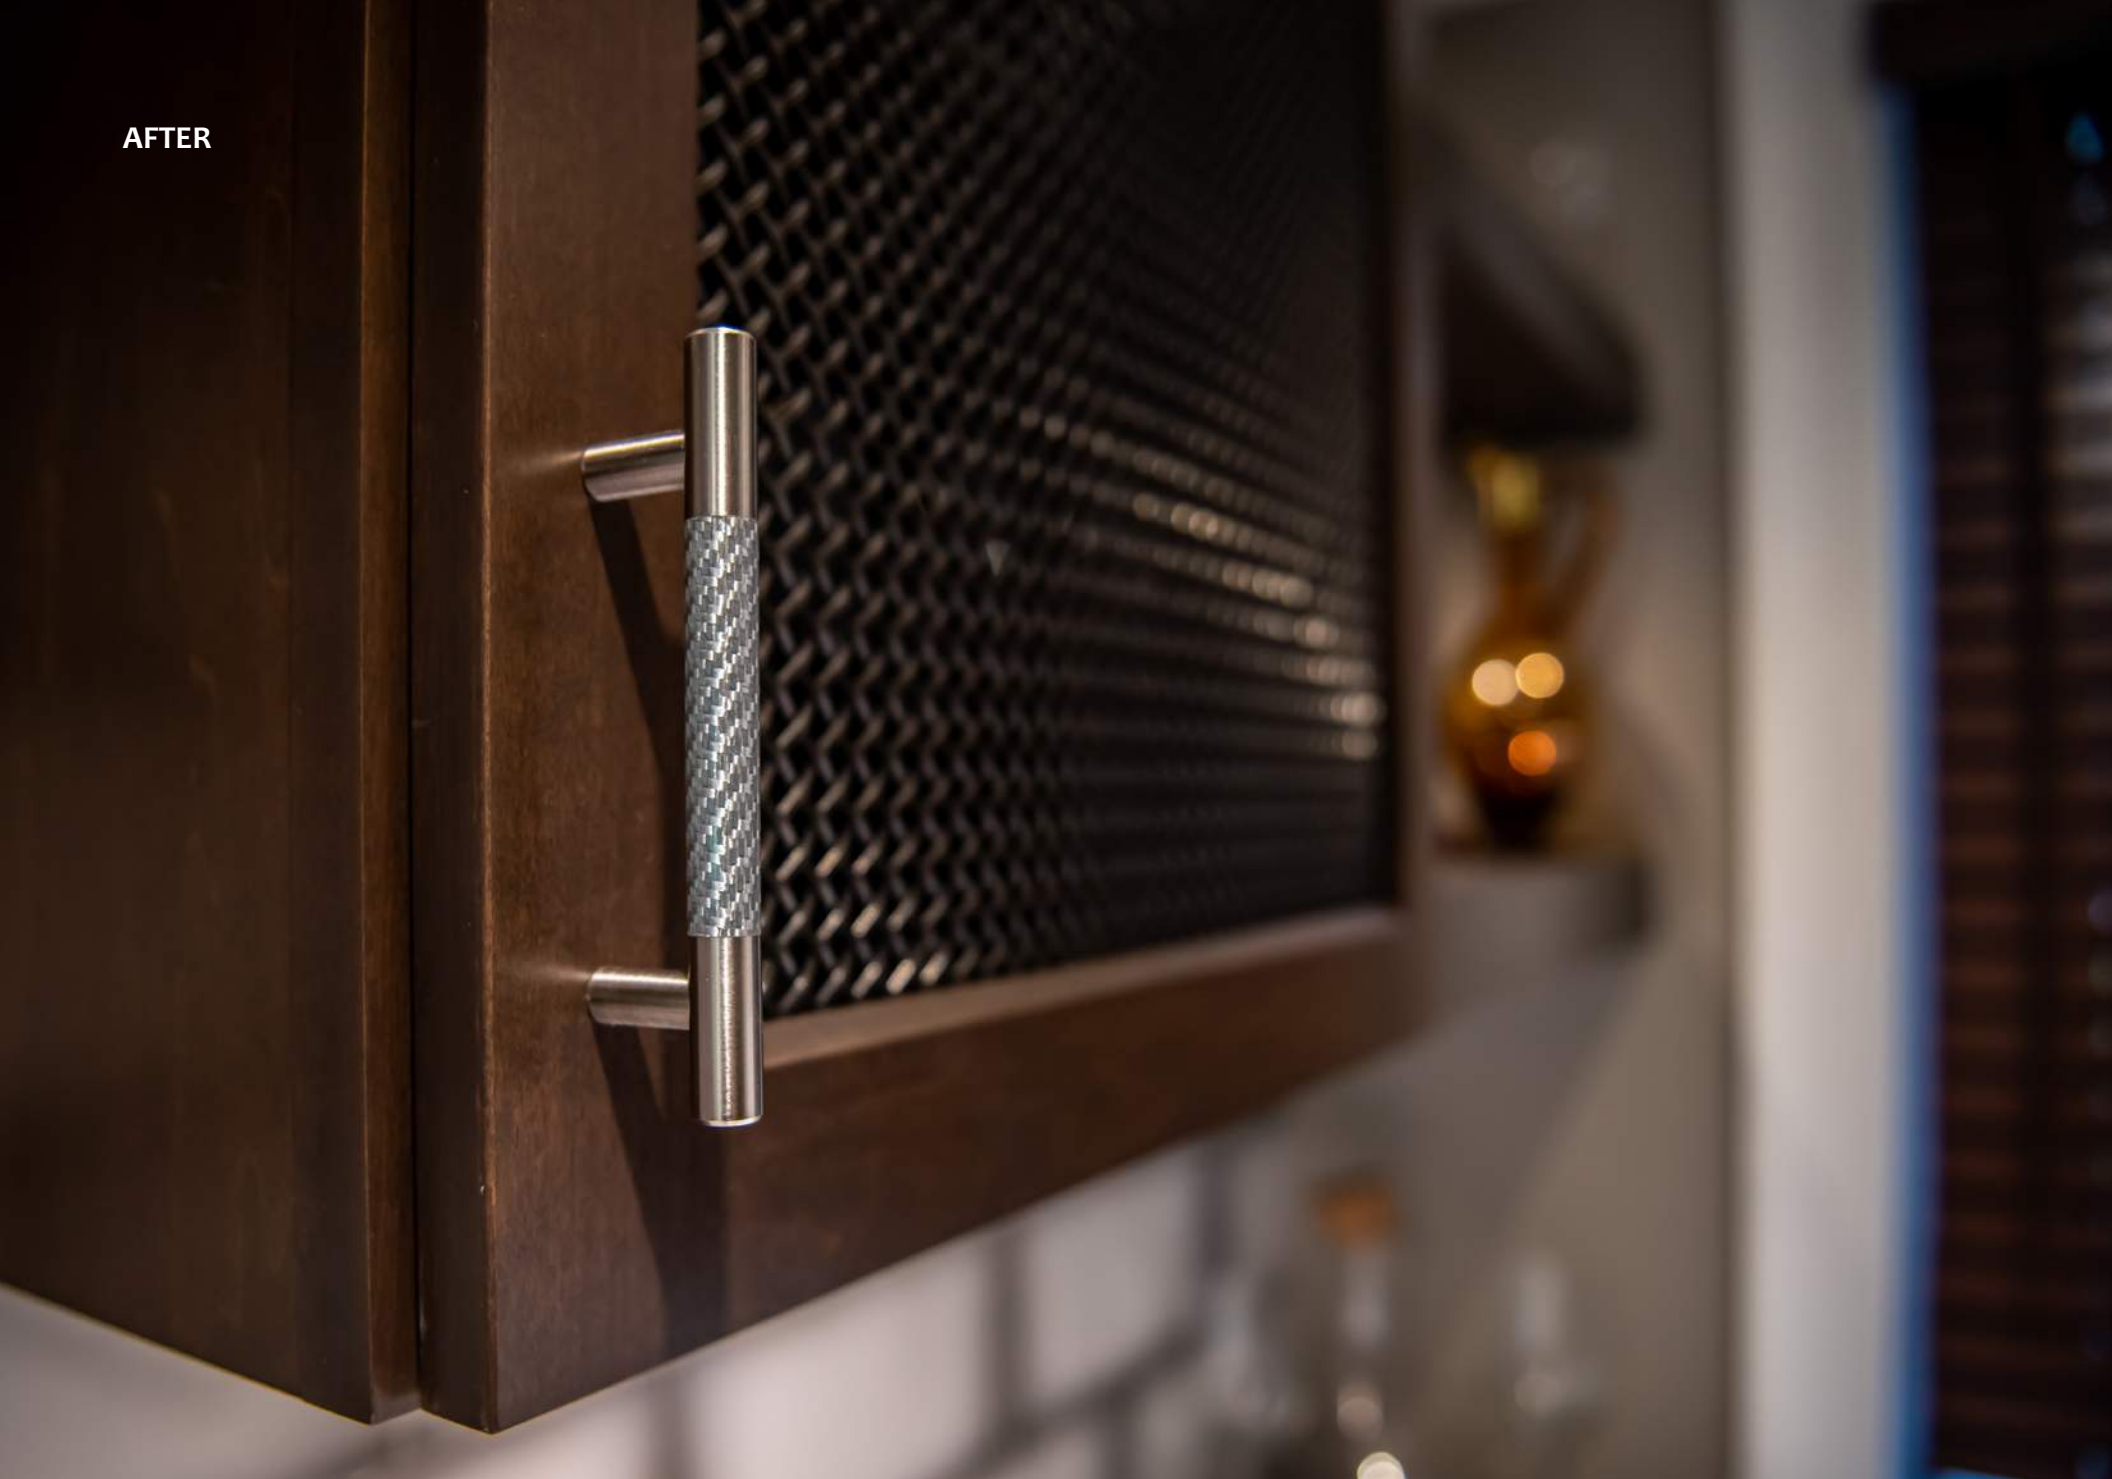
The use of woven wire grille in the upper cabinets is not just a design statement. It is also a functional solution.

Located above the bar sink is a double return air intake, which serves a significant portion of the lower level. This air intake could not be relocated without significant drywall and mechanical work. The solution we decided upon was to hide the return grille in plain sight, which allows the needed airflow back to the furnace.

The use of the woven wire grille in the upper cabinets is not just a design statement, it is also a functional solution. Over the bar sink exists a double return air intake which serves a significant portion of the lower level and there was no location to which this could be relocated without significant drywall and mechanical work. The solution became to hide the return grille in plain sight. The woven wire doors of the recessed cabinet open to reveal the black-painted interior, allowing the needed airflow back to the furnace. The look and solution were repeated as a design feature in the two cabinets left and right of the return grille. No one would be any the wiser without opening the doors.

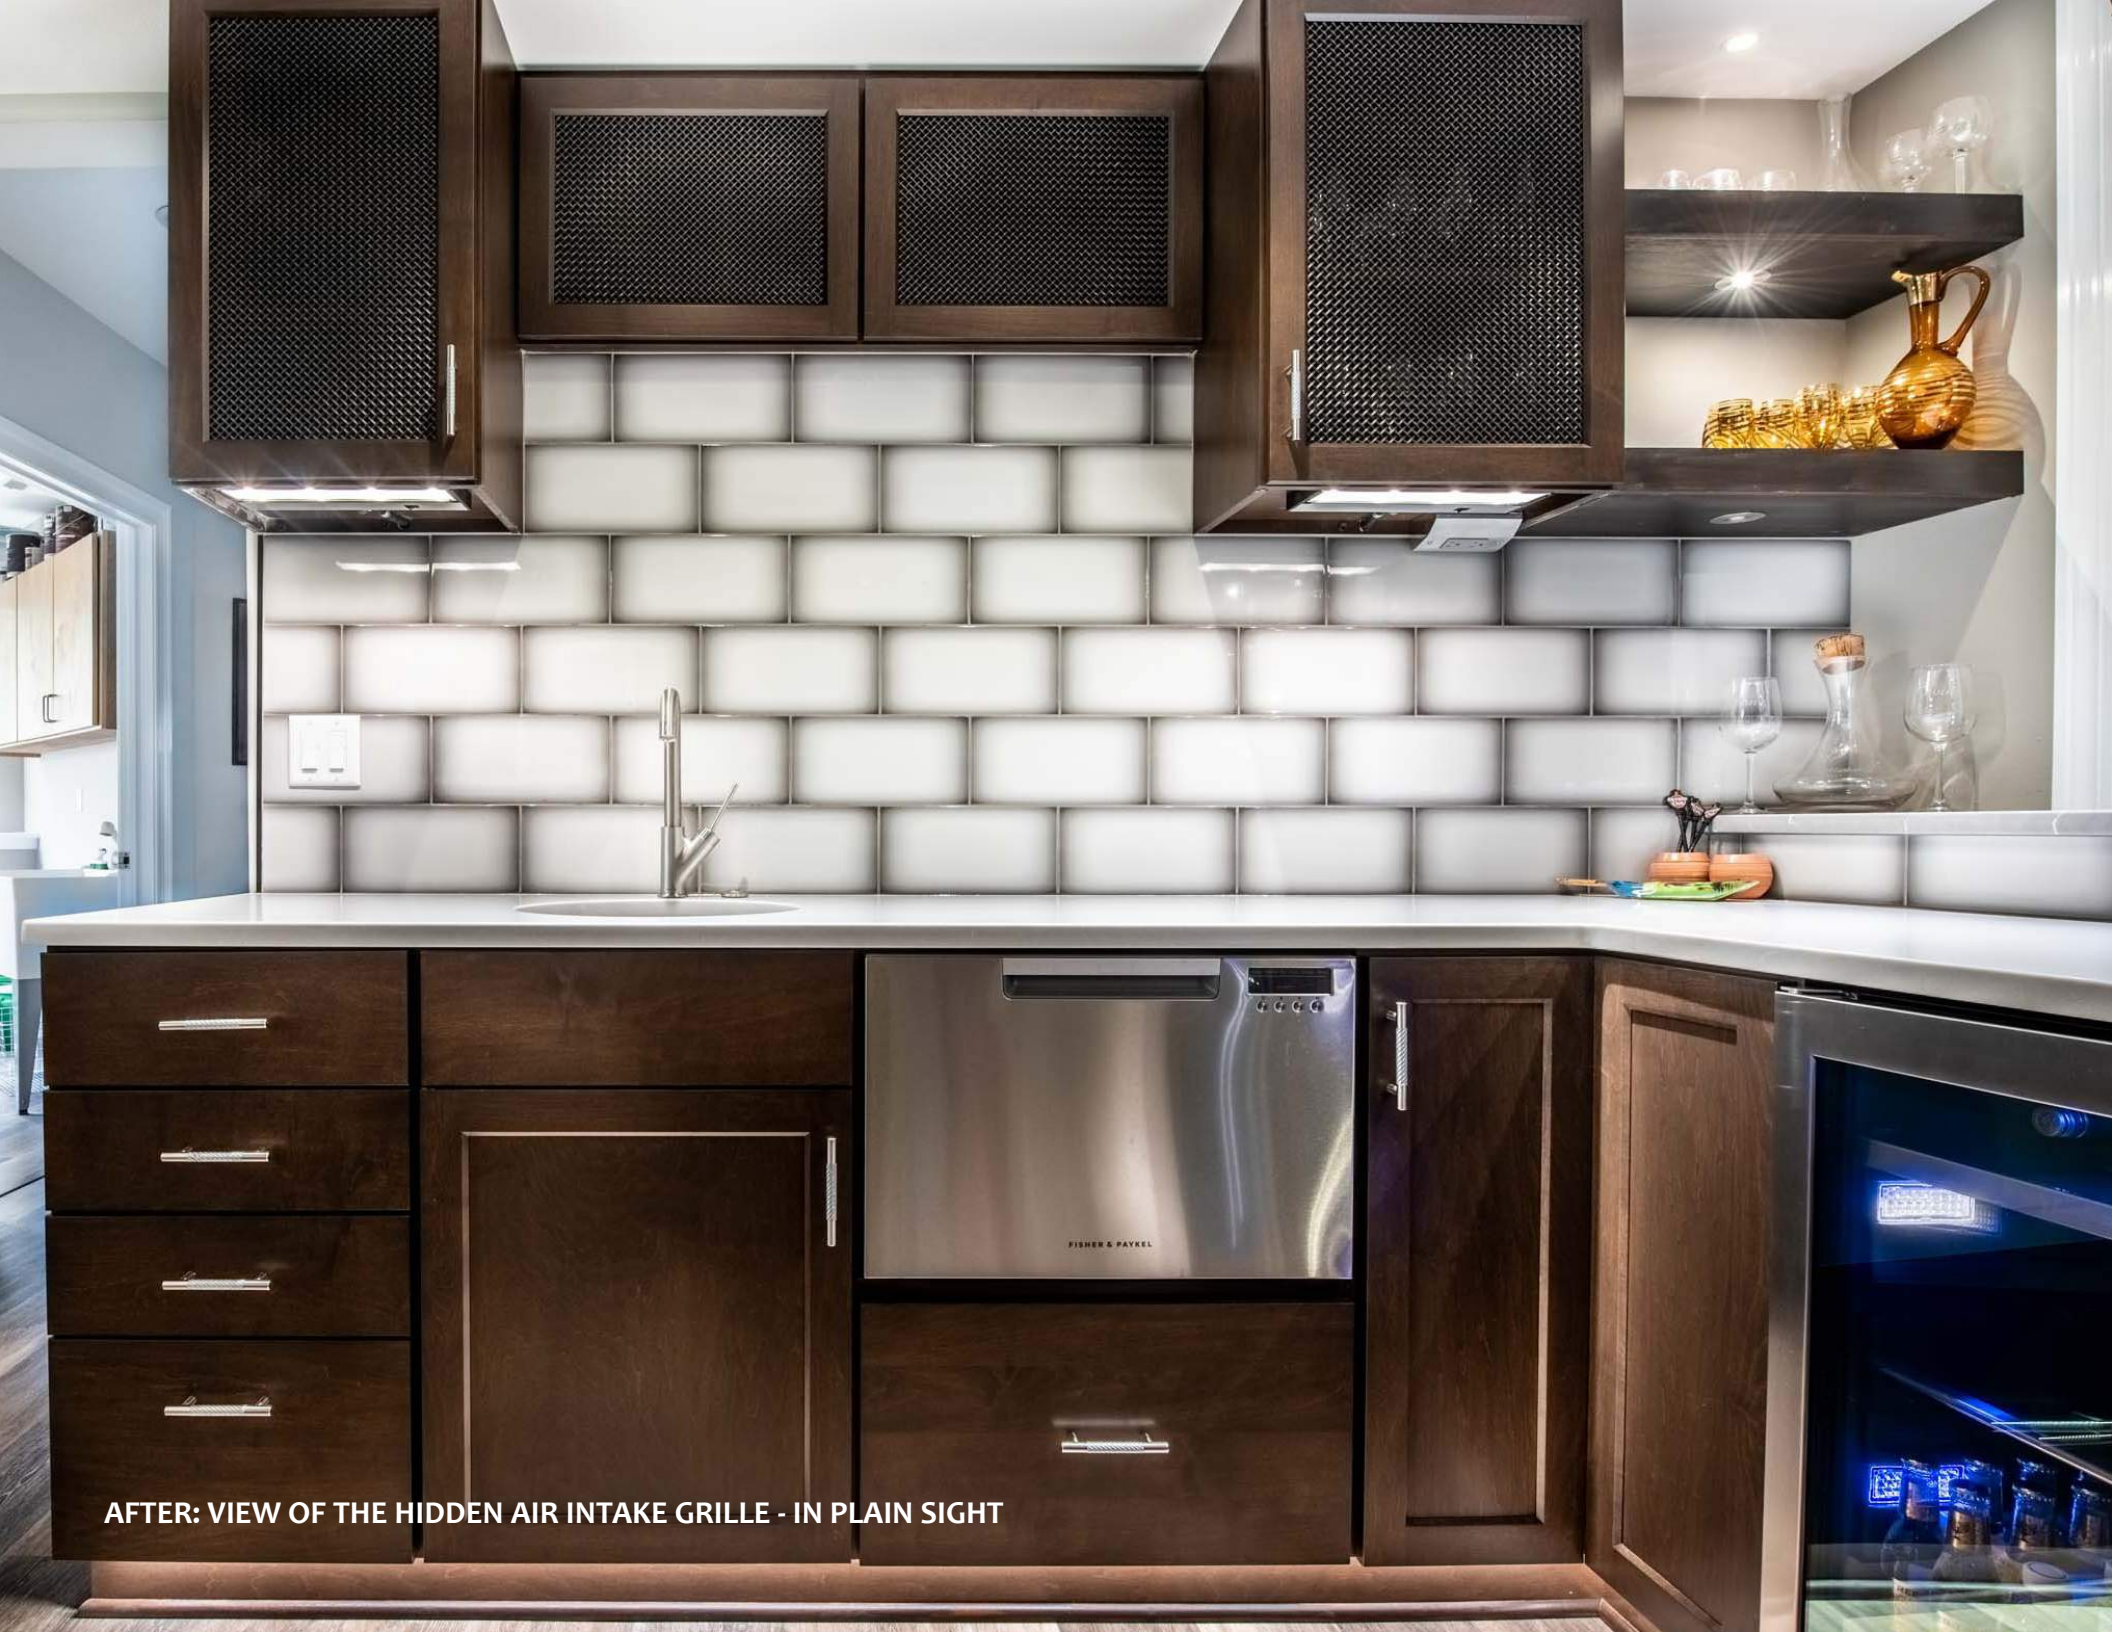
AFTER: THE RECESSED CABINET'S WOVEN WIRE DOORS OPEN TO REVEAL BLACK PAINTED INTERIOR

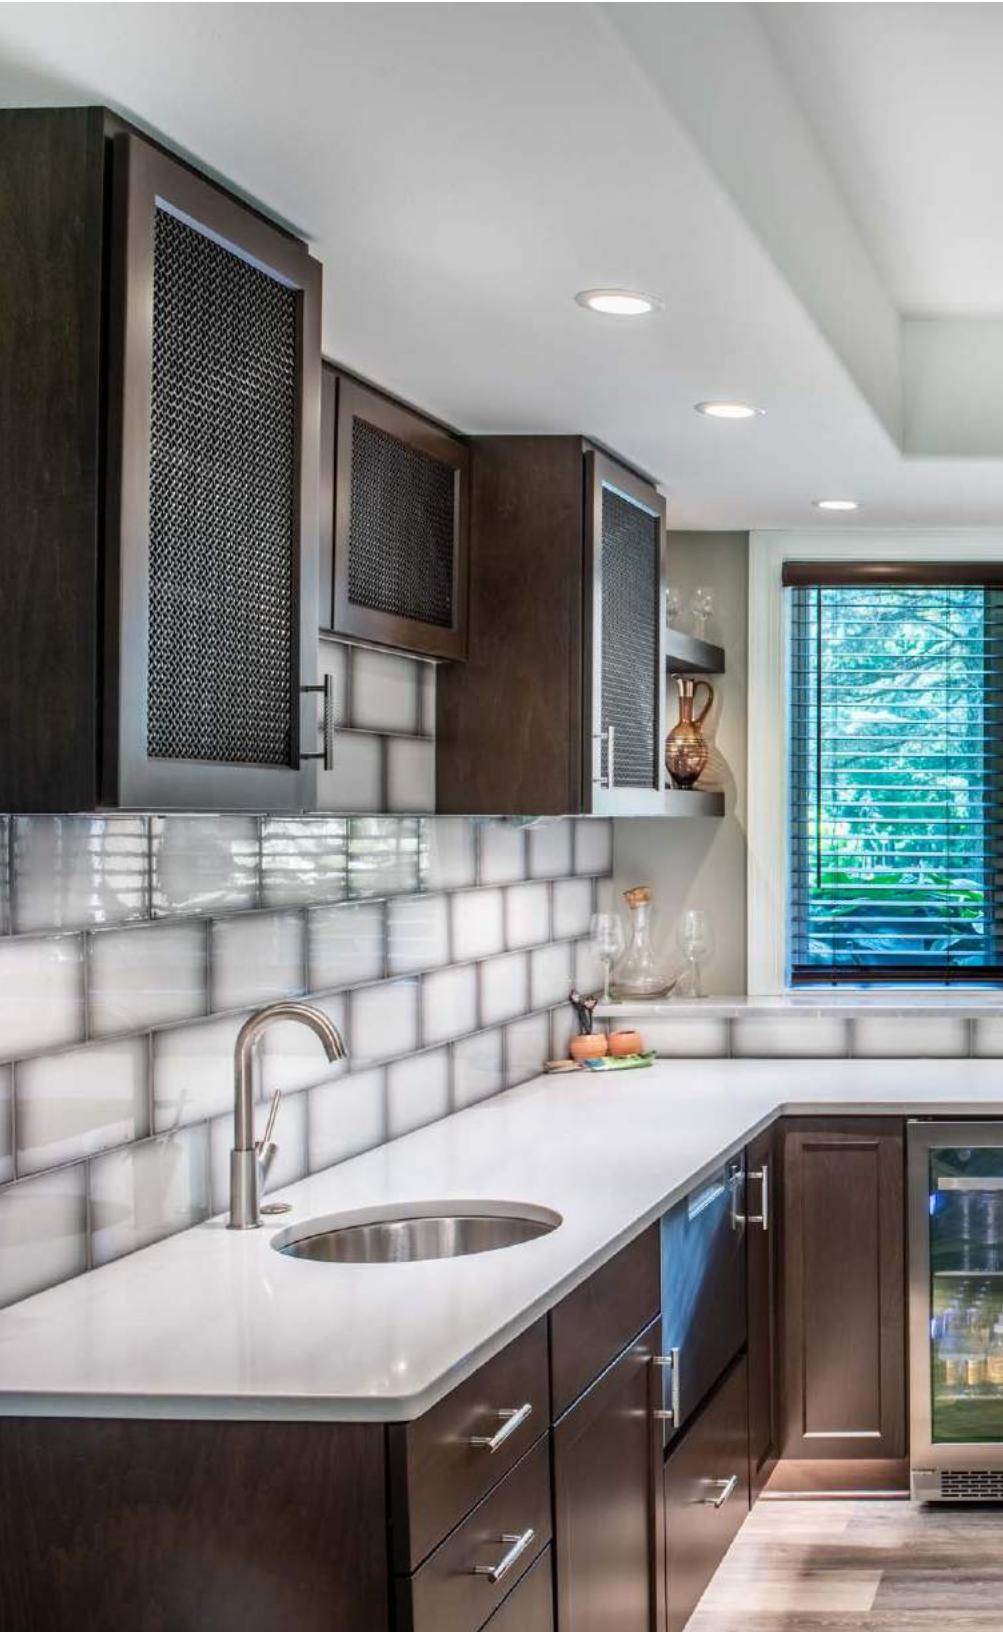
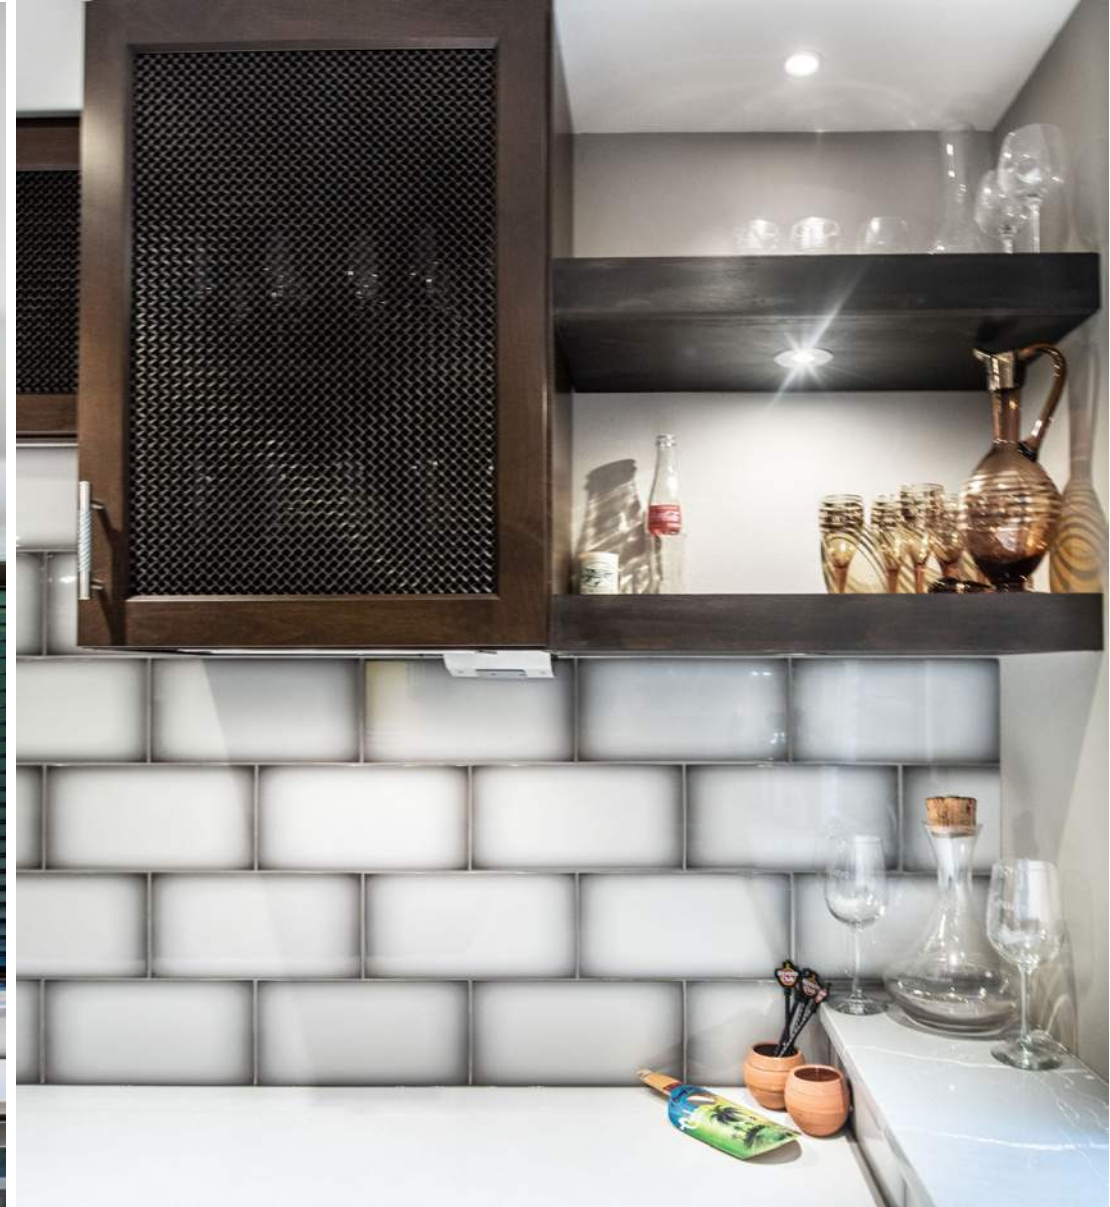
AFTER: VIEW OF THE HIDDEN AIR INTAKE GRILLE - IN PLAIN SIGHT

The look and solution were repeated as a design feature in the two cabinets to the left and right of the grille. No one would be any the wiser without opening the doors.
