Project Category: Residential Interior Element

Residential Interior: \$30,000 and Over

Completion Date: March 16, 2020

Location: Madison, WI

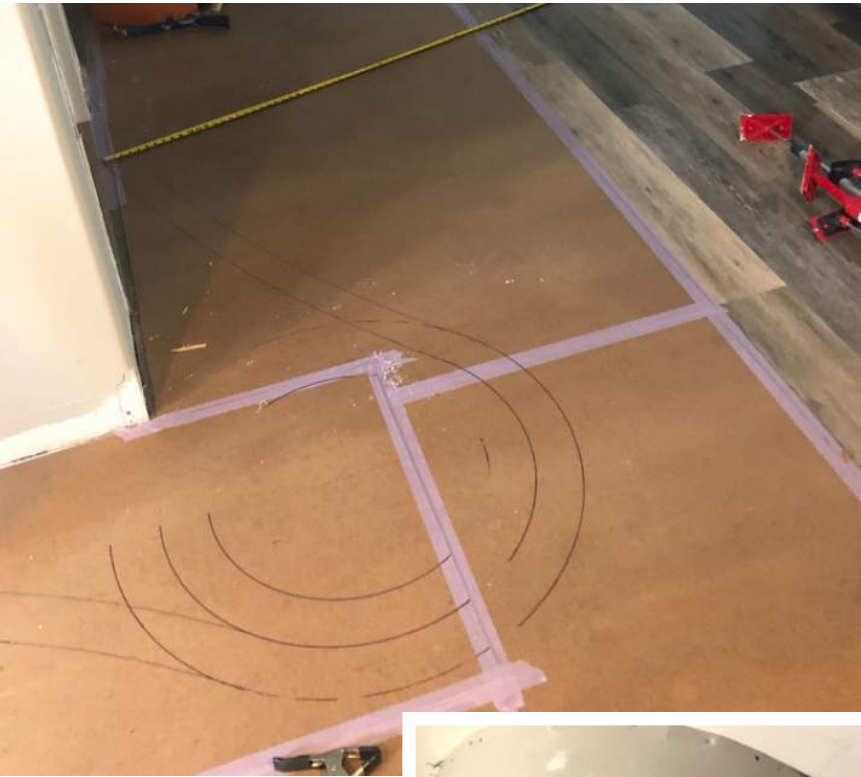
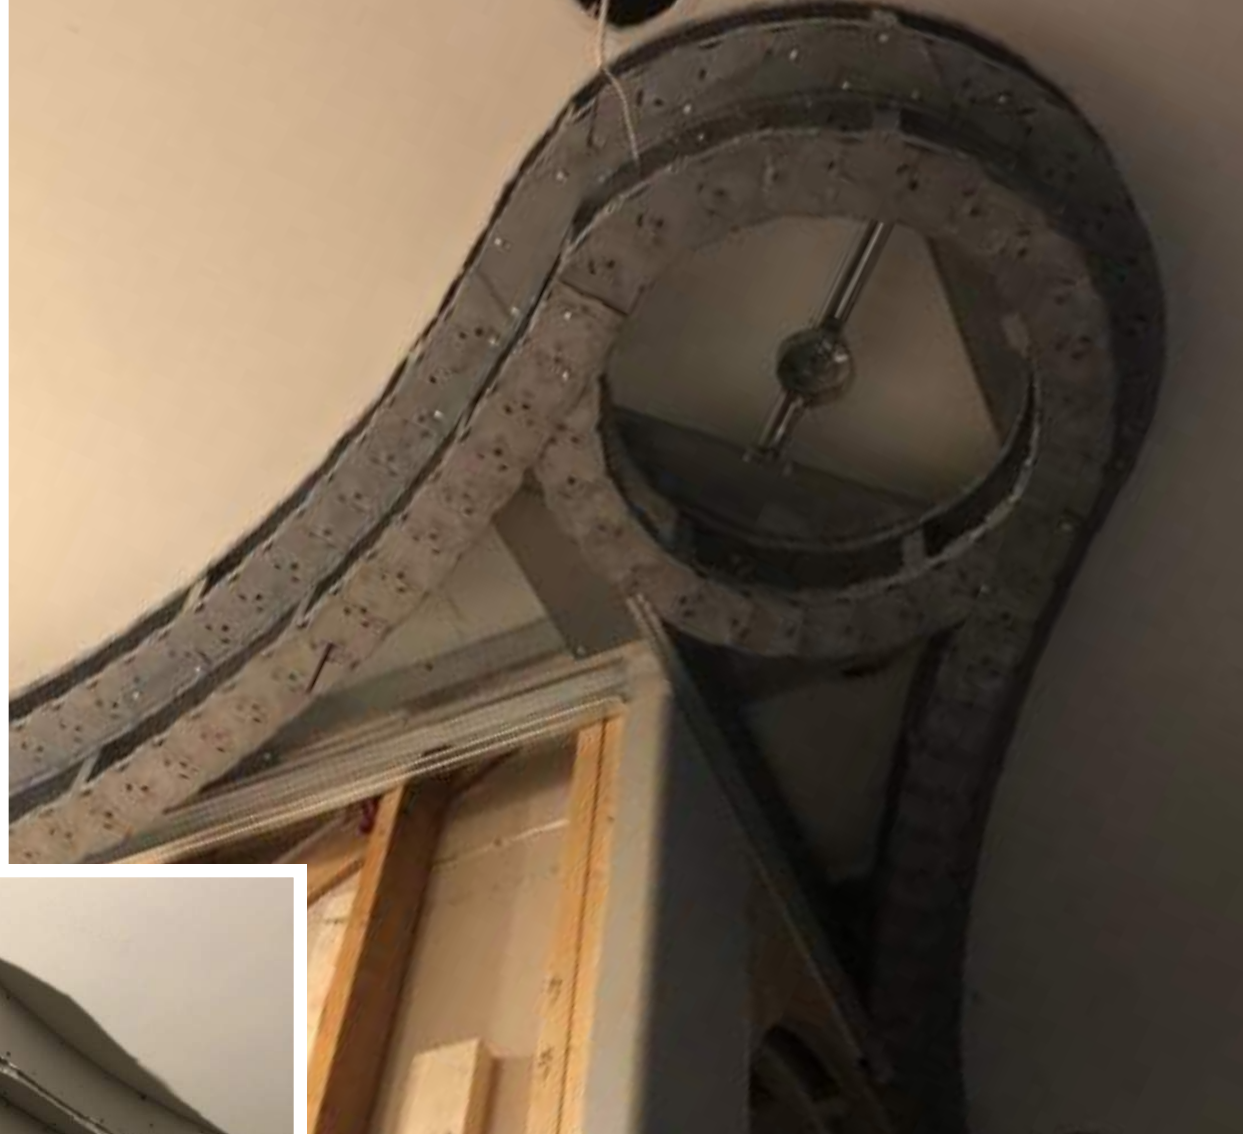
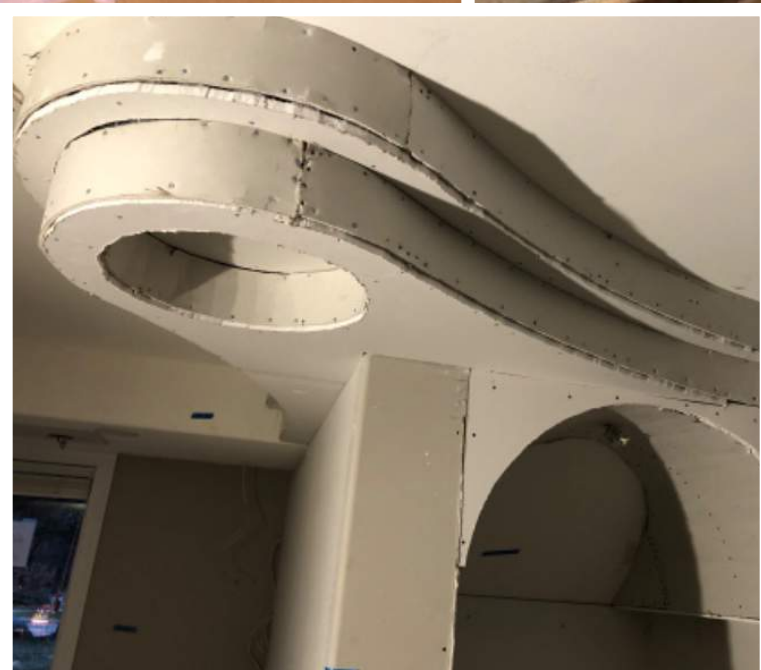
Perhaps one of the most significant features of this remodel, is the uniquely curved soffit, which mimicks the curves of the table below.

CAD drawings allowed us to draw precise circles and radii at full scale by locating exact center points.

There are several ways in which the level of precision and framing and finishing show this evidence. The curved soffit framing itself is architecturally appealing, as well as the arched ceiling in the wine tasting room, which accents the curved drywall work beautifully. The trimwork was executed with precision with perfectly painted cut lines. Custom built floating shelves create a perfect liquor cabinet, and the precisely cut wire cabinet doors (at \$600) offered no room for error.
